Mechanical Seal Analysis (MSA)

Work Order	2155432	Failure Code	S1003
Pump House	TEC	Pump Position	2229
Date	2017-01-20	Seal Model	1030
MSA #	2017-003	Shaft Size	3.625
Inquiry #	I-17-0015	Drawing #	FSI-2209-B
Customer	Anchor Seals	Seal Serial #	01301-R01
Tag #	1317	Inboard Rotary Material	Silicon Carbide
End User	USS Clairton	Inboard Stationary Material	Tungsten Carbide
Contact	Jason DiBiase	Install Date	12/05/2015
Phone	412-327-5375	Removal Date	01/17/2017
		Days in Service	409 Days

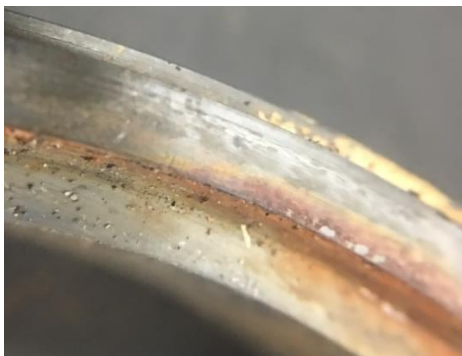
Stationary: Tungsten Carbide – face showed signs of heat checking (Figure 1)

Figure 1: visible heat checking

The heat checking on the face would suggest lack of lubrication between seal faces. This causes the seal face to become hot and lose its seal with the mating ring.

Ensure flush lines are free of debris. Provide adequate continuous flush to seal faces to prevent heat checking.

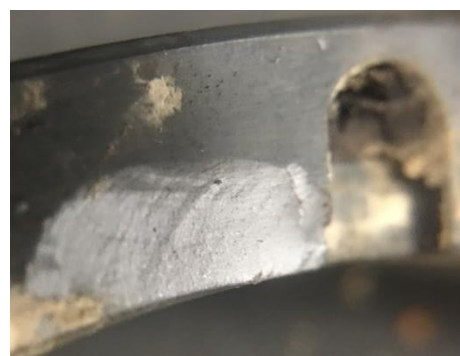
Rotary: Silicon Carbide – small chip by drive lug (Figure 2)

Figure 2: small chip by drive lug
