Mechanical Seal Analysis (MSA)

Work Order	N/A	Failure Code	P1000
Pump House	Total Equipment Co.	Pump Position	339
Date	2017-01-25	Seal Model	1040/SP
MSA #	2017-009	Shaft Size	2.000"
Inquiry #	I-17-0007	Drawing #	2357
Customer	Anchor Seals	Seal Serial #	02053
Tag #	N/A	Inboard Rotary Material	Silicon Carbide
End User	USS Clairton	Inboard Stationary Material	Antimony Carbon
Contact	Jason DiBiase	Install Date	Not Given
Phone	412-327-5375	Removal Date	Not Given
		Days in Service	Not Given

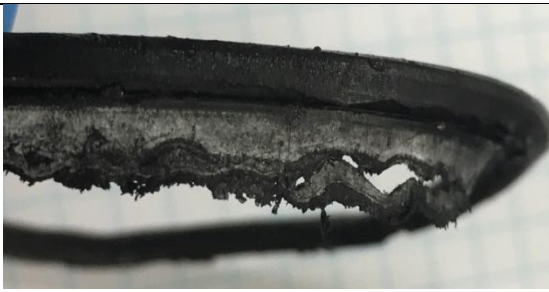
Figure 1

Bushing o-ring was degraded (Figure 1). Shaft sleeve o-ring was cut in half (info from TEC).

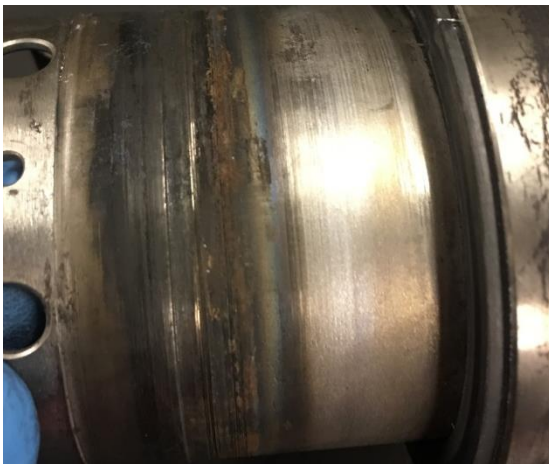
Figure 2

Sleeve: rubbing on OD, heat damage (Figure 2)

It would suggest the seal failure was attributed from the pump run-out. This is shown by:

1. The rubbing on the sleeve OD
2. The rubbing on the gland ID
3. The fatigued springs from heat damage.

It is recommended to check pumps for run out. This will allow seals to be repairable. Check pump manufacturer's specifications and ensure they are "in spec" before installing new seal.

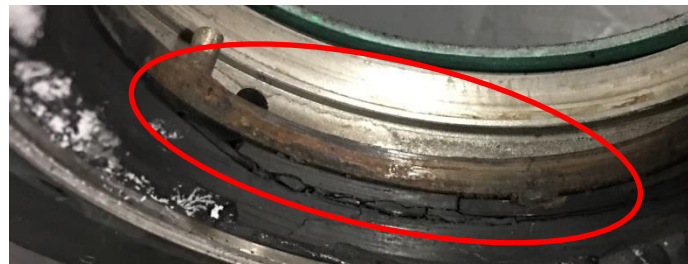
Figure 3

Gland: rubbing on ID, heat damage (Figure 3)
