Mechanical Seal Analysis (MSA)

Work Order #	N/A	Failure Code	S-1005
Date	3/29/17	Pump Position	P-2031
MSA #	2017-053	Seal Manufacturer	FSI
Inquiry #	I-17-0104	Seal Model	1040/SP
Customer	Anchor Seals	Shaft Size	1.750"
Job #	2157653	Drawing #	2215
End User	USS Clairton	Seal Serial #	01558-R01
Pump House	Total Equipment Co.	Inboard Rotary Material	Silicon Carbide
Contact (TEC)	Ron Sipes	Inboard Stationary Material	Carbon
Phone	412-269-0999	Install Date	N/A
Salesperson	Jason DiBiase	Removal Date	N/A
		Days in Service	N/A

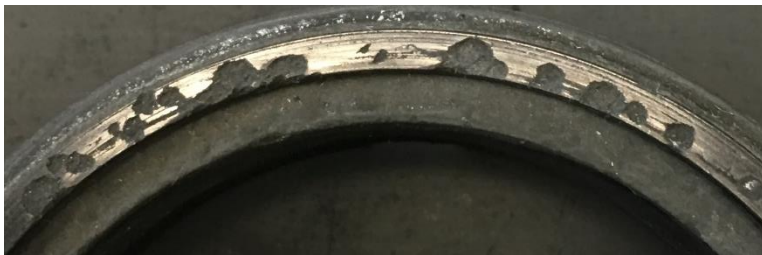
Figure 1

Stationary: Carbon – blistering, abrasive wear (Figure 1)

The blistering on the carbon was caused by the heat generation due to lack of clean fluid between the seal faces. This heat generated caused a thermal shock to the silicon, which resulted in the damage in Figure 2.

Ensure all flush lines are free of debris to produce a clean fluid between the seal faces.

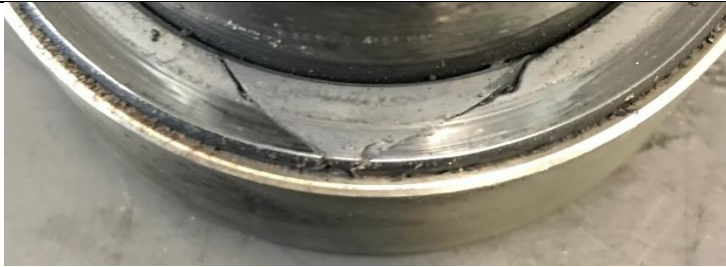
Figure 2

Rotary: Silicon Carbide – fractured into multiple pieces (Figure 2)

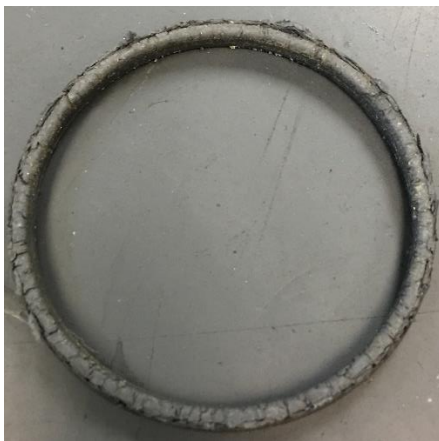
Figure 3

IB stationary Elastomers show signs of chemical degradation. (Figure 3)
