Mechanical Seal Analysis (MSA)

RB Work Order #	3332158	Failure Code	P1000
Date	04/10/2017	Pump Position	P-620A
MSA #	2017-061	Seal Manufacturer	PPC
Inquiry #	I-17-0118	Seal Model	1500E
Customer	Anchor Seals Inc.	Shaft Size	2.125"
Job #	2158169	Drawing #	-
End User	USS Clairton	Seal Serial #	00885
Pump House	Total Equipment Co.	Inboard Rotary Material	Silicon Carbide
Contact (TEC)	Ron Sipes	Inboard Stationary Material	Tungsten Carbide
Phone	(412) 269-0999	Elastomers	Chemrez 505
Salesperson	Jason DiBiase	Install Date	02/20/2012
		Removal Date	02/20/2017
		Days in Service	1827

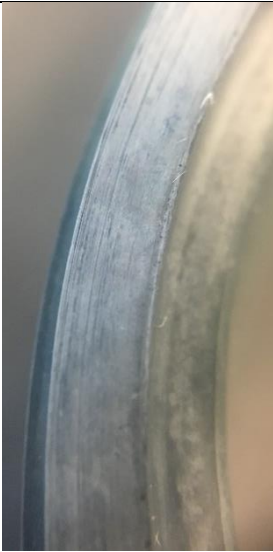
Figure 1

Stationary: Tungsten Carbide – abrasive scoring, chipping (Figure 1)

Abrasive scoring and blistering would suggest lack of lubrication to seal faces. Mechanical seal faces need adequate lubrication for operation. When the faces lack lubrication it causes the temperature to rise creating blisters. Five years is an excellent run time.

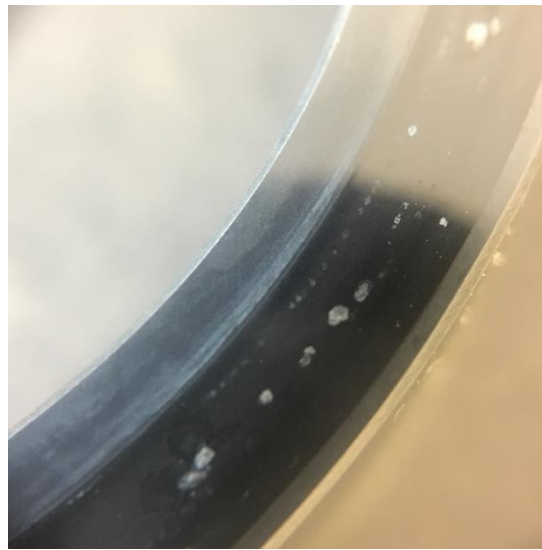
Figure 2

Rotary face fracture could be seen from exterior. Seal had no compression.

Rotary: Silicon Carbide – Blistering, fractured (Figure 2)

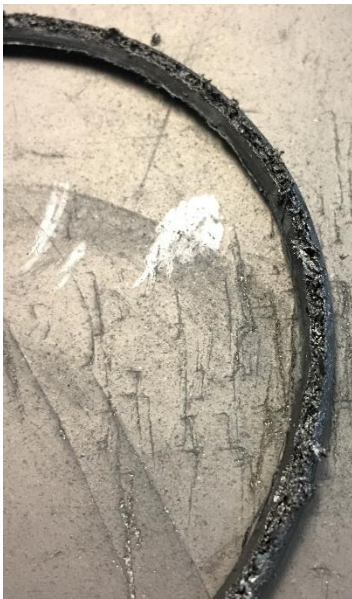
Figure 3

All elastomers showed signs of chemical and thermal degradation. (Figure 3)

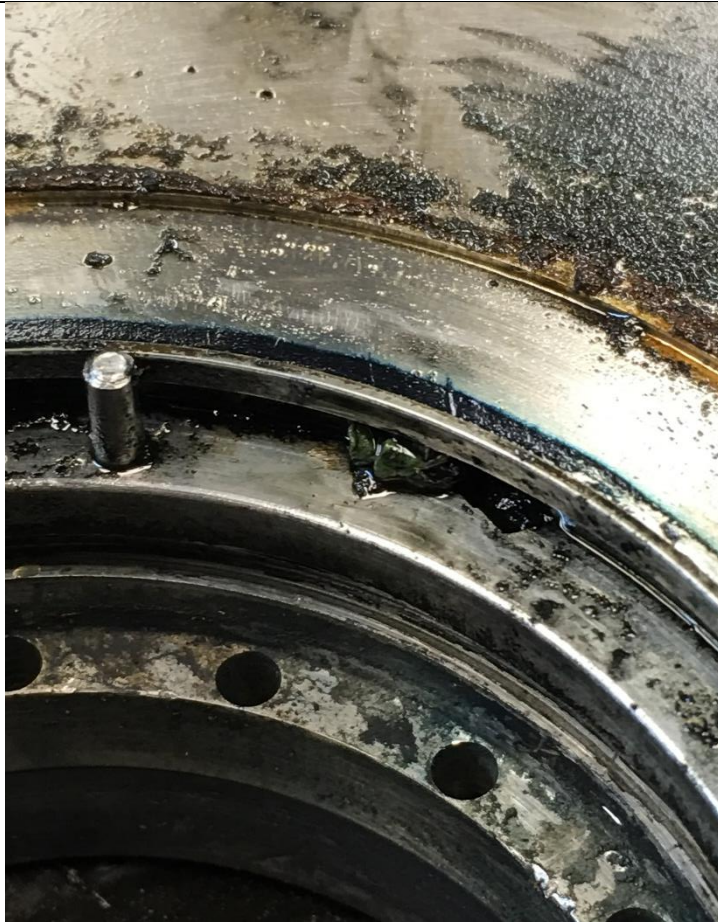
Debris found in flush port (Figure 4)

Figure 4: Hard debris found in flush port

The debris found in the flush port could've caused a lack of lubrication to the faces.

Ensure all flush lines are free of debris by cleaning or replacing them each time a mechanical seal is replaced.
