Mechanical Seal Analysis (MSA)

RB Work Order #	3762903	Failure Code	S1002
Date	08/31/17	Pump Position	2019
MSA #	2017-086	Seal Manufacturer	FSI
Inquiry #	I-17-0199	Seal Model	1040/HD
Customer	Anchor Seals Inc.	Shaft Size	2.125"
Job #	2162348	Drawing #	2395-B
End User	USS Clairton	Seal Serial #	02061
Pump House	Total Equipment Co.	Inboard Rotary Material	Silicon Carbide
Contact (TEC)	Ron Sipes	Inboard Stationary Material	Carbon
Phone	(412) 269-0999	Elastomers	Kalrez 1050 LF
Salesperson	Jason DiBiase	Install Date	11/17/2015
		Removal Date	08/31/2017
		Days in Service	653

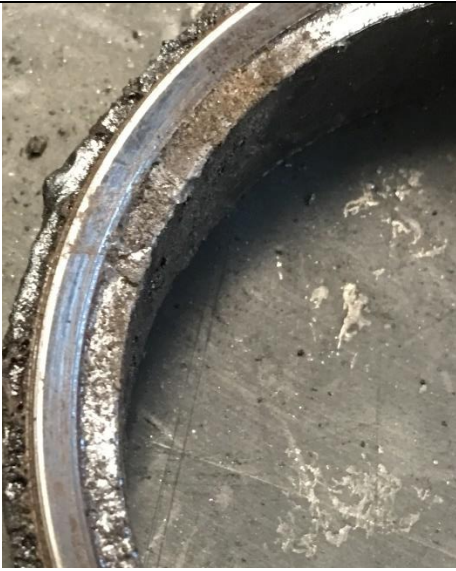
Figure 1

Stationary: Carbon – recessed carbon nose (Figure 1)

The seal appeared to have failed due to lack of lubrication across the seal face. The product worked its way between the faces causing the grooving. It also clogged the springs not allowing axial movement.

Ensure steam quench is operating at 3-5 psi to keep product in a liquid state to aid in draining. Once product becomes hardened it will cause significant damage to seal.

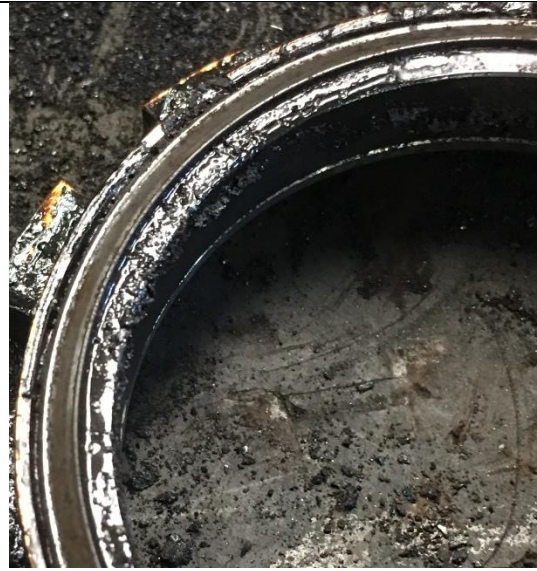
Figure 2

Rotary: Silicon Carbide – heat checking, recessed wear groove (Figure 2)

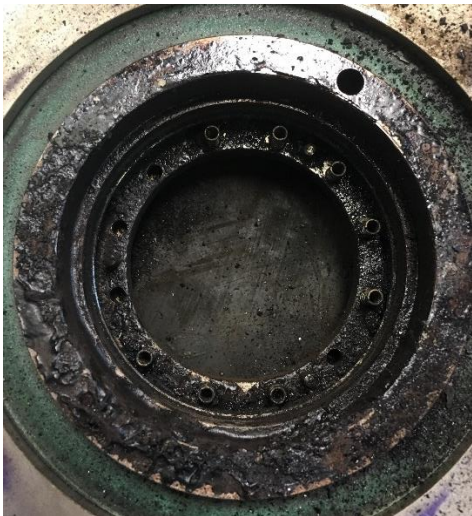
Figure 3

Gland – coated with hardened product, no metal deformation (Figure 3)
