## Mechanical Seal Analysis (MSA)

<b>Work Order</b>	4875947	<b>Failure Code</b>	S1008
<b>Date</b>	12/3/18	<b>Pump Position</b>	P594B
<b>MSA #</b>	2018-083	<b>Seal Model</b>	FSI 1030
<b>Inquiry #</b>	I-18-0147	<b>Shaft Size</b>	1.125"
<b>Customer</b>	ASI	<b>Drawing #</b>	MS103000182XSX77
<b>Tag #</b>	2175727	<b>Seal Serial #</b>	02216
<b>End User</b>	USS Clairton	<b>Inboard Rotary Material</b>	Silicon Carbide
<b>Contact</b>	Ron Sipes	<b>Inboard Stationary Material</b>	Tungsten Carbide
<b>Phone</b>	412-269-0999	<b>Outboard Rotary Material</b>	N/A
<b>Salesperson</b>	J DiBiase	<b>Outboard Stationary Material</b>	N/A

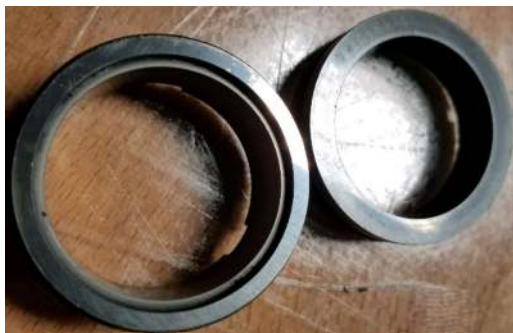
Seal faces showed minimal wear.

Overall seal condition looked good. It appears the gland came in contact with the sleeve. This could be from installation or the gland became loose and “dropped”. The contact from the sleeve to the gland caused excessive heat and the orings took a set. The heat also caused the faces to go out of flat which caused leakage.

It is recommended to review seal installation procedures ensuring that the gland is center on the stuffing box. Check concentricity of stuffing box and coupling alignment to manufacturer’s specifications.

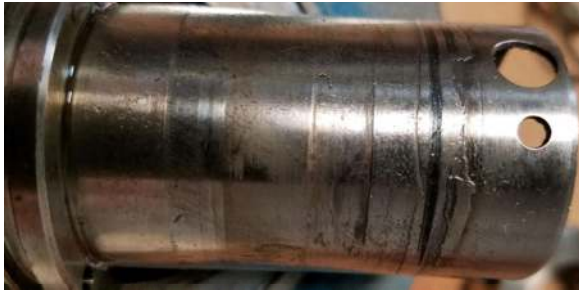
Sleeve worn on OD

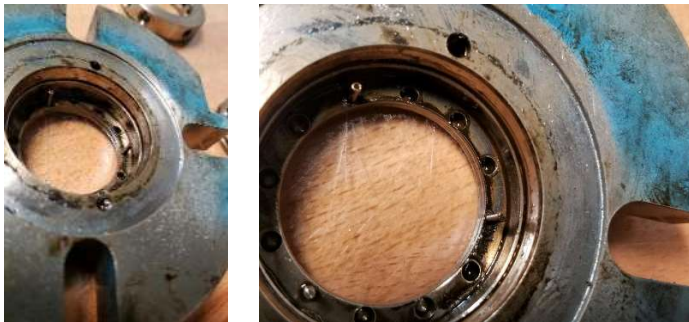
Gland worn on ID from contact with sleeve
