Mechanical Seal Analysis (MSA)

Date	1/29/19	Pump Position	203A
MSA #	2019-006	Seal Manufacturer	PPC
Inquiry #	I-19-0011	Seal Model	151
Customer	Anchor Seals	Shaft Size	2.625"
Customer Ref #	2176903	Drawing #	A-5116-E
End User	USS Clairton Works	Seal Serial #	00904
Pump House	TEC	Inboard Rotary Material	Tungsten Carbide
Contact	Jason DiBiase	Inboard Stationary Material	Tungsten Carbide
Phone	412-299-6900	Outboard Rotary Material	-
Salesperson	House	Outboard Stationary Material	-
		Elastomers	Chemraz

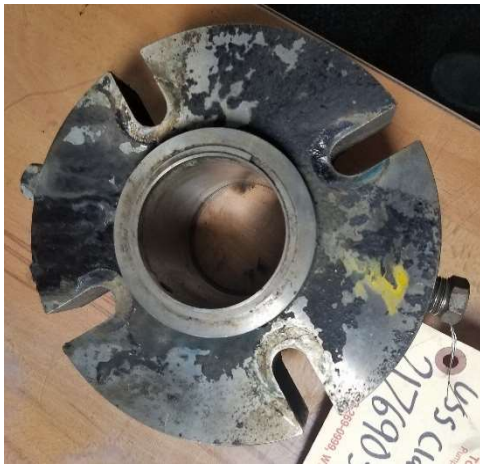
Seal was returned assembled. Flush port was open and clear of debris.

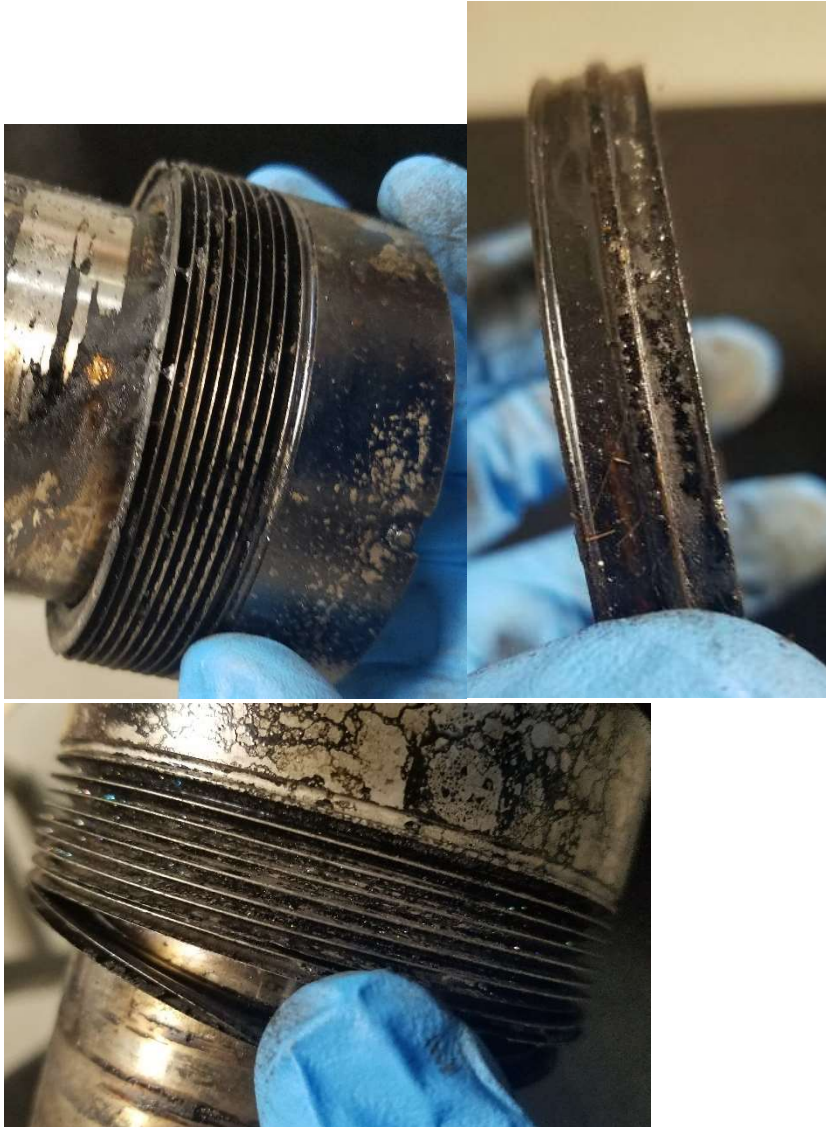
Tungsten carbide face bellows capsule was fractured and came off in two pieces.

Failure Explanation: The seal appears to have failed due to the bellows fracture. From the breakage it appears there was a high level of torque at the seal face interchange due to the lack of lubrication. This caused the setting of the process between the seal faces and when the pump turned on the bellows weld at the front adapter broke, which caused the seal to lose its compression and leak.

Maintain liquid across the seal faces at all times. Steam trace the stuffing box and/or keep a quench with low pressure steam on the seal to prevent the product from solidifying. A Plan 11 is recommended for single seals with standard bore stuffing boxes. This ensures product is moving from stuffing box and helps remove heat being generated by the seal faces.

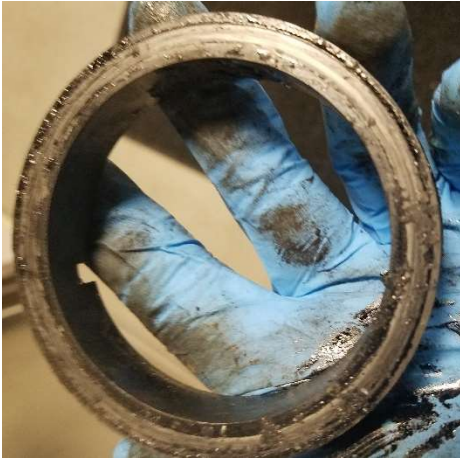
Tungsten carbide stationary face was coated with product but shows even wear pattern.

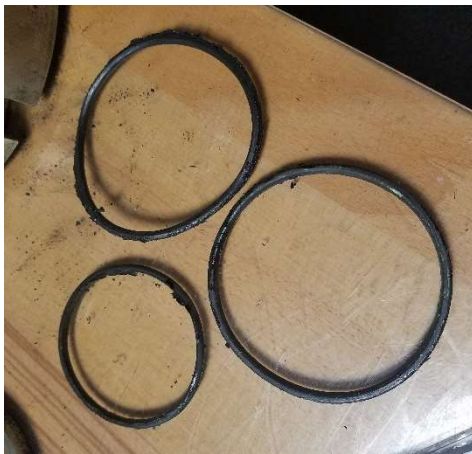
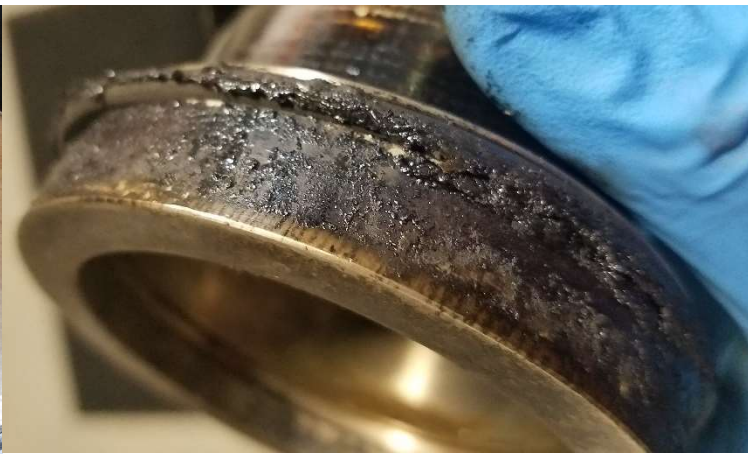
All o-rings were swelled and extruded from sleeve ID, sleeve OD and stat face OD.

As a result of the product solidifying, which is noted on the gland and the seal moving caused the orings to extrude from their groove.

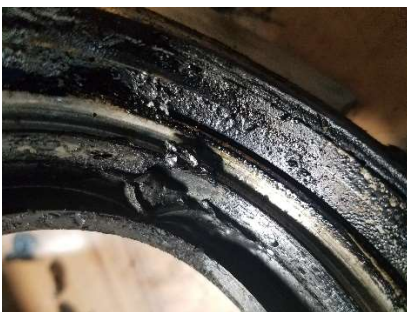
Gland bore was full of caked on product
