Mechanical Seal Analysis (MSA)

Date	3/20/19	Pump Position	TTYP-1
MSA #	2019-018	Seal Manufacturer	FSI
Inquiry #	I-19-0046	Seal Model	MS2080N00
Customer	Anchor Seals	Shaft Size	1.875"
Customer Ref #	2178982	Drawing #	FSI-2330
End User	USS Clairton Works	Seal Serial #	02211
Pump House	TEC	Inboard Rotary Material	Silicon Carbide
Contact	Jason DiBiase	Inboard Stationary Material	Tungsten Carbide
Phone	412-299-6900	Outboard Rotary Material	Silicon Carbide
Salesperson	House	Outboard Stationary Material	Tungsten Carbide
		Elastomers	Kalrez 6375

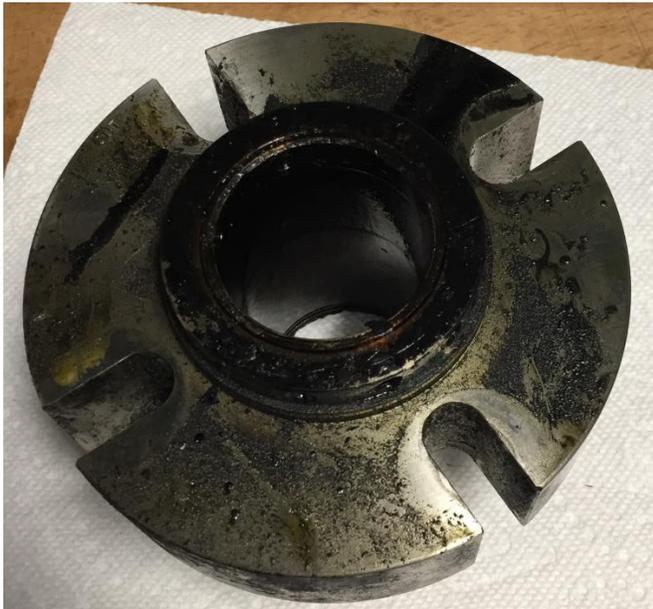
Seal was returned assembled cover in product. The product had hardened and was preventing the seal from rotating.

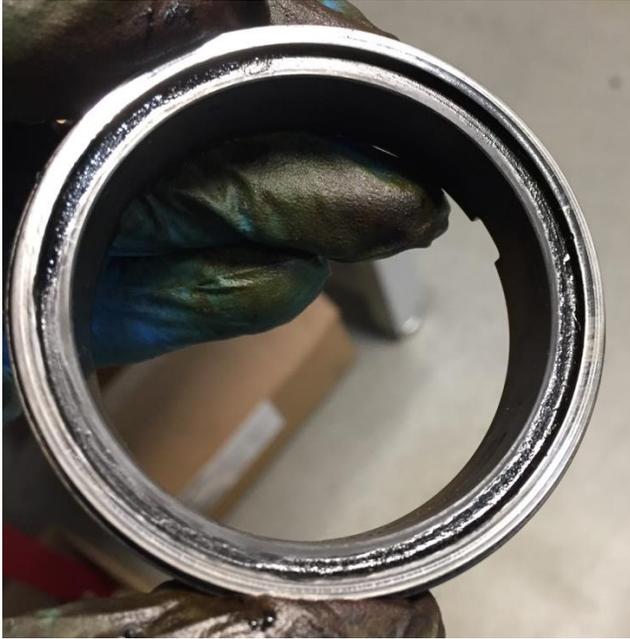
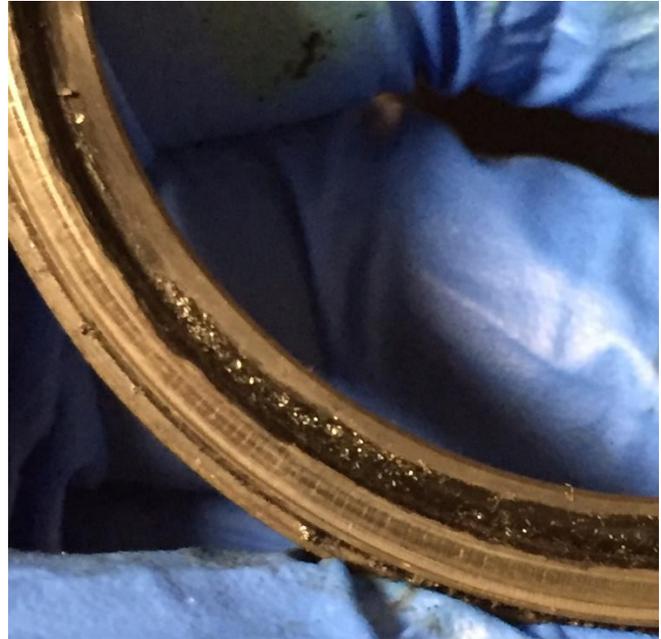
Inboard Tungsten carbide stationary face was coated in product. Once cleaned it shows chipping on the ID and heat checking across the face.

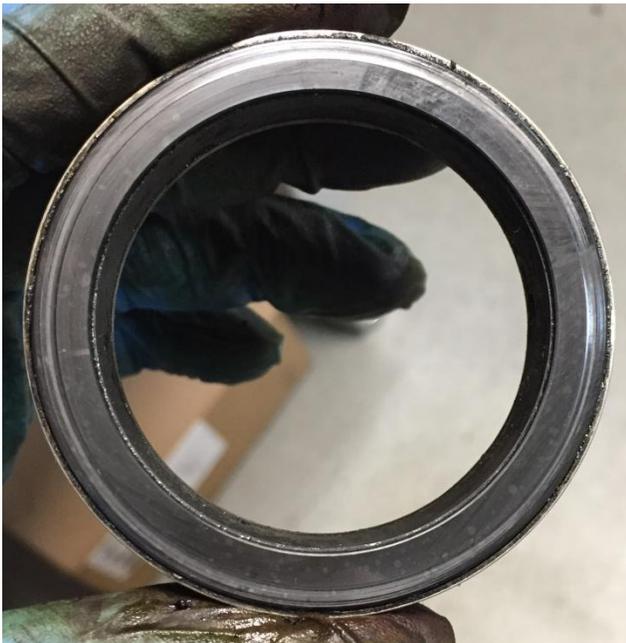
Inboard silicon carbide rotary face was coated in product. Once cleaned showed a groove wore into the sealing face.

Failure Explanation: It would appear that this seal failed due either hardened product sticking the inboard faces from sealing or the barrier pot not being maintained at the correct level/pressure. Both barrier ports were clogged with the hardened product. This indicates that the barrier fluid was lost at some point during operation. The product appeared to build-up in the seal. Torque from the pump along with the hardened product resulted in the broken and chipped faces. Evidence to further support this is the rubbing on the ID of the sleeve and the flattened drive screws. This means that at some point during the operation the shaft rotated inside of the seal sleeve due to the hardened product.

Recommendation: It is recommended to keep the barrier fluid in the seal pot at the recommended level and pressurized 15-25 psi above the maximum stuffing box pressure. This practice will help maintain the proper pressure differential between the process fluid and barrier fluid. Also in order to prevent the loss of the seal in the event of the loss of barrier fluid we suggest installing a low level alarm and/or a pressure switch.

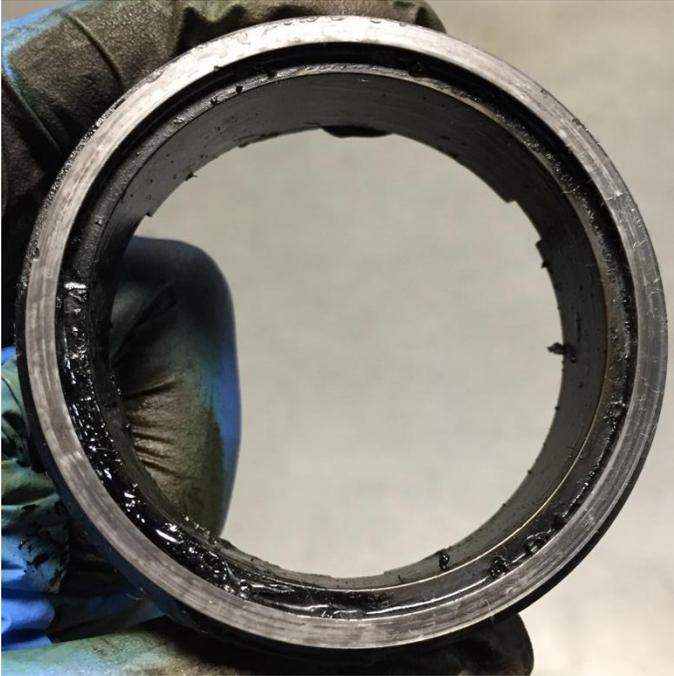
Outboard Tungsten carbide stationary face was covered in product. Once cleaned it had chipping around the OD.

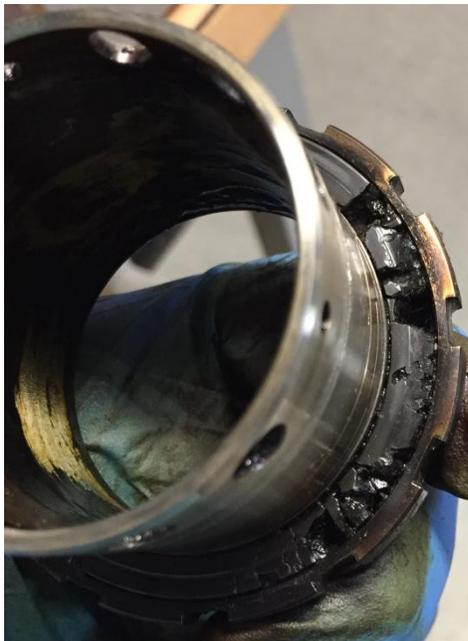
Outboard silicon carbide rotary face was coated in product. Once cleaned it was cracked, chipped and broken in several locations.

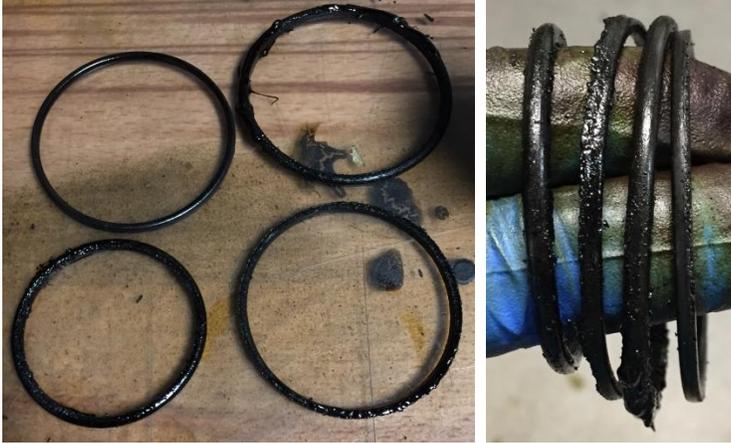
All O-rings are swollen, hardened and were extruding from grooves.

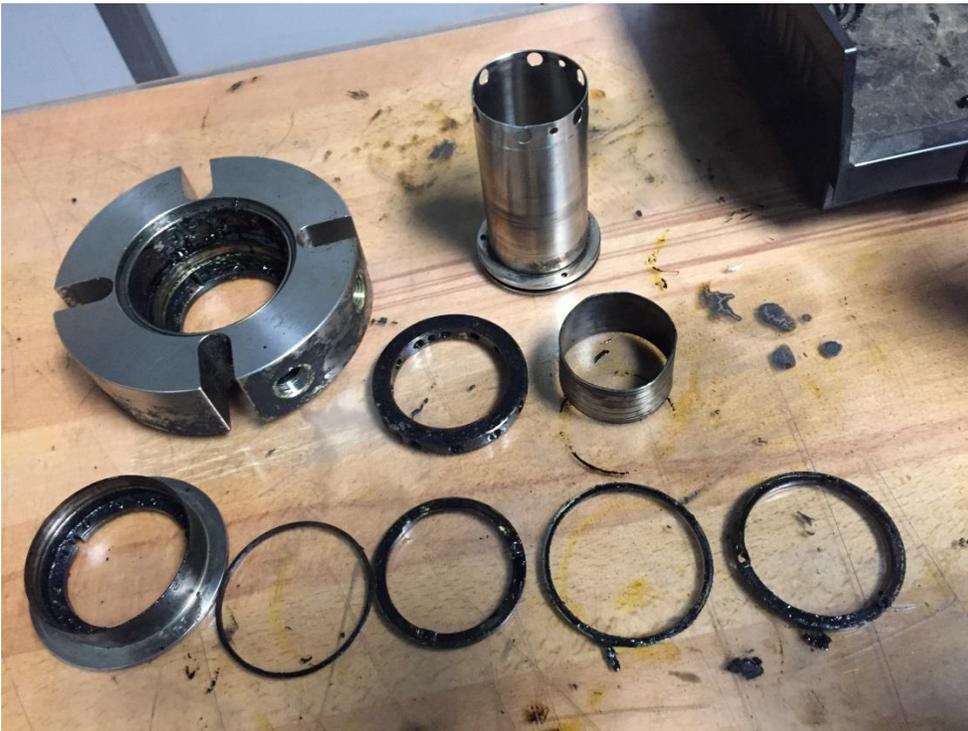
Gland Plate, Inboard Gland, Sleeve, Thrust Discs, Back Up Rings, Seat Carrier and Drive Collar were found covered product.

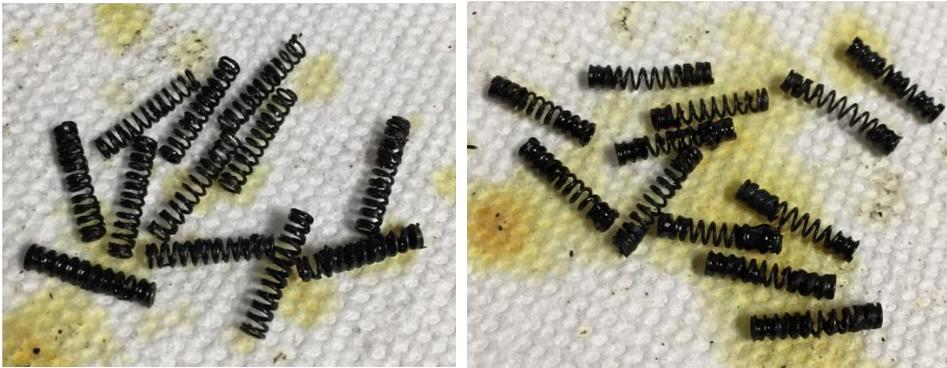
Springs were coated with product but flexed freely once removed. While installed they were stuck due to product.

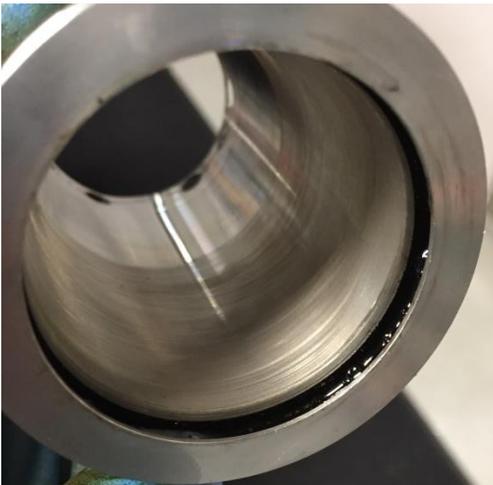
Sleeve shows signs of rubbing on the ID.

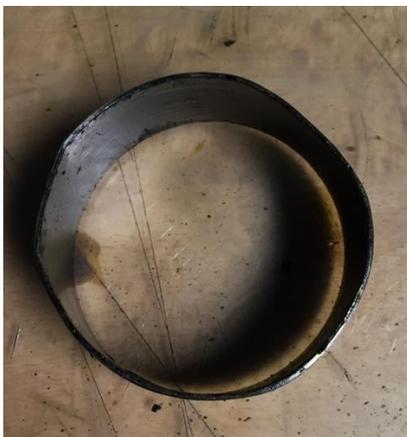
Due to hardened product the Locating Sleeve was stuck to the sleeve and damaged during disassembly.
