Mechanical Seal Analysis (MSA)

Date	4/29/19	Pump Position	-
MSA #	2019-025	Seal Manufacturer	FSI
Inquiry #	I-19-0061	Seal Model	R2080NSP0030-2330
Customer	Anchor Seals	Shaft Size	1.875"
Customer Ref #	-	Drawing #	FSI-2330
End User	USS Clairton Works	Seal Serial #	01900-R02
Pump House	TEC	Inboard Rotary Material	Silicon Carbide
Contact	Jason DiBiase	Inboard Stationary Material	Tungsten Carbide
Phone	412-299-6900	Outboard Rotary Material	Silicon Carbide
Salesperson	House	Outboard Stationary Material	Tungsten Carbide
		Elastomers	Kalrez 6375

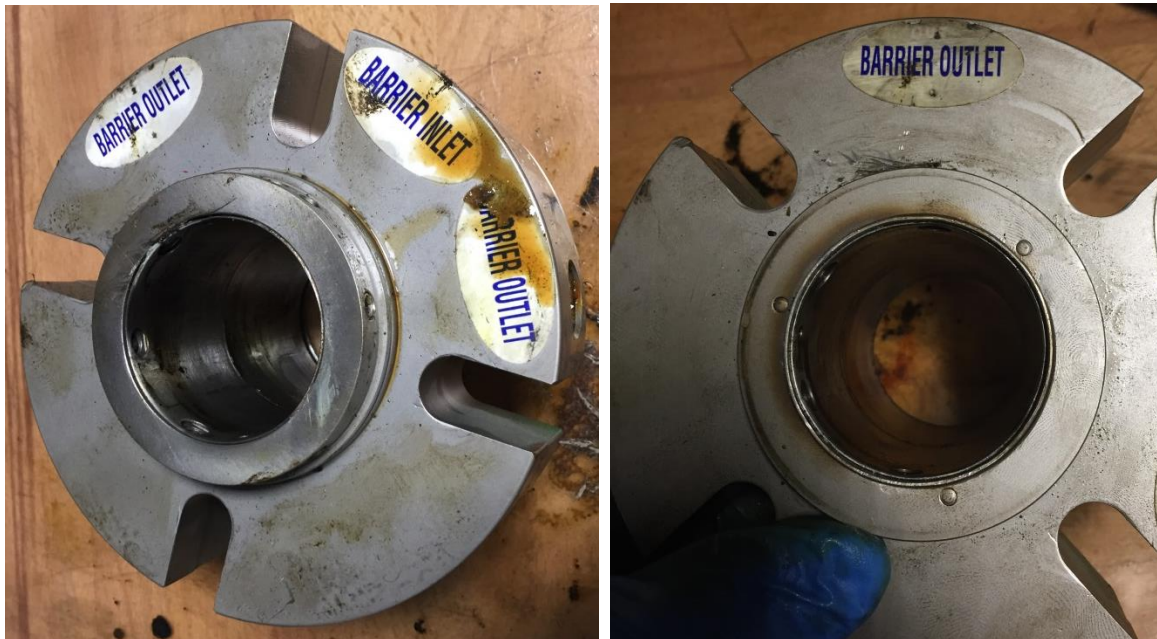
Figure: 1 & 2 Seal Assembly

Seal was returned assembled cover in product. The Gland shows signs of heat on the ID from the sleeve making contact.

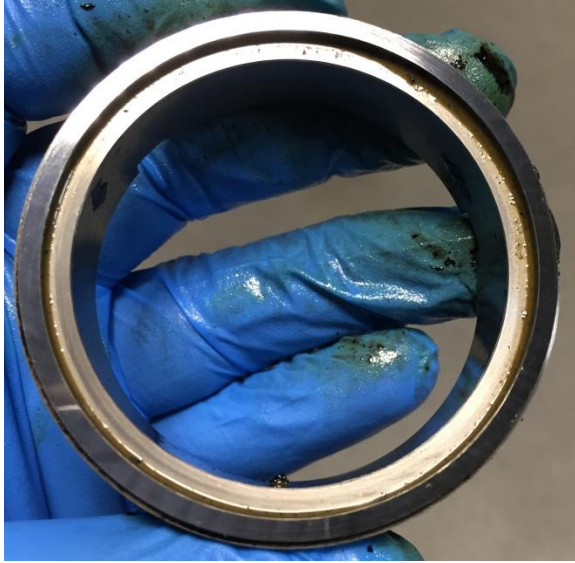
Figure 3: Inboard Stationary Face

Inboard Tungsten carbide stationary face was coated in product. Once cleaned it showed an even wear pattern.

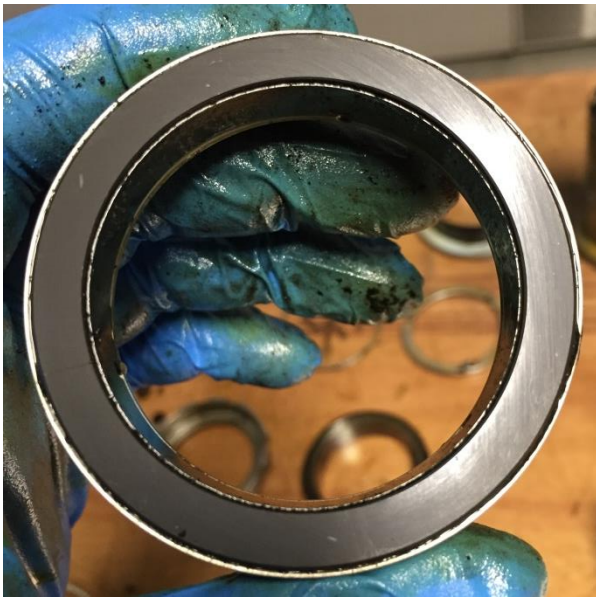
Figure 4: Inboard Rotary Face

Inboard silicon carbide rotary face was coated in product. Once cleaned it showed an even wear pattern.

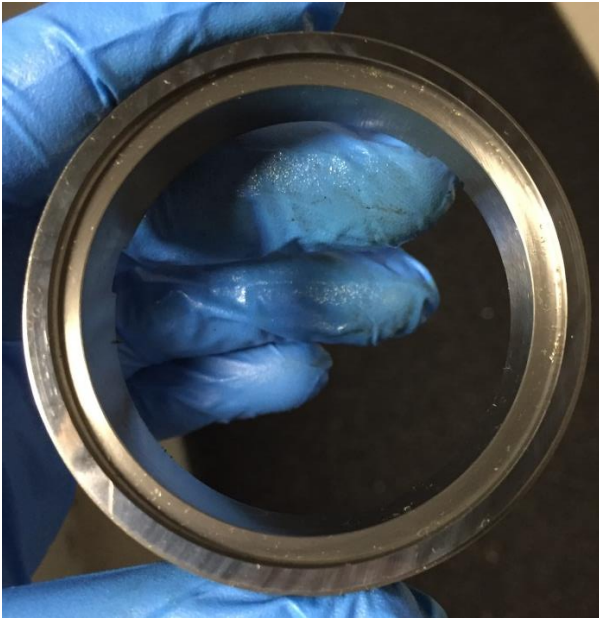
Figure 5: Outboard Stationary Face

Outboard Tungsten carbide stationary face was covered in barrier fluid. Once cleaned it showed an even wear pattern.

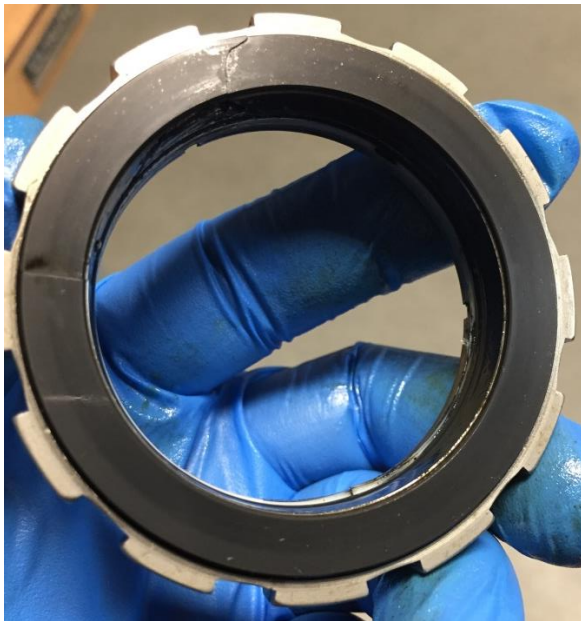
Figure 6: Outboard Rotary Face

Outboard silicon carbide rotary face was coated in barrier fluid. Once cleaned it was cracked in two locations caused by the impact of the Sleeve hitting the Gland.

Failure Explanation: The seal sleeve made contact with the gland ID causing the discoloration of the Sleeve and Locating Sleeve as well as the wear marks as noted above. Since the rubbing occurred on part of the sleeve and not the entire OD, the seal appeared to be cocked or not concentric. The impact and heat caused by the sleeve wearing on the gland caused the Outboard Rotary Face to crack resulting in the seal failure.

Recommendation: Check concentricity of the stuffing box of the pump. Make sure seal is installed properly with the proper torque on all set screws and gland bolts.

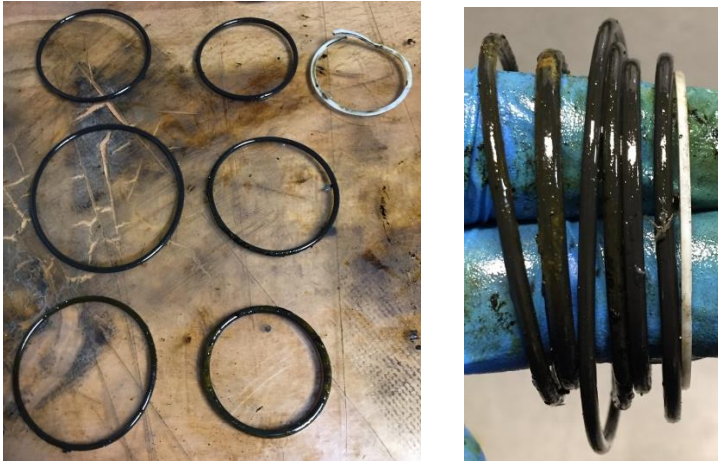
Figure7 & 8: O-rings

All O-rings look to be in good working order. The PTFE anti extrusion ring was damaged during disassembly.

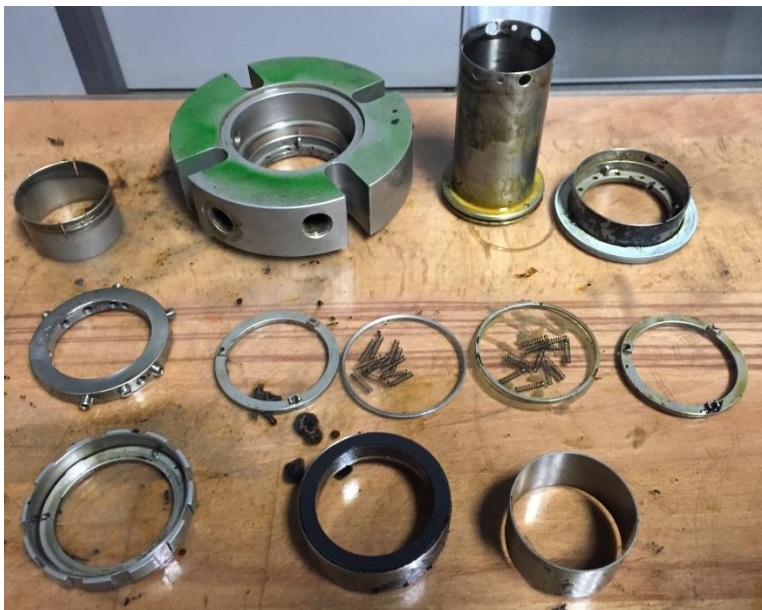
Figure 9: Metal Components

Gland Plate, Sleeve, Locating Sleeve, and Outboard Thrust Disc all show signs of making contact and building heat. The other metal components were found covered product but in good working order.

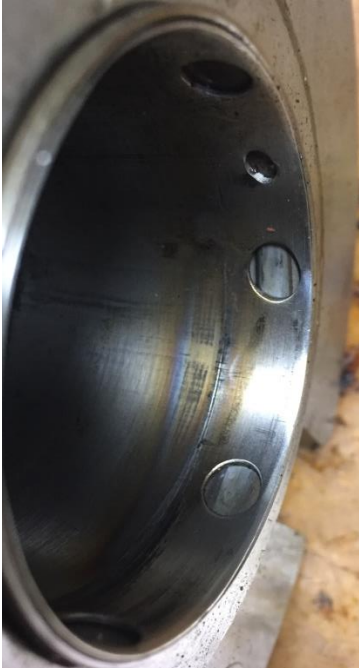
Figure 10: ID of Seal Sleeve

The ID of the Sleeve is discolored due to excessive heat.

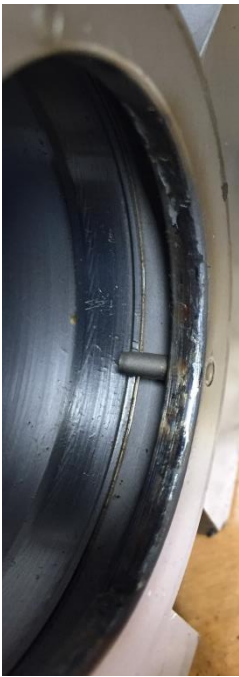
Figure 11: ID of Gland

The ID of the Gland is discolored due to heat from rubbing the OD of the Sleeve.

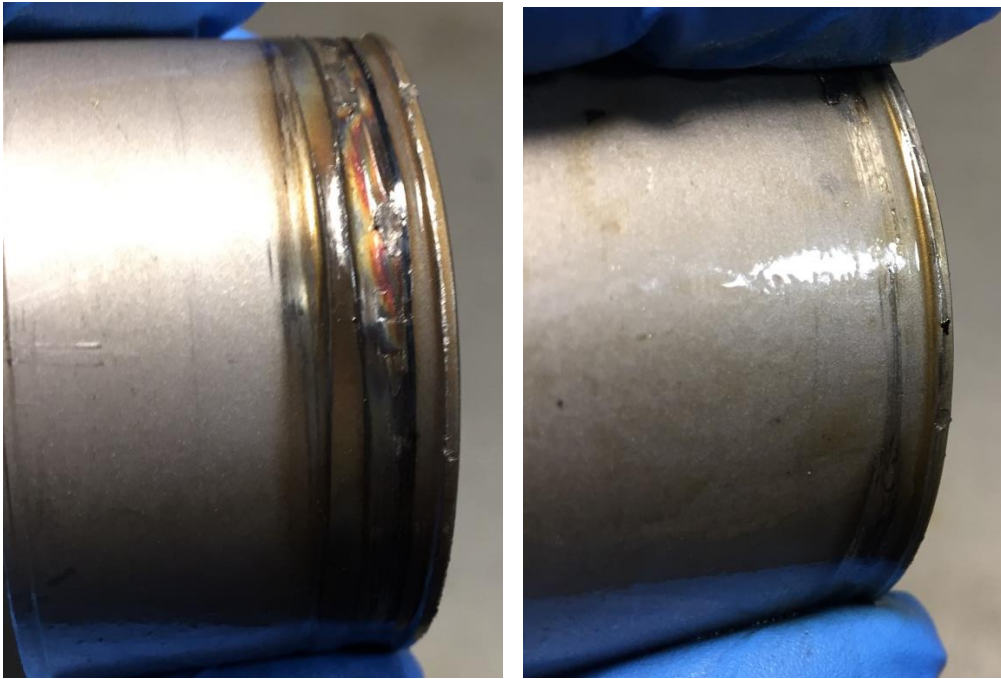
Figure 12 & 13: OD of Locating Sleeve

The OD of the Locating Sleeve is discolored from making contact with the ID of the Gland. Note that the rub is not the entire way around the locating sleeve.

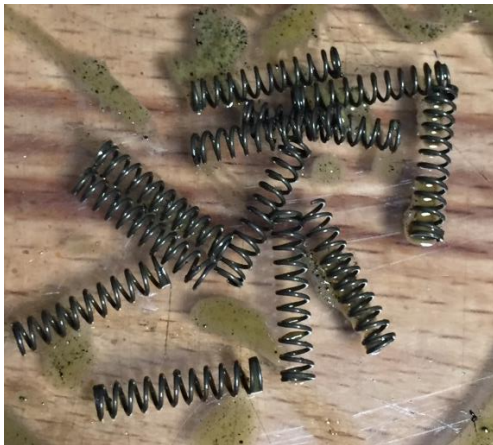
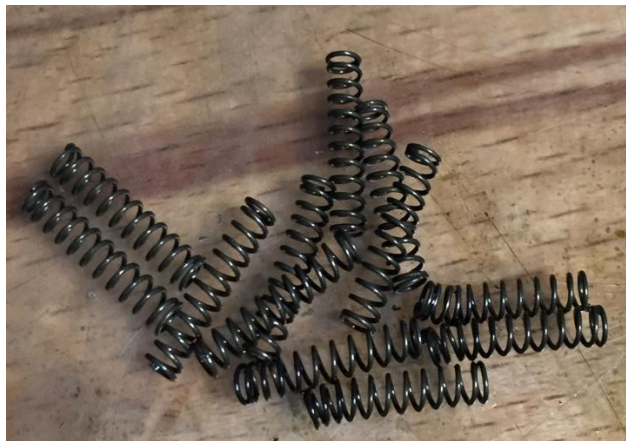
Figure 14: Inboard Springs, Figure 15: Outboard Springs

The Inboard springs were coated in product and the Outboard springs were coated in barrier fluid.
