Mechanical Seal Analysis (MSA)

Job #	2156853	Failure Code	S1001
Date	2017-03-20	Pump Position	Desuper Heating 1
MSA #	2017-048	Seal Manufacturer	FSI
Inquiry #	I-17-0071	Seal Model	1040/SP
Customer	Anchor Seals	Shaft Size	1.3125"
Tag #	1329	Drawing #	FSI-2618-A
End User	USS Clairton	Seal Serial #	02107
Pump House	Total Equipment	Inboard Rotary Material	Tungsten Carbide
Contact (TEC)	R. Sipes	Inboard Stationary Material	Carbon
Phone	(412) 269-0999	Elastomers	Viton
Salesperson	Jason DiBiase	Install Date	03/31/2016
		Removal Date	02/23/2017
		Days in Service	329

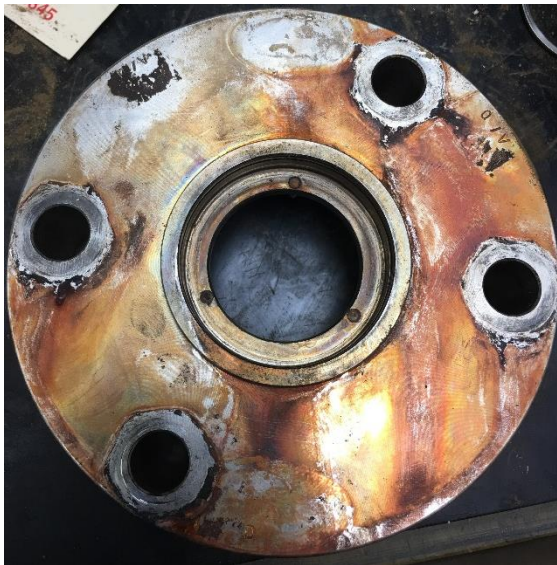
Figure 1

Stained product on OB (Figure 1)

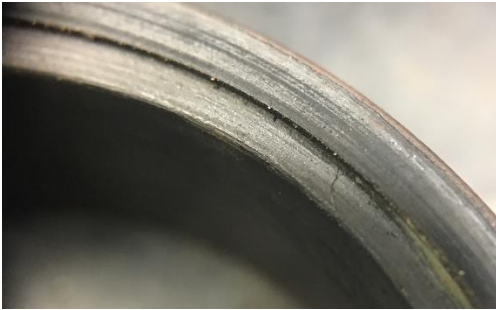
Figure 2

Stationary: Carbon – abrasive wear, recessed nose (Figure 2)

Abrasive wear, as seen in figure 2 on the carbon primary ring, would indicate a lack of lubrication on the seal face. Mechanical seal faces need marginal lubrication for optimal performance. Without lubrication, the seal faces will become out of flatness, causing excessive leakage.

FSI recommends checking the system and flush lines to ensure they are free of debris. It is always a best practice to clean or replace flush lines when installing a new mechanical seal.

Ensure flush pressure is 10-15 psi higher than stuffing box pressure.

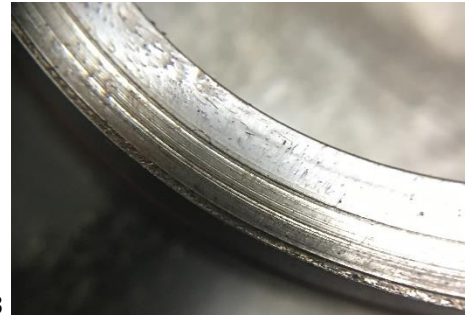
Figure 3

Rotary: Tungsten Carbide – recessed groove (Figure 3)

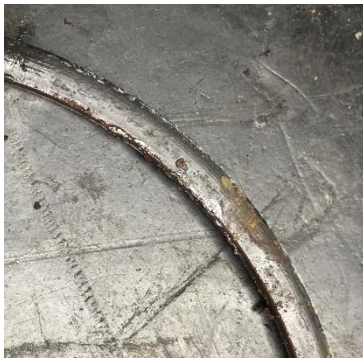
Figure 4

All elastomers had taken a compression set (Figure 4)

The elastomers have taken a compression set. This indicates a thermal degradation.

With the given conditions of condensate at 210° it is recommended to upgrade to Aflas elastomers.

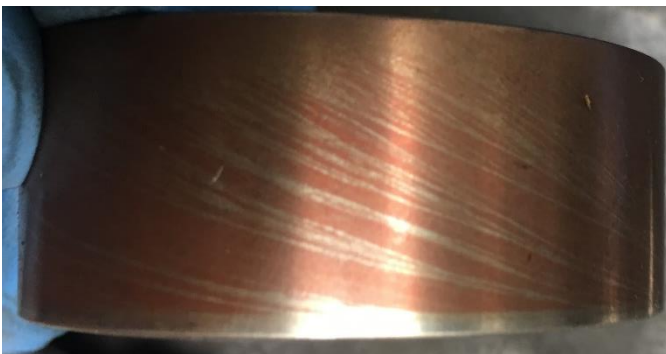
Figure 5

All metal components had product stained on them (Figure 5)
