Mechanical Seal Analysis (MSA)

Date	06/24/20	Pump Position	805P7A
MSA #	2020-028	Seal Manufacturer	FSI
Inquiry #	I-20-0067	Seal Model	MS2080NSP0030-2330
Customer	Anchor Seals	Shaft Size	1.875"
Customer Ref #	2191848	Drawing #	FSI-2330
End User	USS Clairton Works	Seal Serial #	01897
Pump House	TEC	Inboard Rotary Material	Silicon Carbide
Contact	Jason DiBiase	Inboard Stationary Material	Tungsten Carbide
Phone	412-299-6900	Outboard Rotary Material	Silicon Carbide
Salesperson	House	Outboard Stationary Material	Tungsten Carbide
		Elastomers	Kalrez 6375

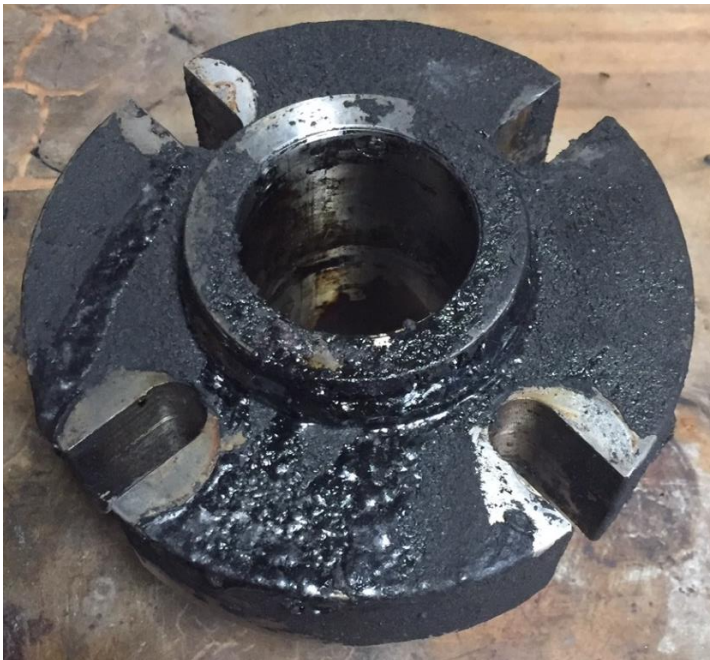
Figure 1: Seal Assembly

Seal was returned assembled cover in product.

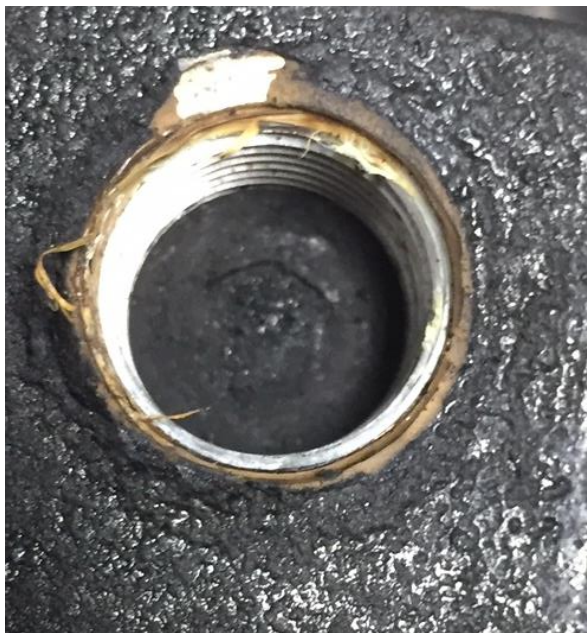
Figure 2: Barrier Outlet Port

The Barrier Outlet port was found clogged with hardened product.

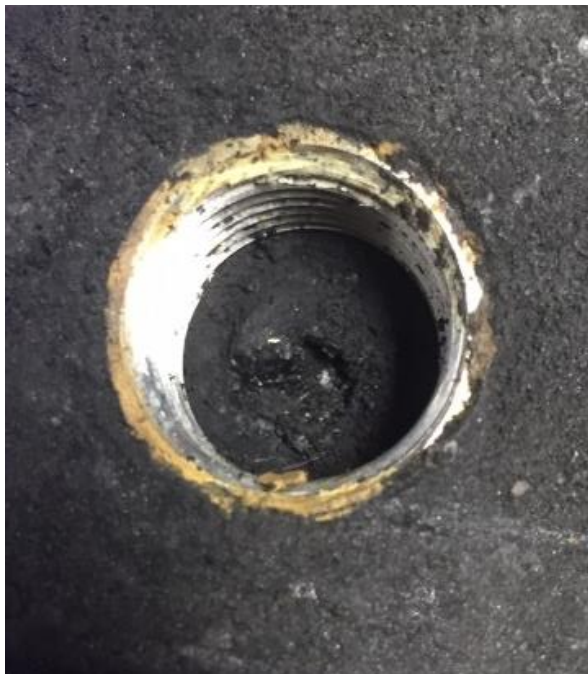
Figure 3: Barrier Inlet Port

The Barrier Inlet port was found clogged with hardened product.

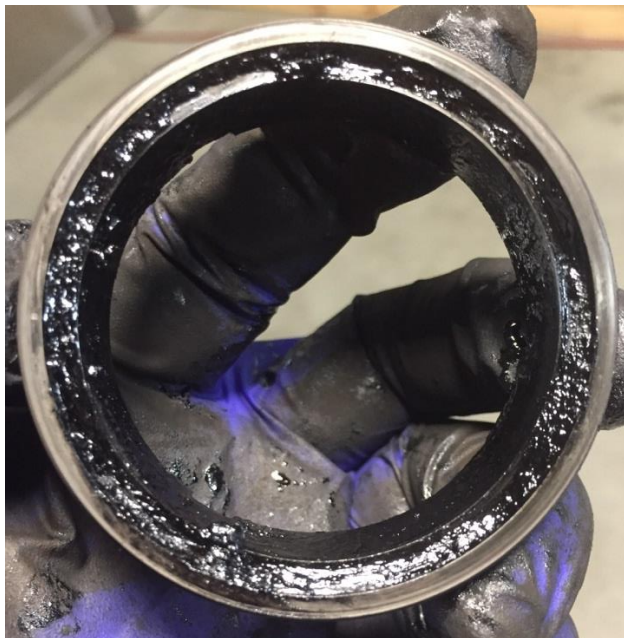
Figure 4: Inboard Stationary Face

Inboard Tungsten carbide stationary face was coated in product. Once cleaned it showed a concentric wear pattern including scratches on the sealing face.

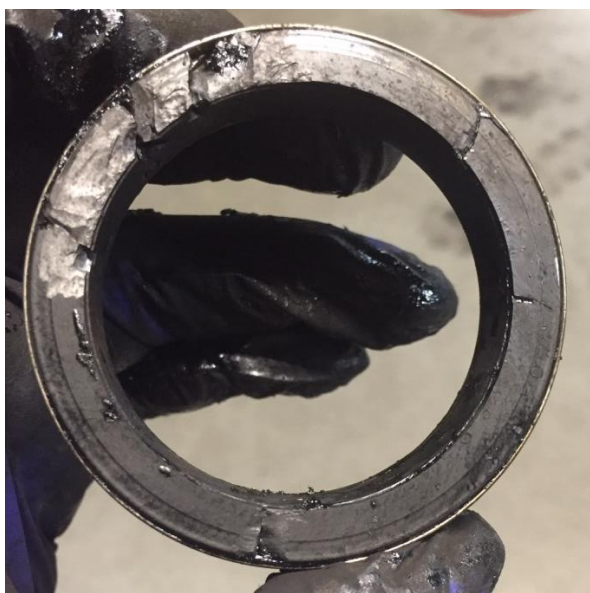
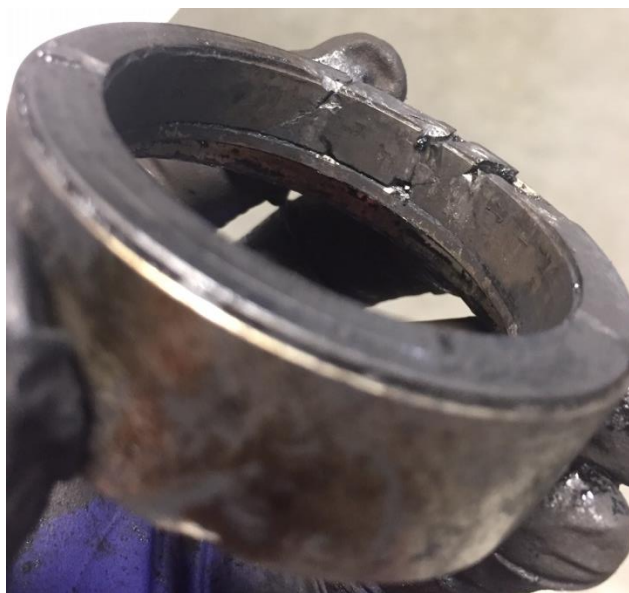
Figure 5 & 6: Inboard Rotary Face

Inboard silicon carbide rotary face was coated in product, cracked in multiple locations. The main break appeared to have started near one of the drive pins.

Failure Explanation: After such a long run life and with such a wide range of damage to the seal it is hard to determine the root cause of the seal failure. The outboard shows evidence of running dry with no barrier fluid. The inboard shows both a damaged stationary O-ring as well as a heavily cracked rotary face originating at the anti-rotation pins of the rotary holder. All of which could have been the result of their own failure mode.

Recommendation: It is recommended to replace this seal our new 2080D double balanced, double seal specified for this application. Also to be installed with the barrier fluid in the seal pot at the recommended level and pressurized 15-25 psi above the maximum stuffing box pressure. This practice will help maintain the proper pressure differential between the process fluid and barrier fluid. Also in order to prevent the loss of the seal in the event of the loss of barrier fluid we suggest installing a low level alarm and/or a pressure switch.

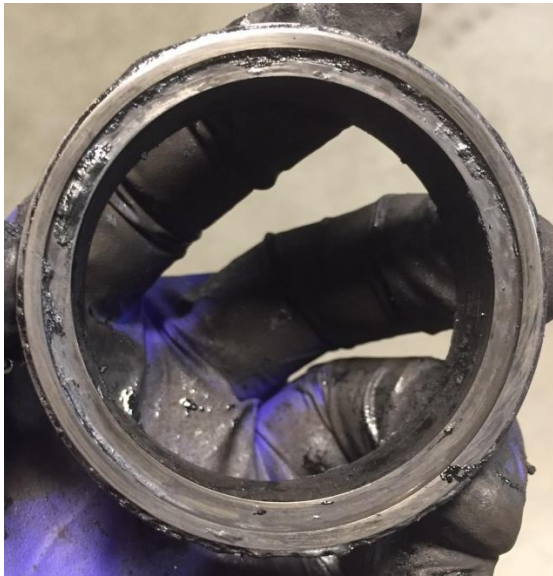
Figure 7: Outboard Stationary Face

Outboard Tungsten carbide stationary face was covered in product. Once cleaned it showed a concentric wear pattern including scratches on the sealing face.

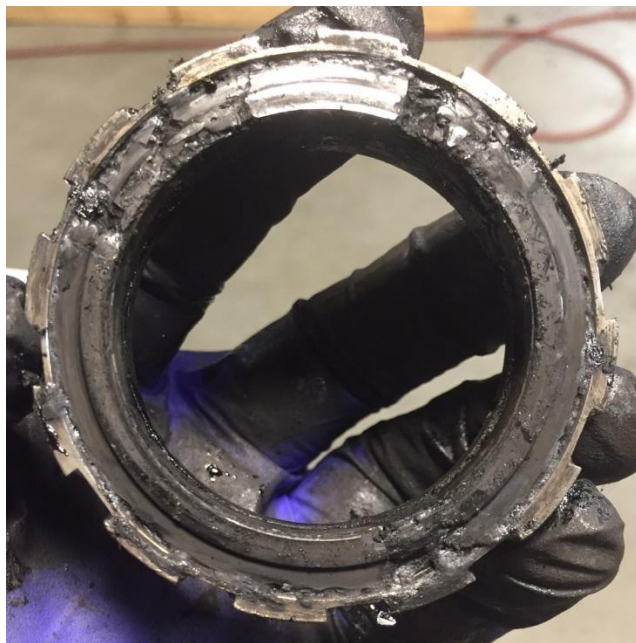
Figure 8: Outboard Rotary Face

Outboard silicon carbide rotary face was coated in product. Once cleaned it was cracked and broken in multiple locations. It should be noted that the wear on the seal face was considerable.

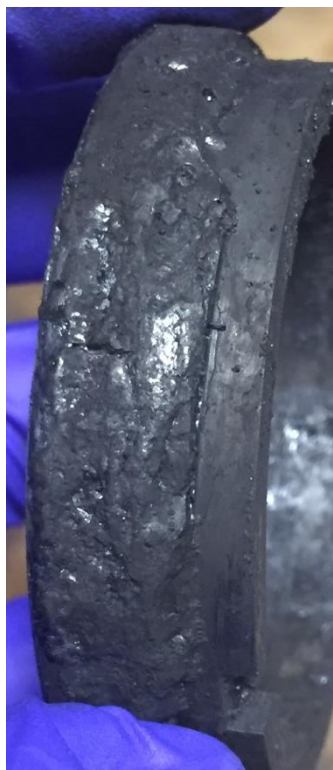
Figure 9: Outboard Stationary O-ring

The Outboard stationary O-ring was cooked and almost no existent.

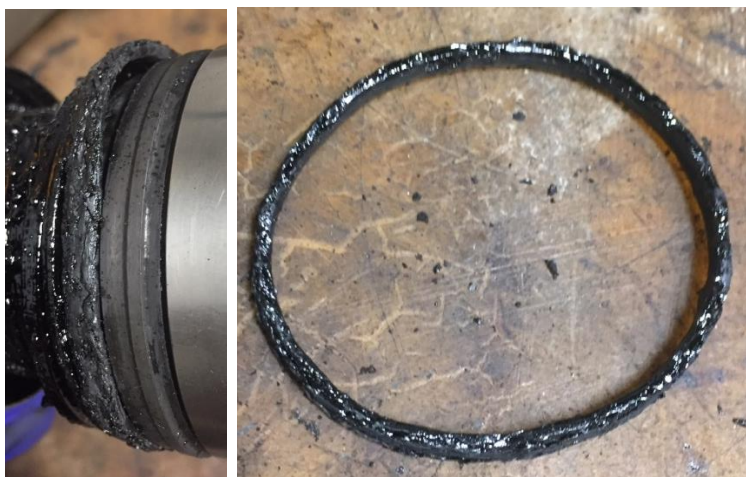
Figure 10 & 11: Inboard Stationary O-ring

The Inboard stationary was found to be swollen, fretted and “gummy” possibly from such long expose to the product.

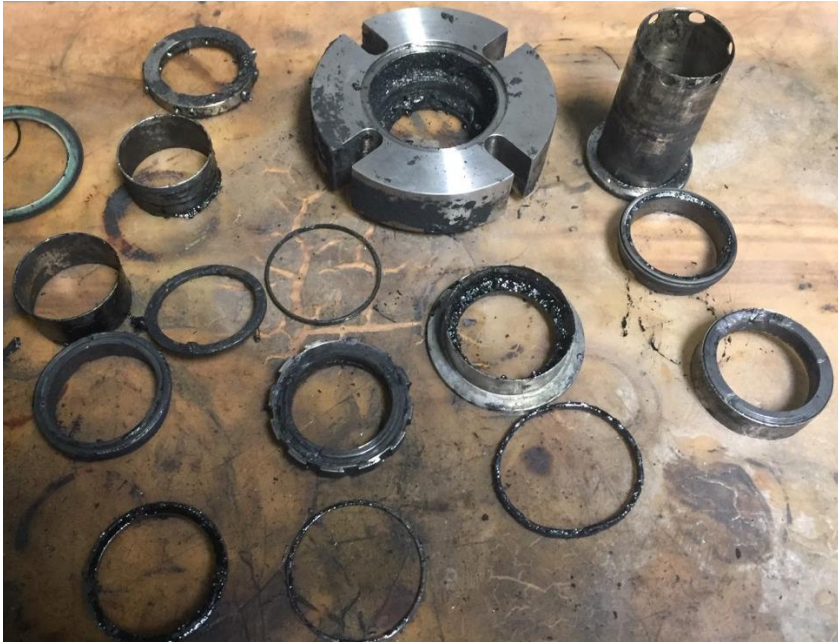
Figure 12: Metal Components

Gland Plate, Inboard Gland, Sleeve, Thrust Discs, Back Up Rings, Seat Carrier and Drive Collar were found covered in product.

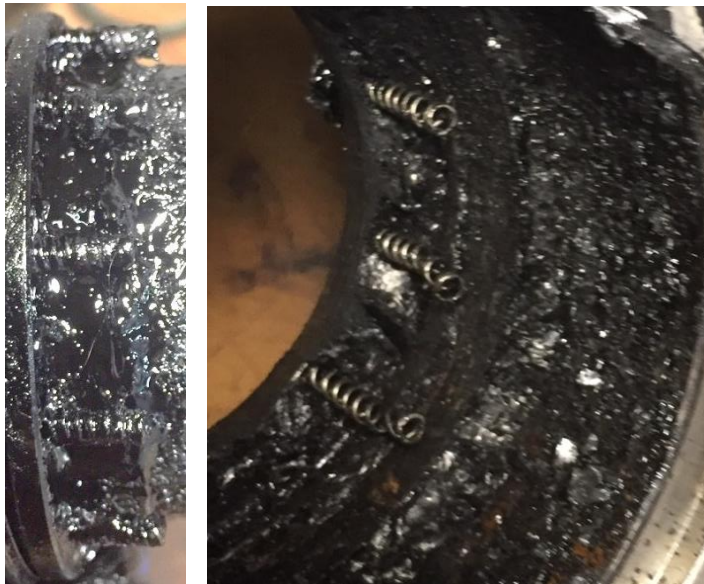
Figure 13: Inboard Springs, Figure 14: Outboard Springs

Both the inboard and outboard springs were coated with product. The inboard springs flexed freely upon removal. The outboard springs were stuck in the gland with baked on hardened product. Most were bent during removal.
