## Mechanical Seal Analysis (MSA)

<b>Date</b>	07/23/20	<b>Pump Position</b>	207C
<b>MSA #</b>	2020-038	<b>Seal Manufacturer</b>	FSI
<b>Inquiry #</b>	I-20-0080	<b>Seal Model</b>	MS1030SP0052-2318
<b>Customer</b>	Anchor Seals	<b>Shaft Size</b>	3.25"
<b>Customer Ref #</b>	2190304	<b>Drawing #</b>	FSI-2318
<b>End User</b>	USS Clairton Works	<b>Seal Serial #</b>	DI-100
<b>Pump House</b>	TEC	<b>Inboard Rotary Material</b>	Silicon Carbide
<b>Contact</b>	Jason DiBiase	<b>Inboard Stationary Material</b>	Carbon
<b>Phone</b>	412-299-6900	<b>Outboard Rotary Material</b>	-
<b>Salesperson</b>	House	<b>Outboard Stationary Material</b>	-
		<b>Elastomers</b>	Viton

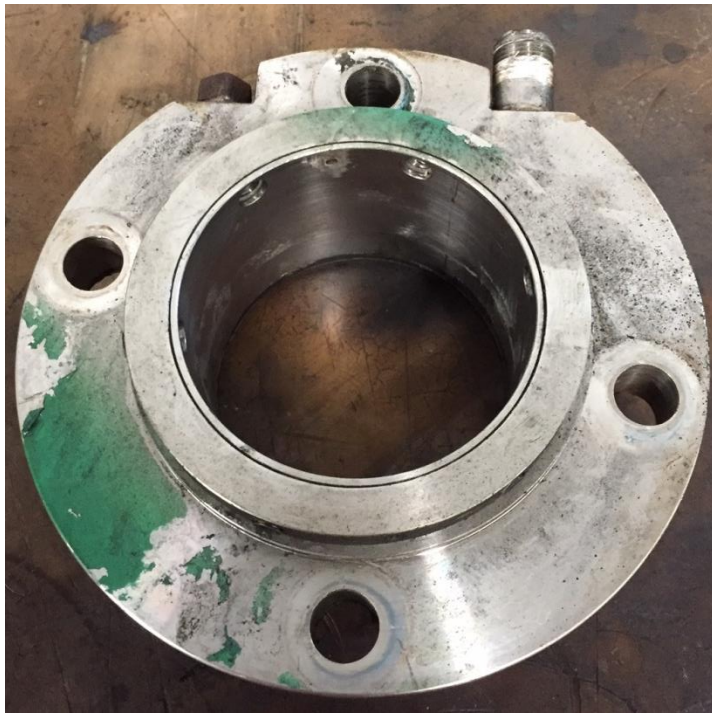
## Figure 1: Seal Assembly

Seal was returned assembled.

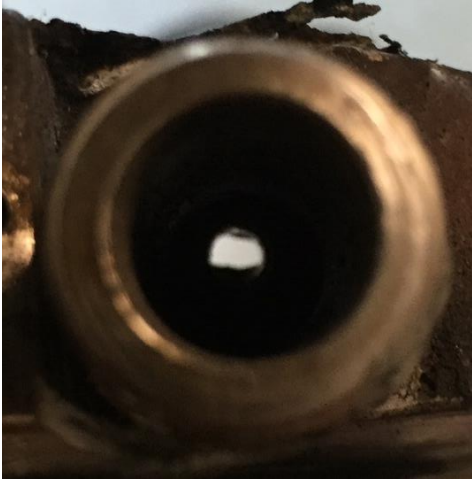
## Figure 2 & 3: Flush Port

Both flush ports were found to be clear.

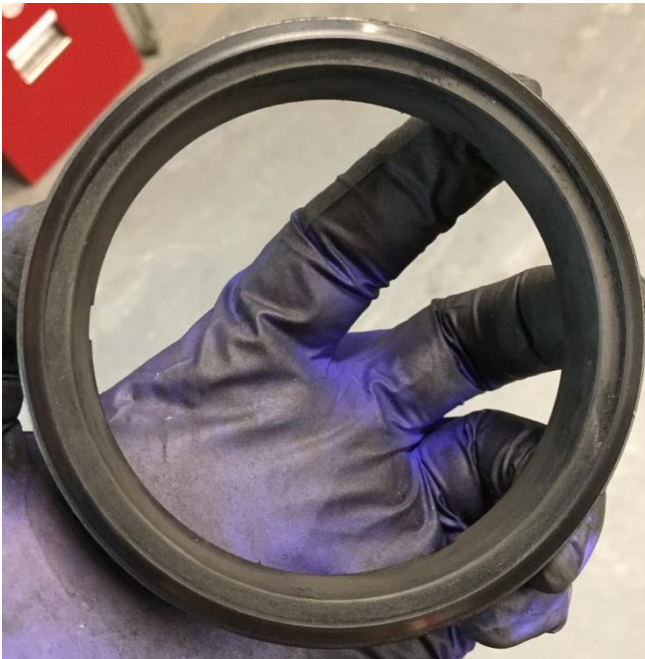
## Figure 4: Stationary Face

The Carbon stationary face was coated in product. Once cleaned it showed a concentric wear pattern including slight scratches on the sealing face.

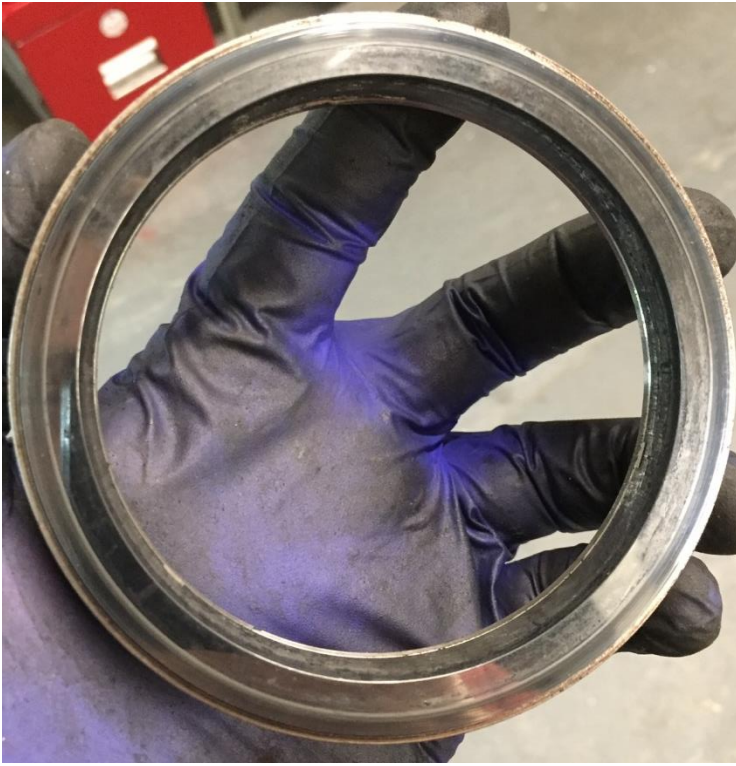
**Figure 5: Rotary Face**

The silicon carbide rotary face was coated in product and cracked near one of the drive

pins.

**Failure Explanation:** It appears that this seal failed due to the crack in the rotary face. Due to the location of the crack in the face this would have resulted from a potential hard start during this seals run life.

**Recommendation:** Replace this seal with the FSI seal currently specified for this pump location.

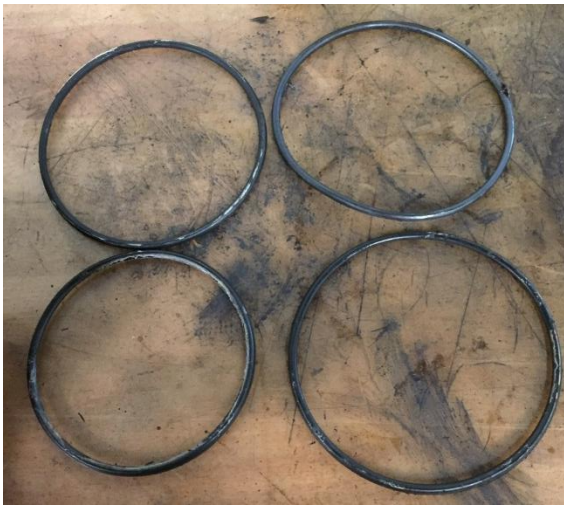
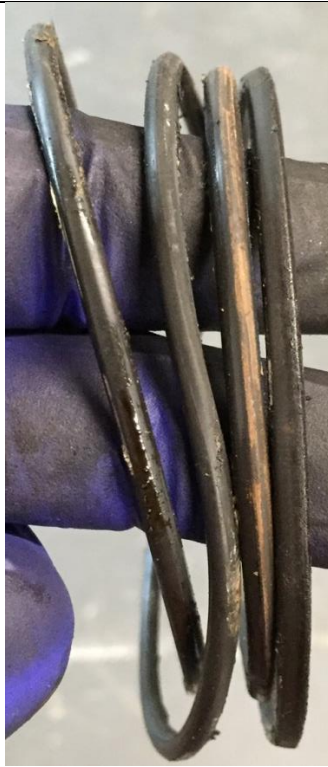
**Figure 6: O-rings**

All O-rings were in fair condition for sealing purposes.

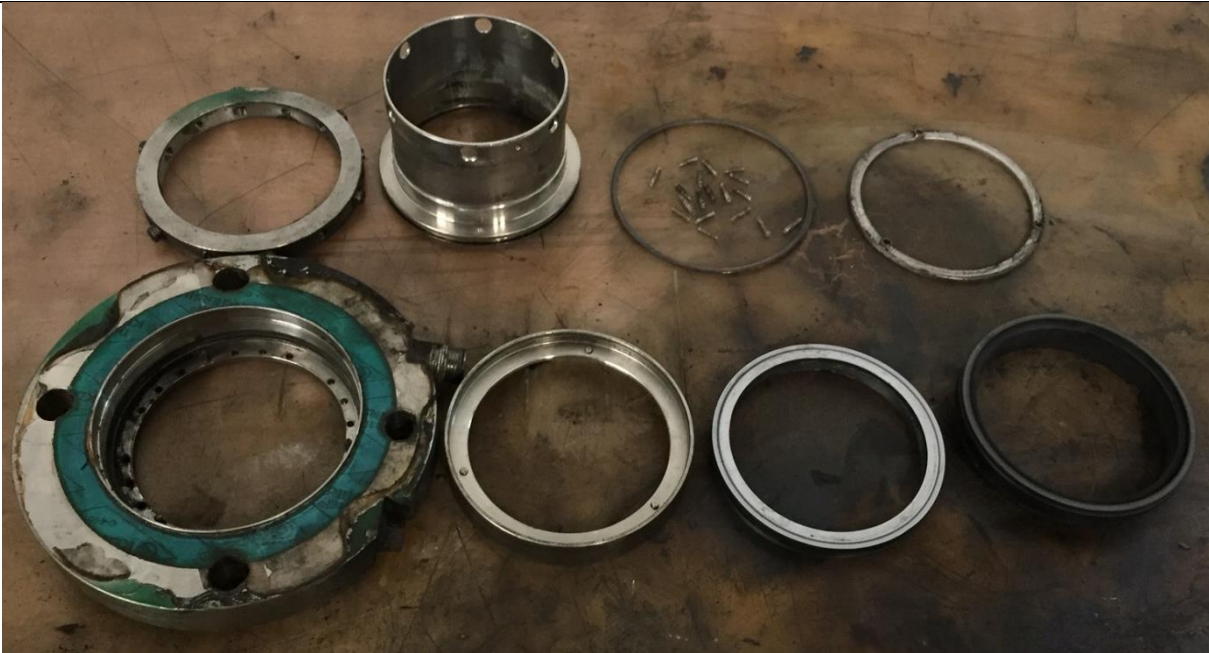
**Figure 7: Metal Components**

All metal parts are in good working condition.

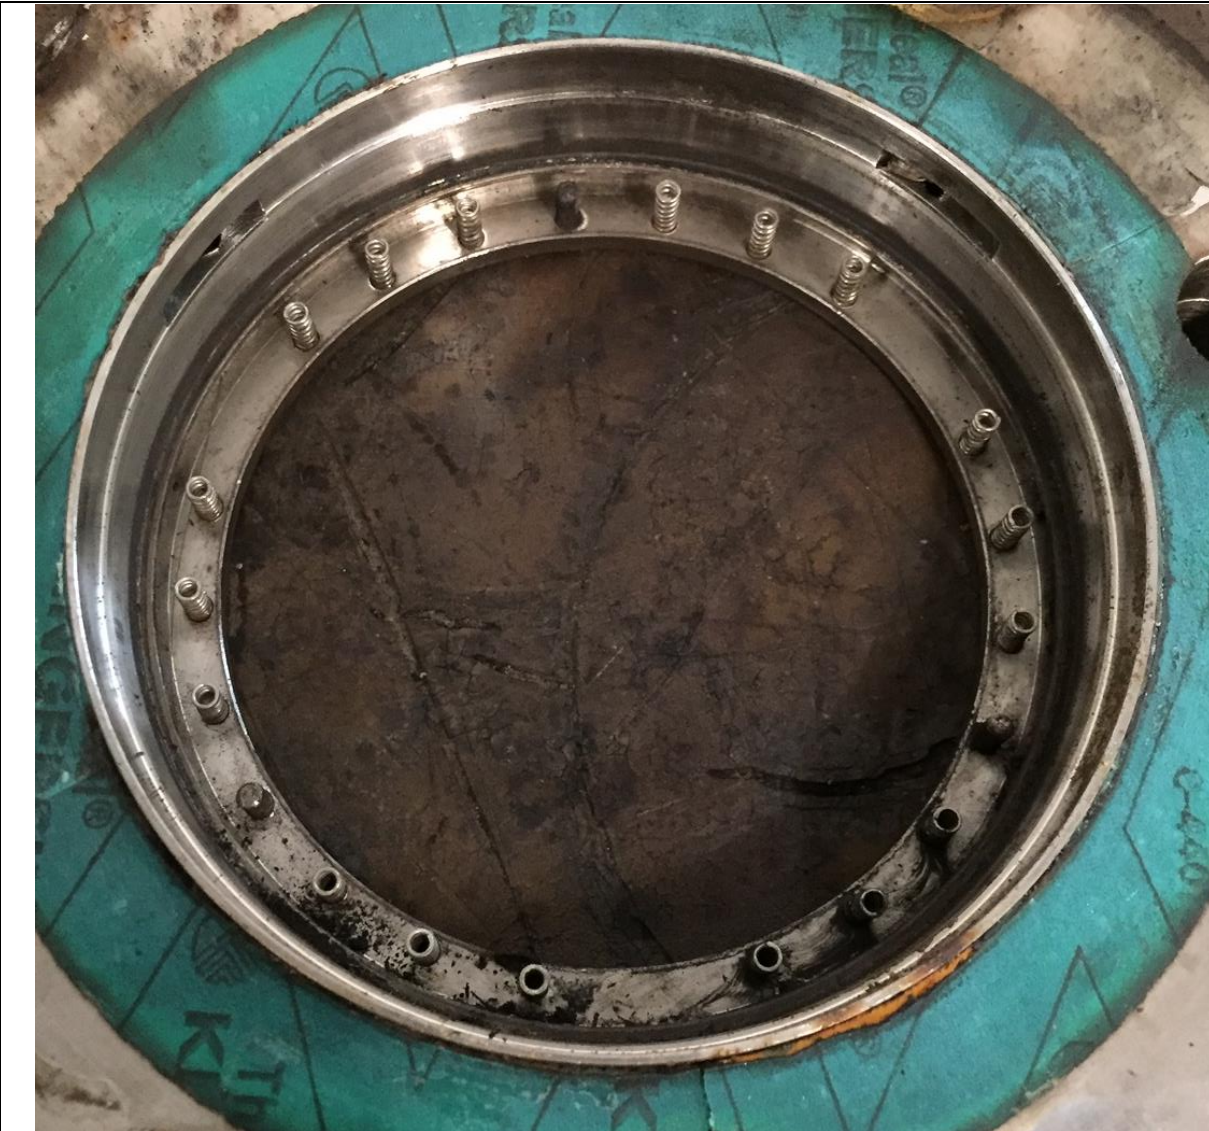
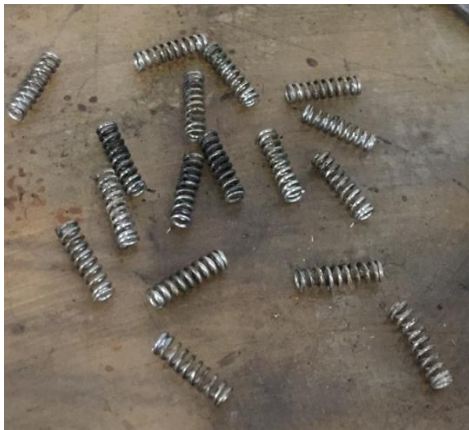
**Figure 8: Springs**

The springs flexed freely upon removal.
