## Mechanical Seal Analysis (MSA)

<b>Date</b>	10/6/20	<b>Pump Position</b>	P-2152
<b>MSA #</b>	2020-049	<b>Seal Manufacturer</b>	FSI
<b>Inquiry #</b>	I-20-0101	<b>Seal Model</b>	MS1010MS0040-2418
<b>Customer</b>	Anchor Seals	<b>Shaft Size</b>	2.50"
<b>Customer Ref #</b>	2194509	<b>Drawing #</b>	FSI-2418
<b>End User</b>	USS Clairton Works	<b>Seal Serial #</b>	02084
<b>Pump House</b>	TEC	<b>Inboard Rotary Material</b>	Tungsten Carbide
<b>Contact</b>	Jason DiBiase	<b>Inboard Stationary Material</b>	Tungsten Carbide
<b>Phone</b>	412-299-6900	<b>Outboard Rotary Material</b>	-
<b>Salesperson</b>	House	<b>Outboard Stationary Material</b>	-
		<b>Elastomers</b>	Aflas / Viton

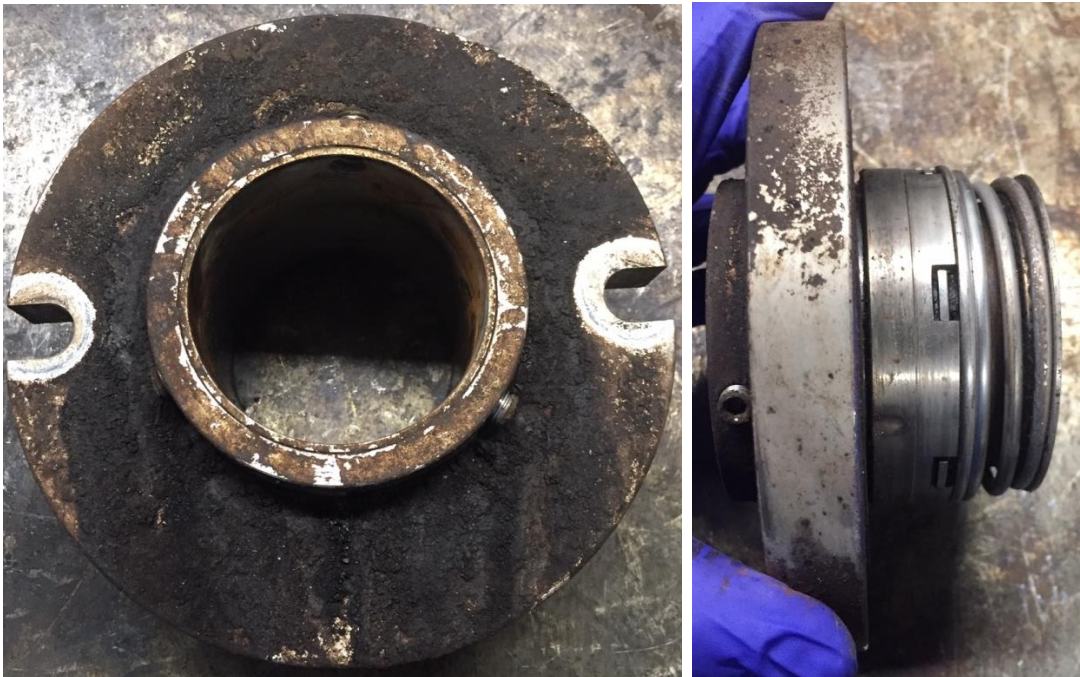
**Figure 1 & 2: Seal Assembly**

Seal was returned covered in product.

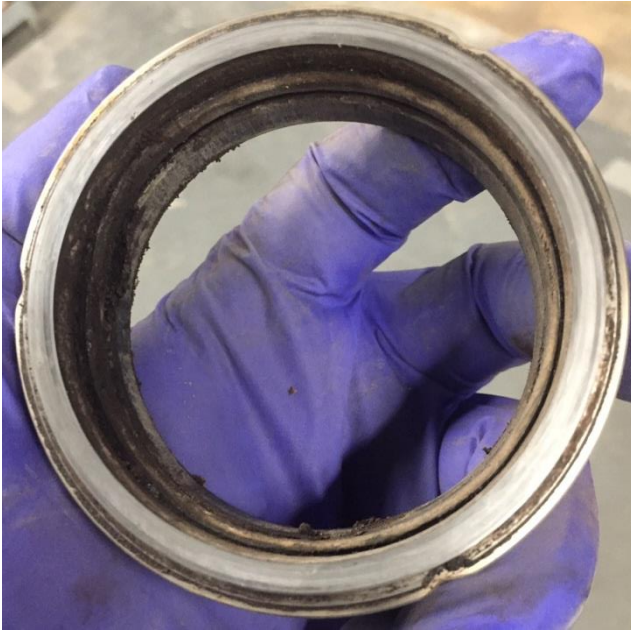
**Figure 3: Rotary Face**

The Tungsten Carbide rotary face was found to have an even wear pattern.

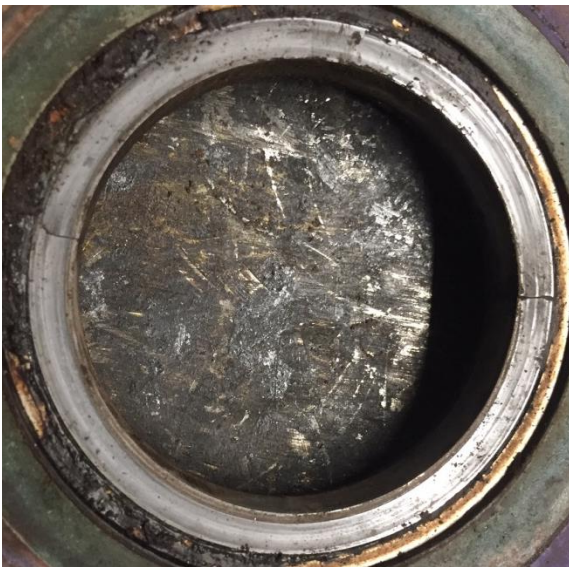
**Figure 4: Stationary Face**

The Tungsten Carbide stationary face was found cracked in two locations 180 degrees apart. The contact the stationary face made with the seal sleeve more than likely caused the face to break.

**Failure Explanation:** It appears that the seal gland dropped allowing the ID of the stationary to make contact with the sleeve OD. That rubbing eventually caused the stationary face to crack and break resulting in the seal failure. It should be noted that there were reports of gravel in the pump casing during pump disassembly. This debris and subsequent vibration may have aided the movement of the gland.

**Recommendation:** Follow all proper installation instructions and required torque specs when installing the seal on the pump. Also filter/ screen or otherwise find a way to eliminate large debris from entering the pump.

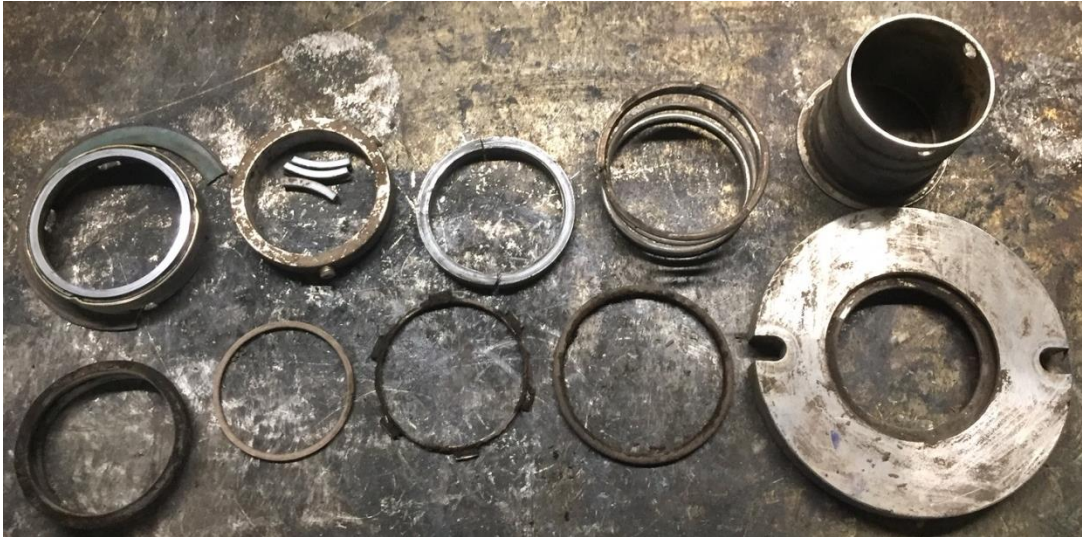
**Figure 6: Seal Components**

Most metal parts were in good condition. The OD of the seal sleeve shows signs of rubbing the ID of the stationary face.

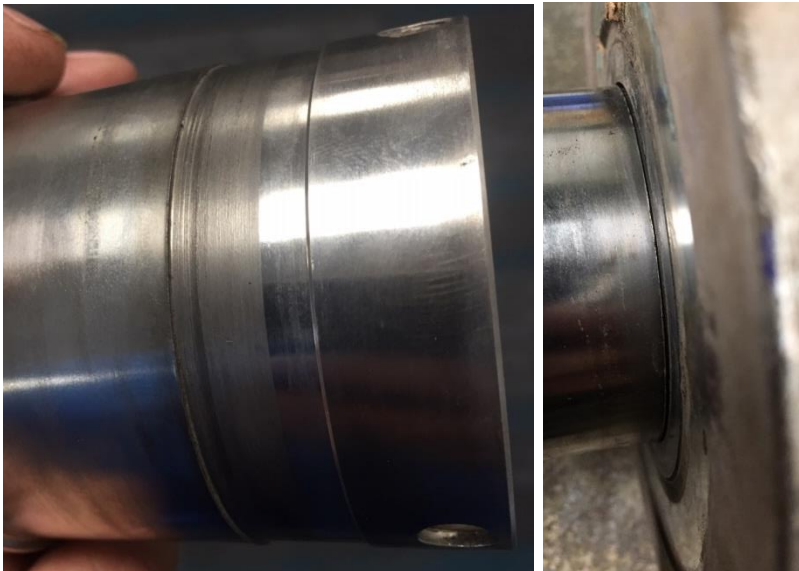
**Figure 7 & 8: Seal Sleeve**

The seal sleeve OD is worn from making contact with the ID of the tungsten carbide stationary face. The marks are the entire way around the sleeve OD. Shown in figure 8 is the seal sleeve reinserted into the gland without the rotary portion of the seal. This better shows where the stationary face (shown) and the seal sleeve (shown) made contact. You can even see the raised edge on the sleeve from the contact.
