### Mechanical Seal Analysis (MSA)

<b>Date</b>	05/14/21	<b>Pump Position</b>	P-207E
<b>MSA #</b>	2021-021	<b>Seal Manufacturer</b>	FSI
<b>Inquiry #</b>	I-21-0055	<b>Seal Model</b>	1040SP
<b>Customer</b>	Anchor Seals	<b>Shaft Size</b>	2.9375"
<b>Customer Ref #</b>	2199033	<b>Drawing #</b>	-
<b>End User</b>	USS Clairton Works	<b>Seal Serial #</b>	MS1040SP003722XXJE
<b>Pump House</b>	TEC	<b>Inboard Rotary Material</b>	Tungsten Carbide
<b>Contact</b>	Jason DiBiase	<b>Inboard Stationary Material</b>	Tungsten Carbide
<b>Phone</b>	412-299-6900	<b>Outboard Rotary Material</b>	-
<b>Salesperson</b>	House	<b>Outboard Stationary Material</b>	-
		<b>Elastomers</b>	Chemraz505

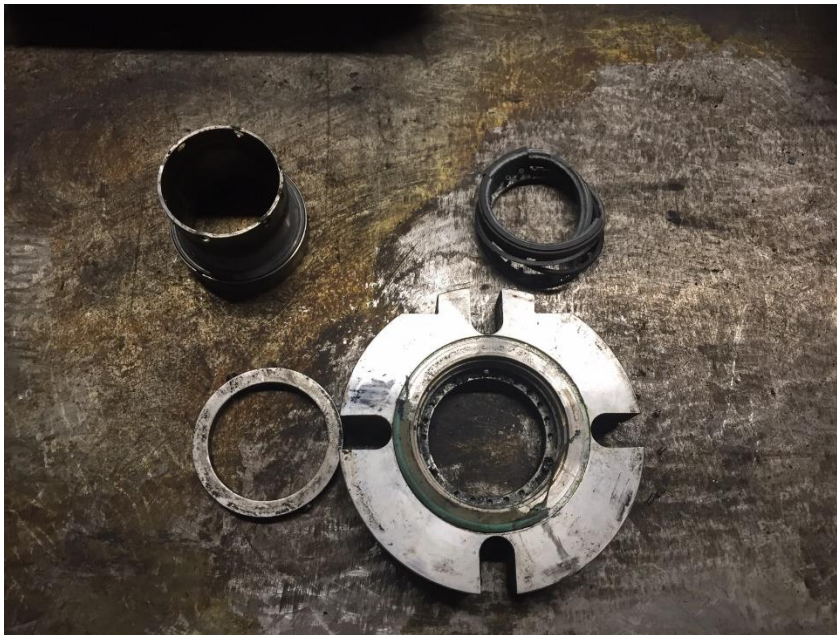
**Figure 1: Seal As Returned**

Seal was returned in pieces.

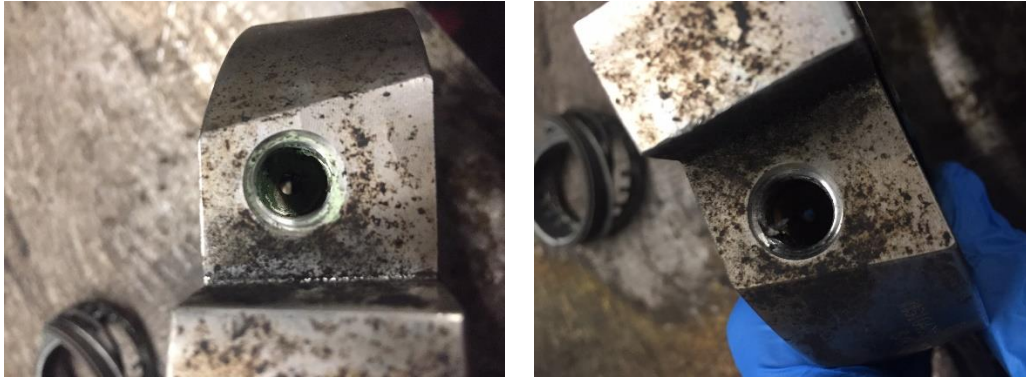
**Figure 2: Flush Port**

The Flush Ports were found to be clear.

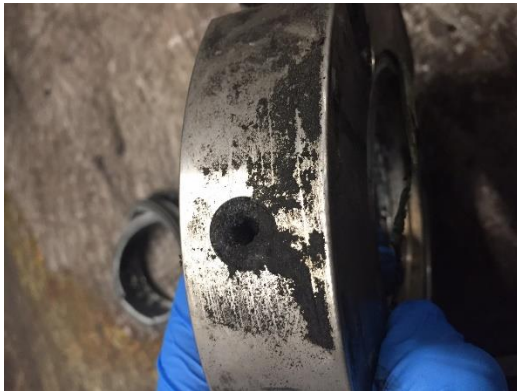
**Figure 3: Quench Port**

The Quench Port was not in use due to the amount of material found in port.

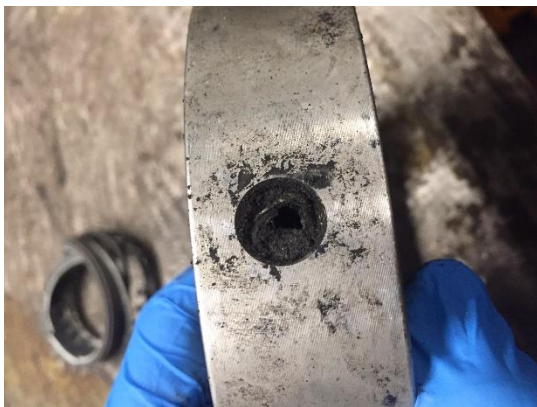
**Figure 4: Drain Port**

The Drain Port was found to be same condition as quench.

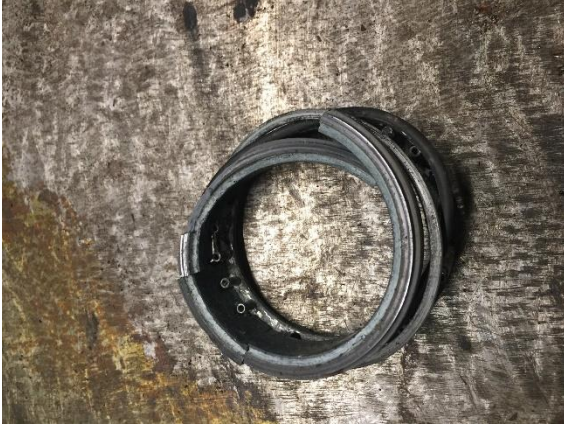
**Figure 4: Stationary Face**

The tungsten carbide stationary face was damaged and in pieces upon arrival and potentially during disassembly.

months. The damage sustained to the seal is likely due to a combination of the seal being removed from the pump and the initial attempted startup of a seized pump.

**Recommendation:** Repair this seal and return to service per manufacturers recommendations.

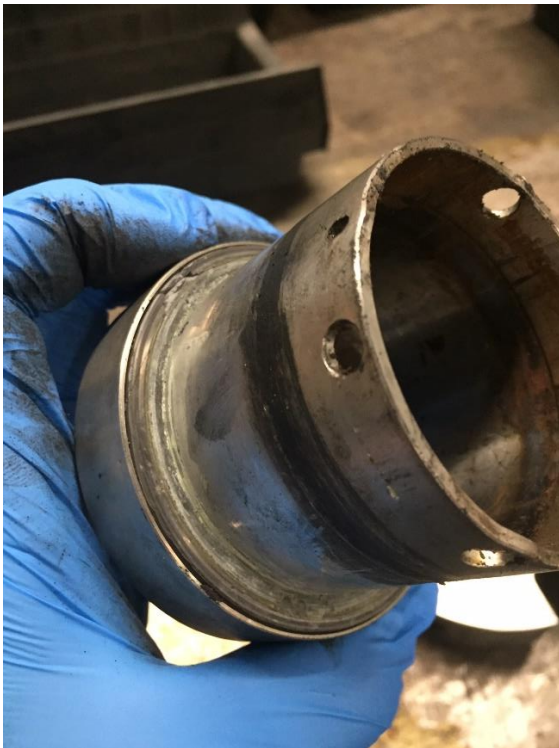
**Figure 5: Rotary Face**

The tungsten carbide rotary face was chipped.

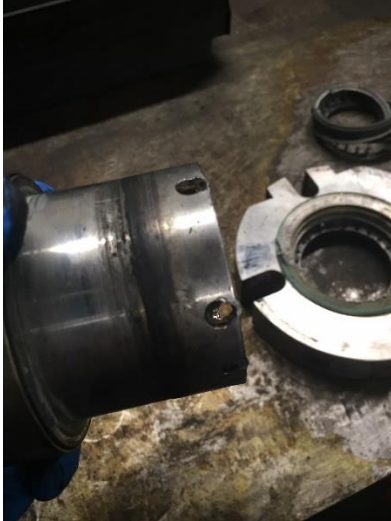
**Figure 6: Seal Sleeve**

Some metal parts were in fair condition with the exception of the Seal Sleeve. Shaft sleeve showed signs of damage likely due to removing seal from seized pump shaft/casing.

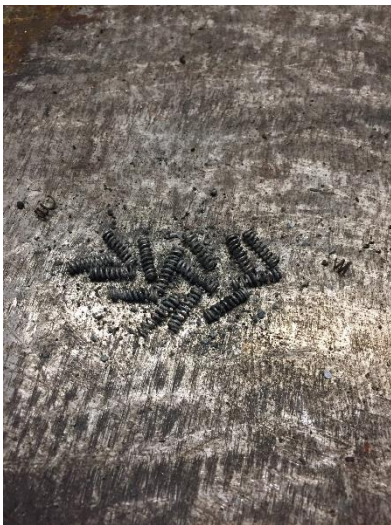
**Figure 7: Springs**

Springs flexed freely with some springs broken upon arrival.
