Mechanical Seal Analysis (MSA)

Date	6/11/21	Pump Position	T Boiler Blowdown Pump
MSA #	2021-024	Seal Manufacturer	FSI
Inquiry #	I-21-0062	Seal Model	MS1015+0028SXSX77
Customer	Anchor Seals	Shaft Size	1.75"
Customer Ref #	2200842	Drawing #	-
End User	USS Clairton Works	Seal Serial #	TEC-0739
Pump House	TEC	Inboard Rotary Material	Silicon Carbide
Contact	Brandon Spithaler	Inboard Stationary Material	Silicon Carbide
Phone	412-865-2101	Outboard Rotary Material	-
Salesperson	House	Outboard Stationary Material	-
		Elastomers	Viton

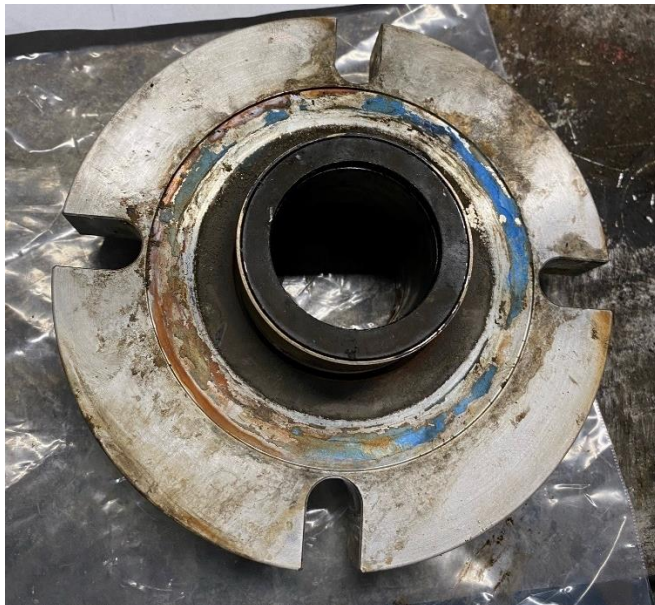
Figure 1: Seal Assembly

Seal was returned assembled.

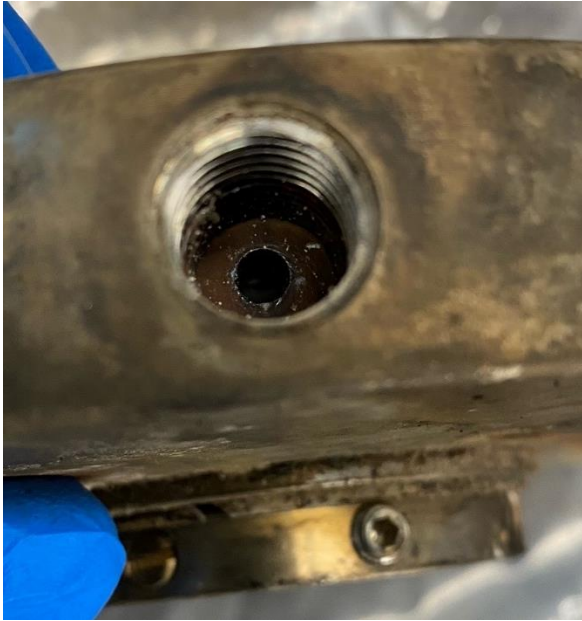
Figure 2: Flush Port

The Flush Port was found to be clear.

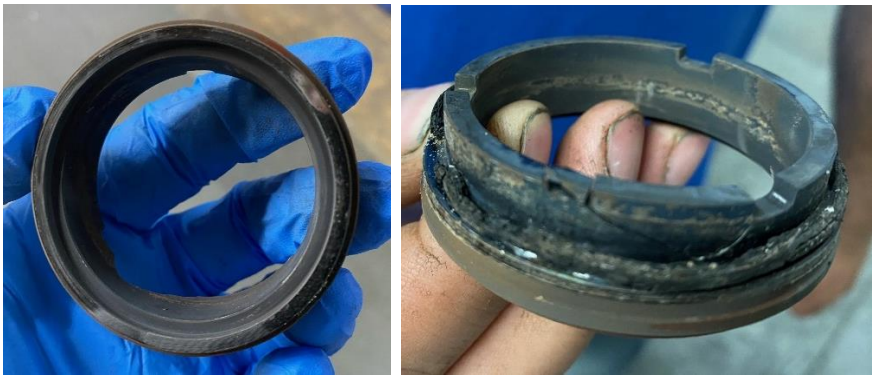
Figure 3 &4: Stationary Face

The silicon carbide stationary face showed signs of damage. The damage near the anti-rotation insert suggests a hard start on the seal face.

Failure Explanation: It appears the seal failure was caused by overheating the elastomers and seal faces. The excessive heat was a result of the lack of lubricity at the seal face interchange. This is based on the temperature of the pumping media and the heat generated by the seal faces. The damage to back the stationary seal face is most likely due to "stick-slip" occurring, based on the lack of lubricity across the seal faces. That torque and resulting impact between the thrust disk and the seal face caused the breaking of the seal face.

Recommendation: Review and confirm the process conditions of this application. Taking into consideration the lack of lubricity provided by a hot water service we may want to look into using Carbon, Silicon Carbide, EPDM for this application moving forward.

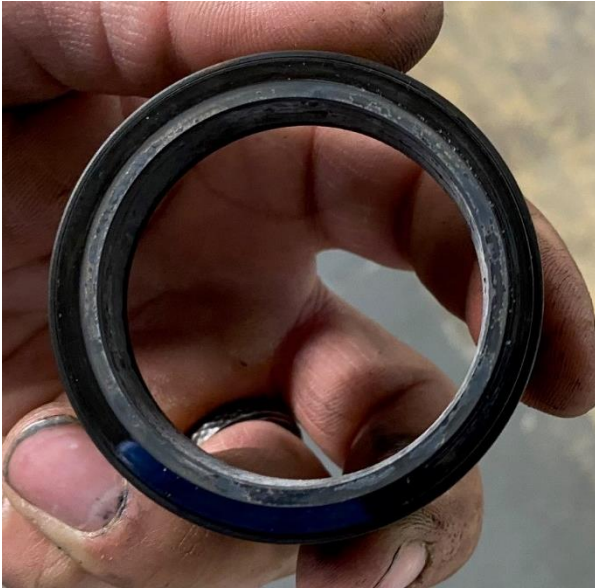
Figure 5: Rotary Face

The silicon carbide rotary face showed signs of excessive wear.

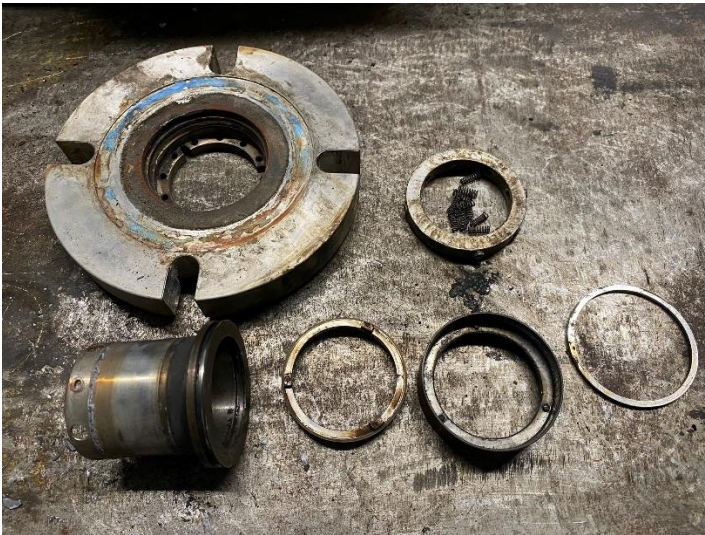
Figure 6: Metal Components

The Gland, sleeve and drive collars are in good working order.

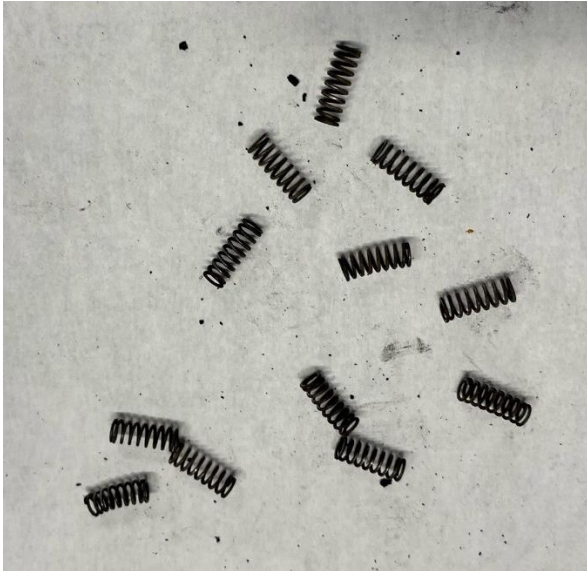
Figure 7: Springs

The springs looked to be in good working order.

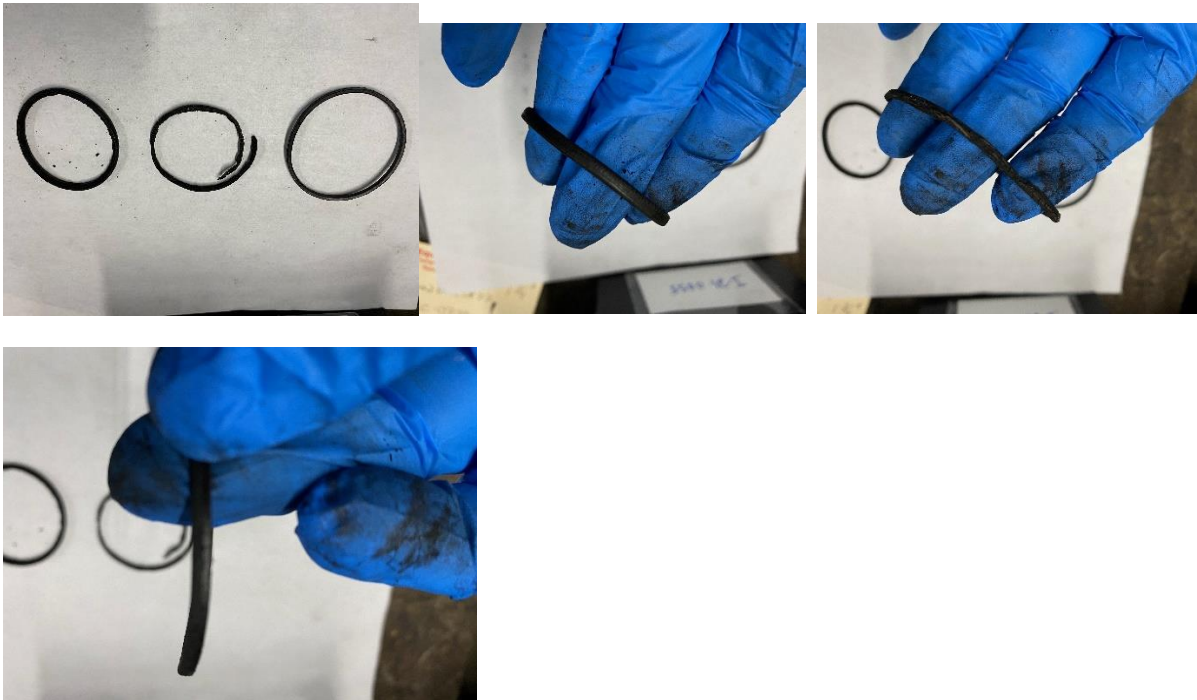
Figure 8-11: Elastomer Components

The O rings showed signs of deformity and destruction from excessive heat.
