Mechanical Seal Analysis (MSA)

Date	09/03/21	Pump Position	P-103A
MSA #	2021-038	Seal Manufacturer	FSI
Inquiry #	I-21-0098	Seal Model	MS6040SP0028-2726
Customer	Anchor Seals	Shaft Size	1.75"
Customer Ref #	2202718	Drawing #	FSI-2726
End User	USS Clairton Works	Seal Serial #	02373
Pump House	TEC	Inboard Rotary Material	Silicon Carbide
Contact	Brandon Spithaler	Inboard Stationary Material	Tungsten Carbide
Phone	412-865-2101	Outboard Rotary Material	-
Salesperson	House	Outboard Stationary Material	-
		Elastomers	Kalrez 6375

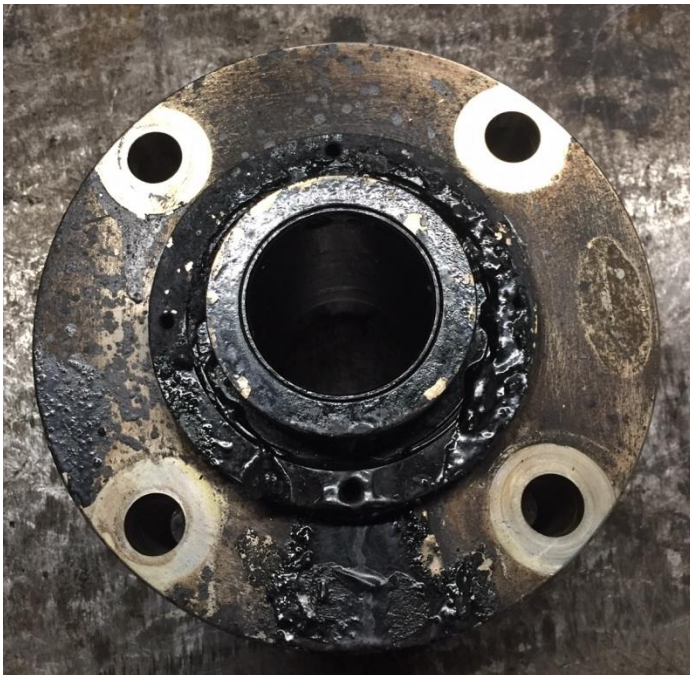
Figure 1: Seal Assembly

Seal was returned assembled.

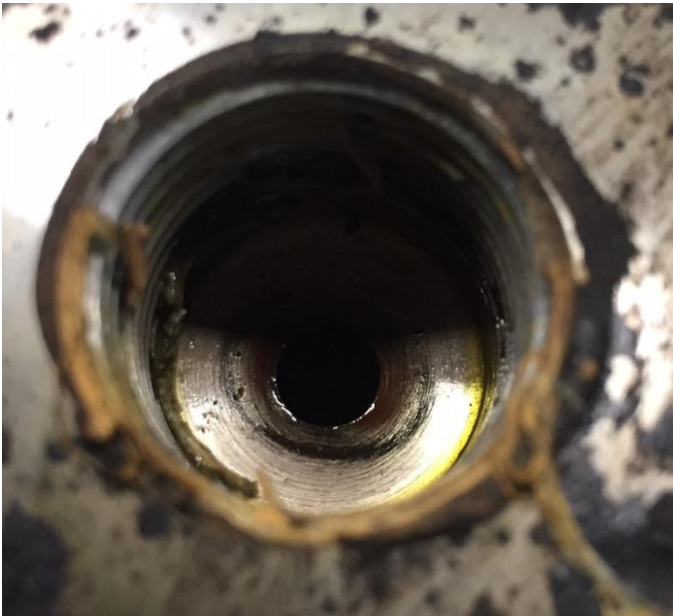
Figure 2: Quench Port

The quench port orifice was found to be clear.

Recommendation: Repair the seal and return it to service. Please ensure that the 3-5 psi steam quench is maintained through operation. This will help to limit the amount of added torque the bellows sees at startup due to hardened product. As well as follow all FSI manufacturer specifications when installing the mechanical seal to the pump.

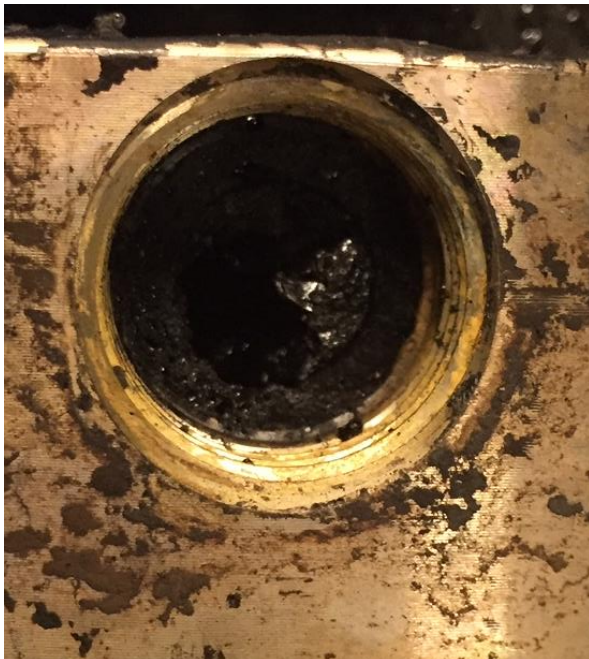
Figure 3: Drain Port

The drain port was found to be mostly clogged with debris.

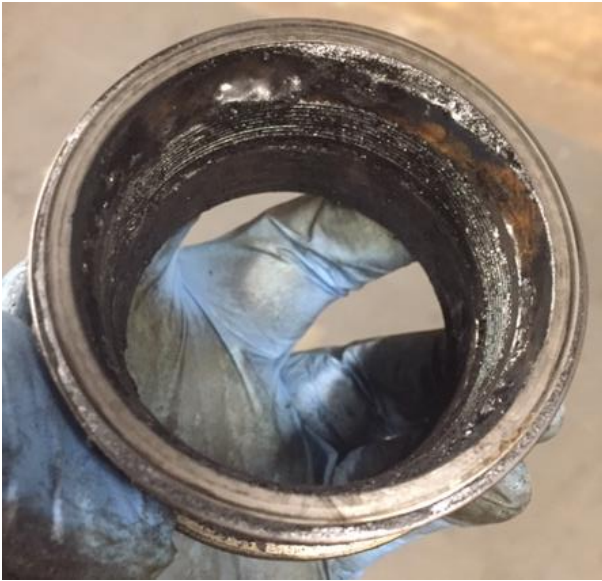
Figure 4: Stationary Face

The tungsten carbide stationary face showed an even and concentric wear pattern.

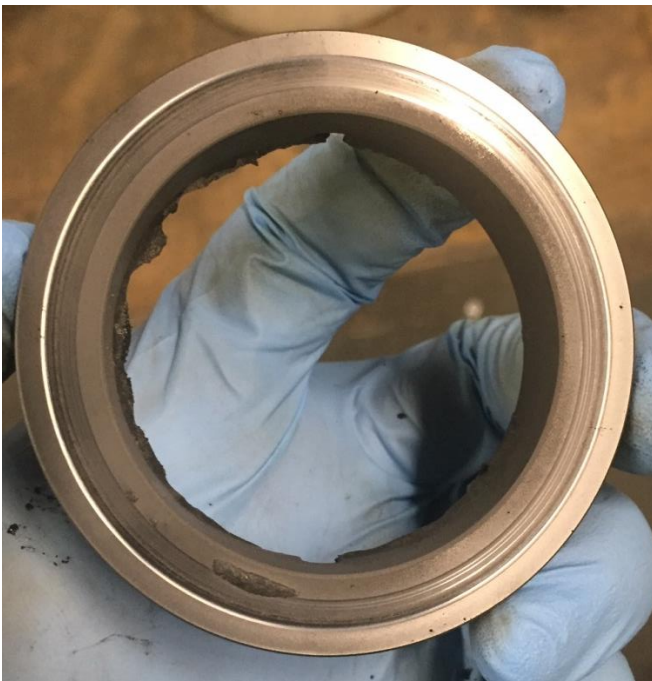
Figure 5: Rotary Face

The Silicon carbide rotary face showed an even and concentric wear pattern, but did show a fair amount of wear.

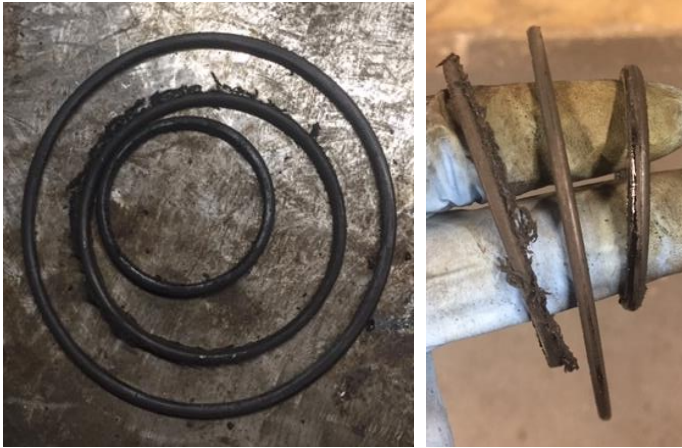
Figure 6 & 7: O-rings

All O-rings appeared to be in fair condition for sealing purposes. The stationary bellows capsule O-ring was fretted.

Failure Explanation: It appears that the seal failure was caused by a leak in the metal bellows. The cause of the tearing the bellows is unknown but there is evidence of possible vibration/runout due to the fretting of the stationary o-ring shown in the above photos.

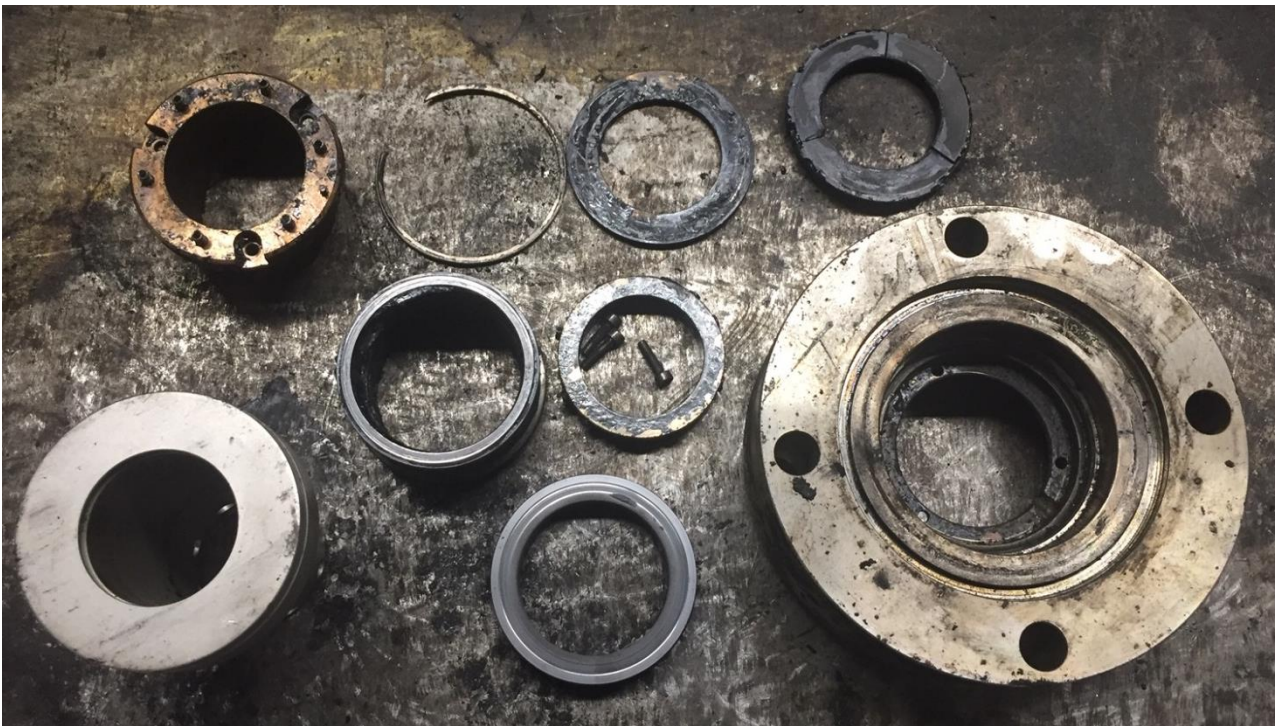
Figure 8: Metal Components

Most metal parts are in good working order. The Baffle plate was damaged during disassembly.

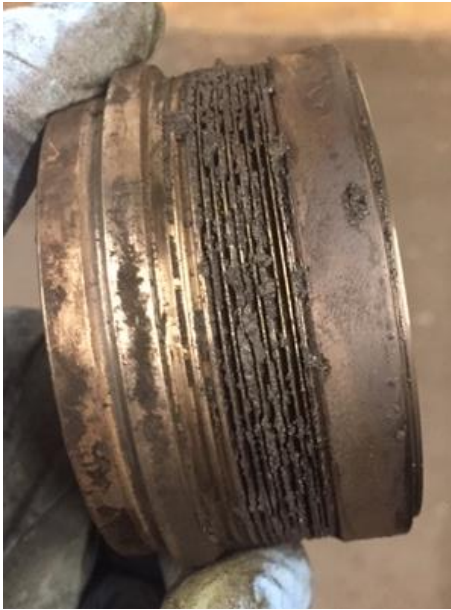
Figure 9: Bellows

After inspection, sandblasting and cleaning the bellows was pressure tested to determine that it did have a leak in the leaflets.
