## Mechanical Seal Analysis (MSA)

| <b>Date</b> | 11/01/21 | <b>Pump Position</b> | 802P2A |
| <b>MSA #</b> | 2021-049 | <b>Seal Manufacturer</b> | FSI |
| <b>Inquiry #</b> | I-21-0118 | <b>Seal Model</b> | MS6040HTC0046-2868 |

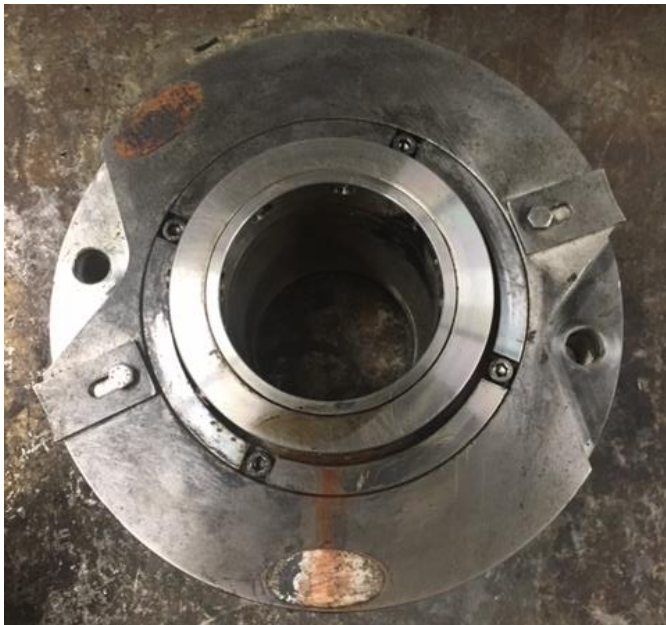
**Figure 1: Seal Assembly**

The seal was removed assembled.

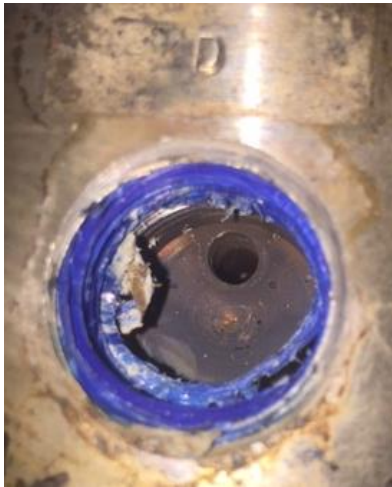
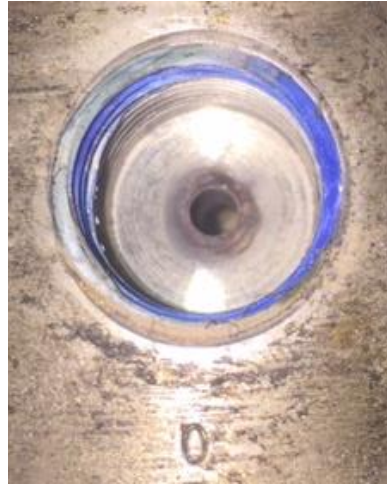
**Figure 2: Drain Port, Figure 3: Quench Port**

Both the drain port and the quench port were found clear of any obstructions.

**Recommendation:** Repair the seal and return it to service. Please ensure 3-5 psi of stream is constantly supplied to the quench port of the seal. It is also crucial that the seal drain piping be piped away from directly below the bearing housing. For the seal repair, we do recommend replacing the bellows capsule during each repair due to having no way to know the stresses that the welds and bellows leaflets have experienced during operation.

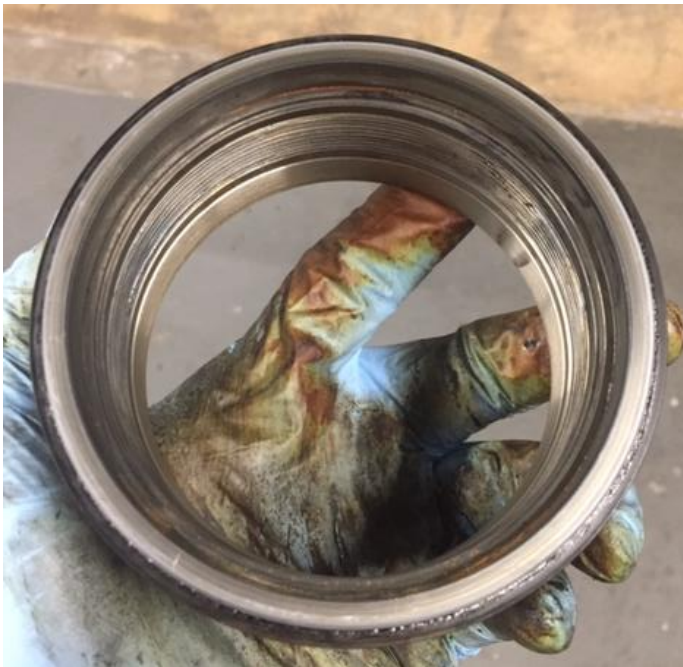
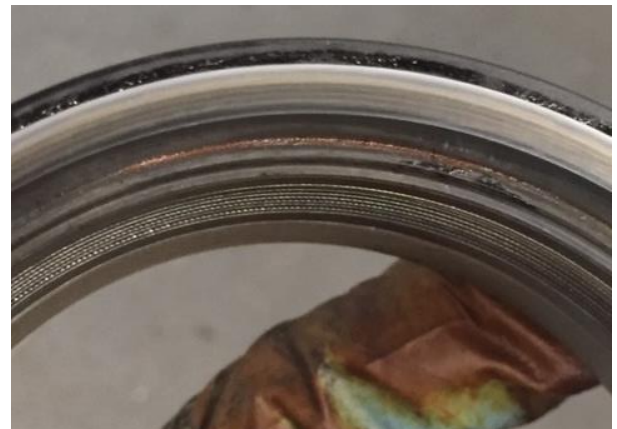
**Figure 4 & 5: Stationary Face**

The Tungsten Carbide stationary face showed an even wear pattern.

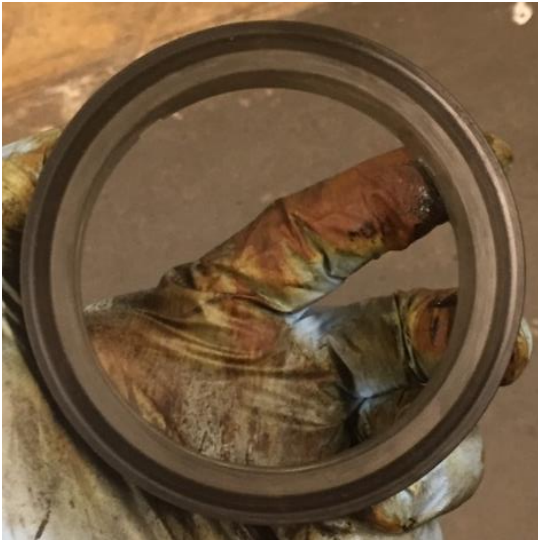
**Figure 6: Rotary Face**

The Silicon Carbide rotary face showed an even wear pattern. This face can be lapped and polished.

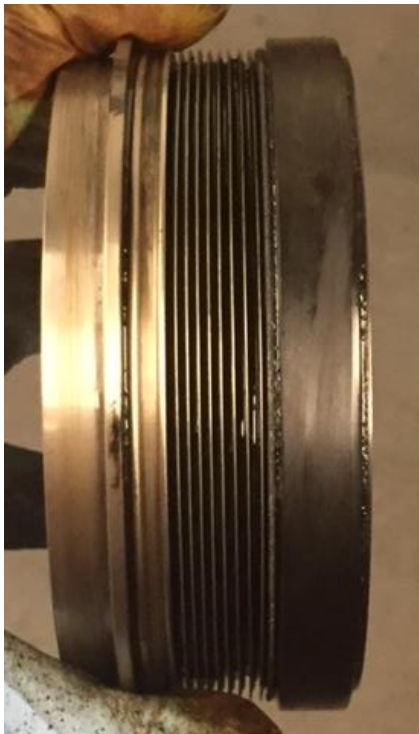
**Figure 7: Metal Bellows**

The metal bellows capsule was pressure tested and showed no signs of leakage.

**Failure Explanation:** This seal did not leak or fail. This seal was on the outboard end of Pump 802P2A and that outboard bearing experienced high vibration. Both the bearing as well as the seal was changed out on the pump onsite at USS Clairton. This seal was brought in for repair and evaluation as a precaution due to the vibration that it endured during service.

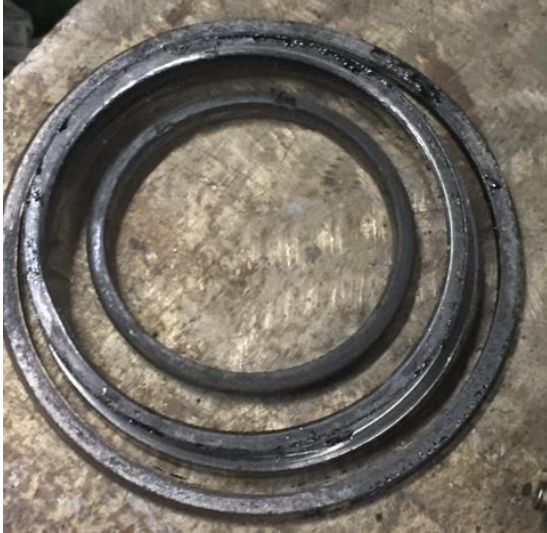
**Figure 8: O-Rings/ Gaskets**

All Graphoil gaskets and Kalrez O-ring were in good condition for sealing purposes.

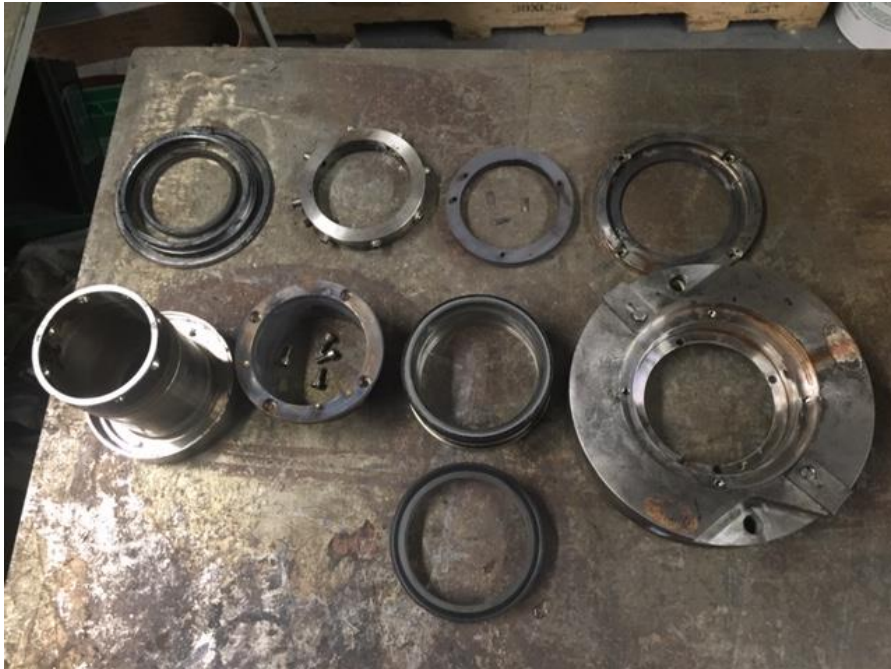
**Figure 9: Metal Components**

All Metal Parts are in good working condition.

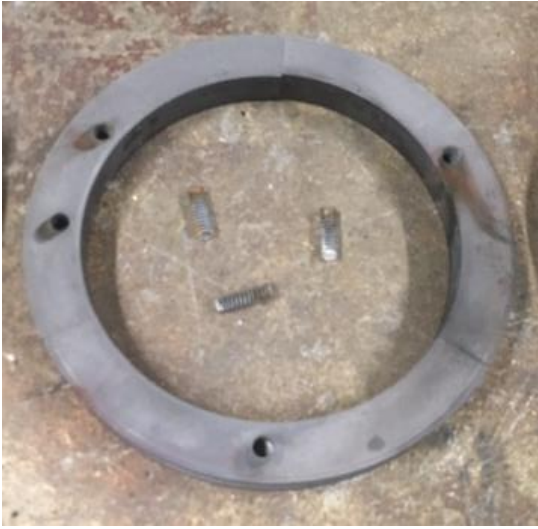
**Figure 10: Metal Parts**

The segmented carbon bushing and springs are in good working condition.
