Mechanical Seal Analysis (MSA)

Date	11/16/21	Pump Position	801P1-B
MSA #	2021-052	Seal Manufacturer	FSI
Inquiry #	I-21-0121	Seal Model	MS1020MSP0038-2371
Customer	Anchor Seals	Shaft Size	2.375"
Customer Ref #	12216597	Drawing #	FSI-2371
End User	USS Clairton Works	Seal Serial #	01744-R01
Pump House	TEC	Inboard Rotary Material	Tungsten Carbide
Contact	Brandon Spithaler	Inboard Stationary Material	Tungsten Carbide
Phone	412-865-2101	Outboard Rotary Material	-
Salesperson	Brandon Spithaler	Outboard Stationary Material	-
		Elastomers	Kalrez 6375

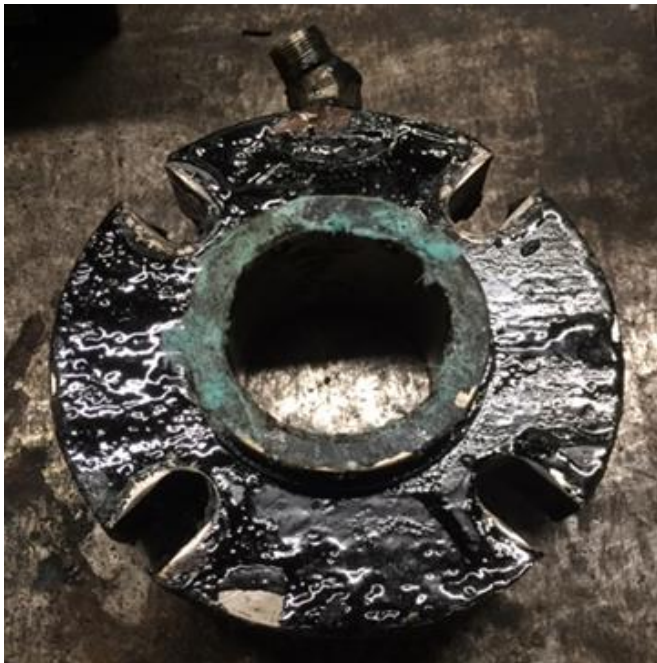
Figure 1: Seal Assembly

The seal was removed assembled and covered in product.

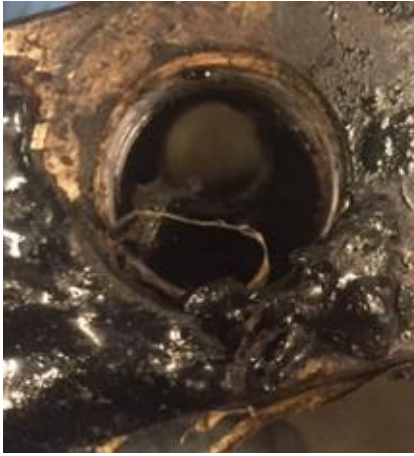
Figure 2: Flush Port

The flush port was found clear of any obstructions.

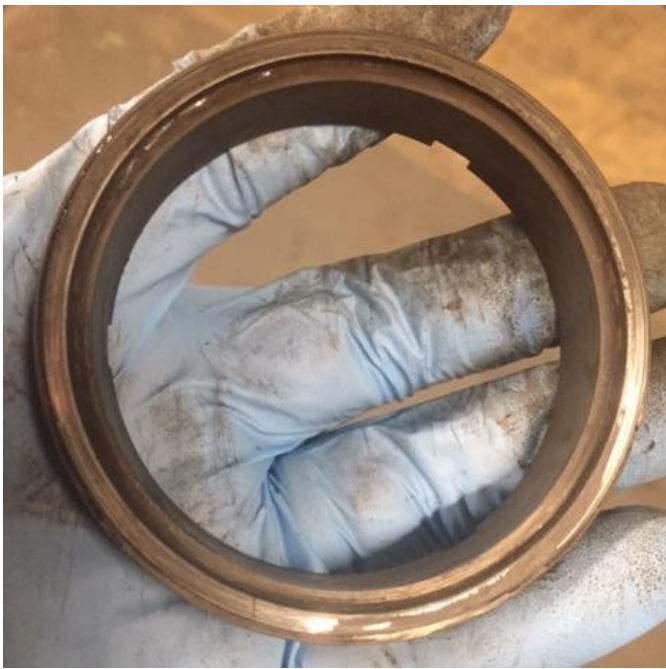
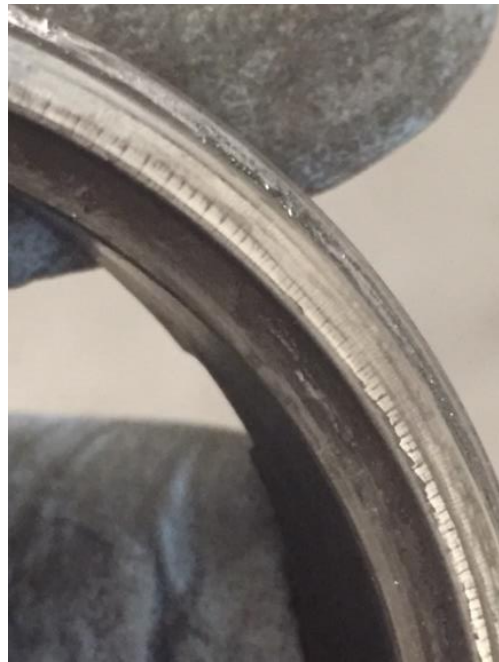
Figure 3 & 4: Stationary Face

The Tungsten Carbide stationary face showed heat checking and signs of excessive heat.

Failure Explanation: It appears this seal failed due to excessive heat due to a loss of lubrication across the seal faces. This is apparent throughout the report in both the heat checking of the Tungsten Carbide face as well as the condition of the O-rings.

Recommendation: Repair the seal and return it to service. Ensure that the seal is constantly supplied an adequate outside source flush at 10-15 psi above the stuffing box pressure.

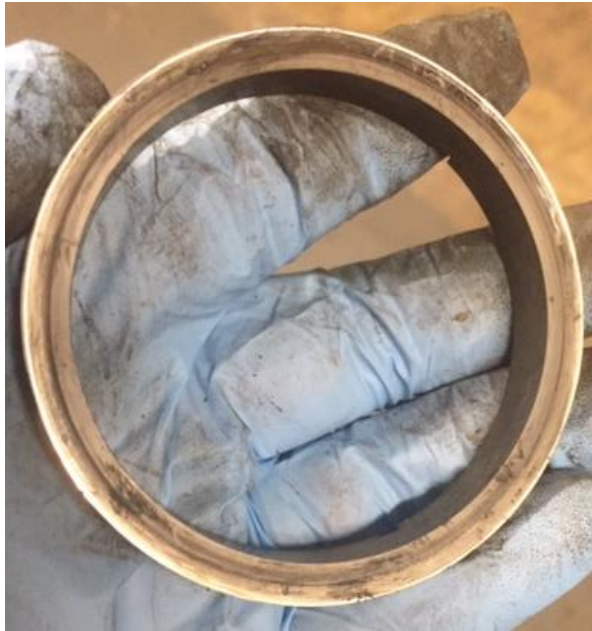
Figure 5: Rotary Face

The Tungsten Carbide rotary face was cracked at the anti-rotation pin.

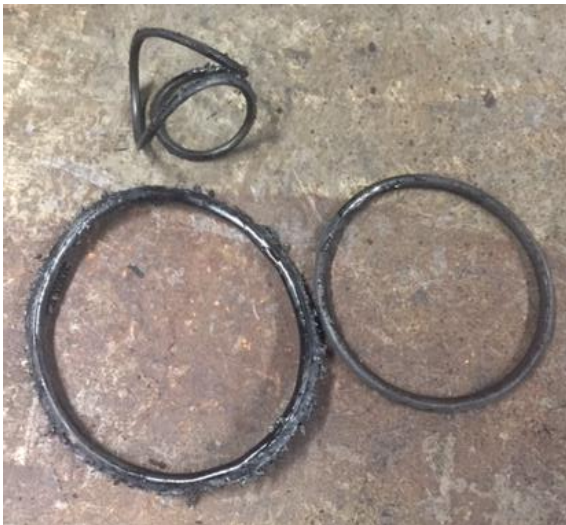
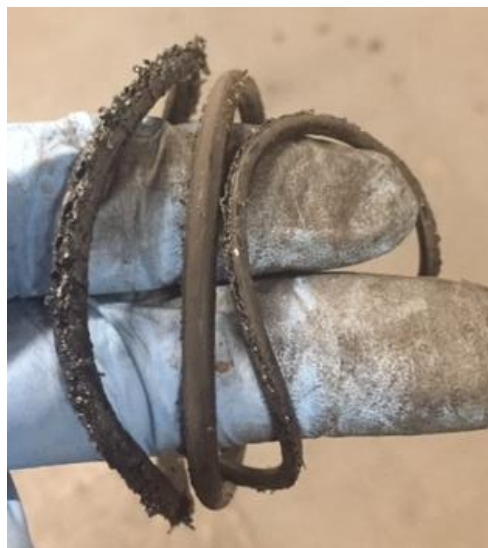
Figure 6 & 7: O-Rings

All Kalrez O-ring were fretted and show signs of excessive heat.

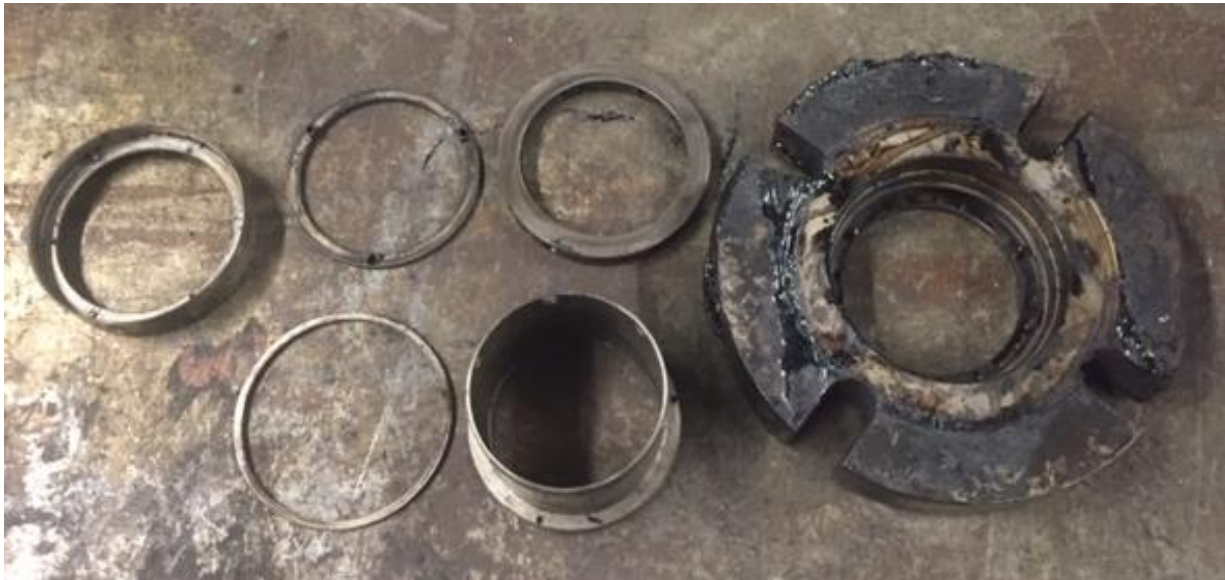
Figure 8: Metal Components

Most Metal Parts are in good working condition.
