Mechanical Seal Analysis (MSA)

Date	12/8/21	Pump Position	P112J
MSA #	2021-056	Seal Manufacturer	FSI
Inquiry #	I-21-0127	Seal Model	MS1030SP0048-2286
Customer	Anchor Seals	Shaft Size	3.00"
Customer Ref #	12257283	Drawing #	FSI-2286
End User	USS Clairton Works	Seal Serial #	02234-R01
Pump House	TEC	Inboard Rotary Material	Silicon Carbide
Contact	Brandon Spithaler	Inboard Stationary Material	Tungsten Carbide
Phone	412-865-2101	Outboard Rotary Material	-
Salesperson	Brandon Spithaler	Outboard Stationary Material	-
		Elastomers	Kalrez 6375

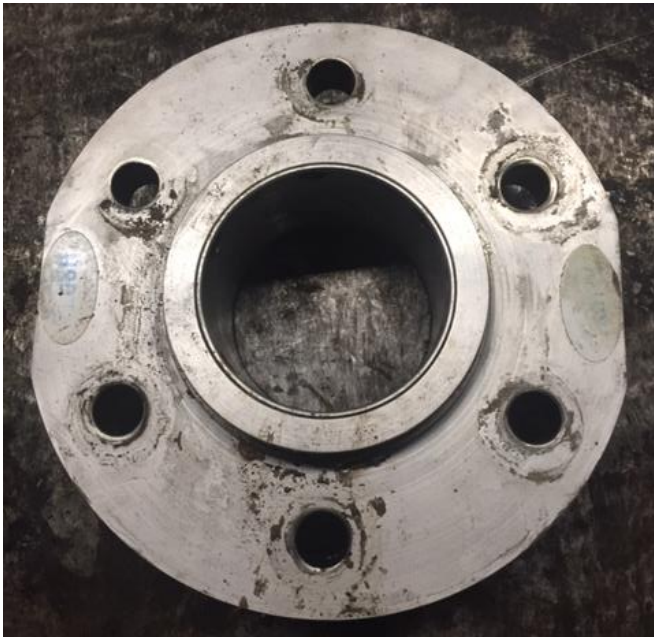
Figure 1: Seal Assembly

The seal was removed assembled and covered in product.

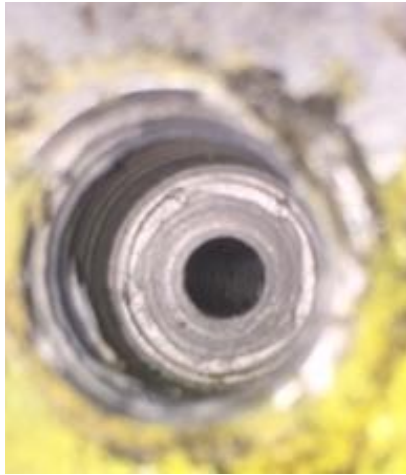
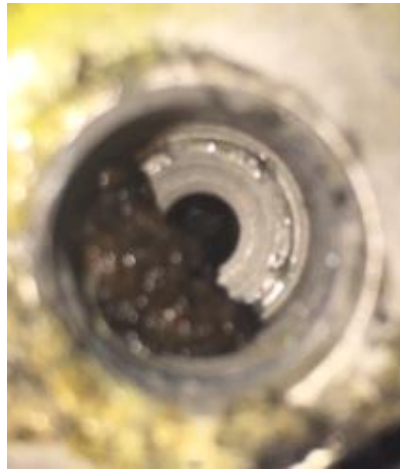
Figure 2 & 3: Flush Ports

One flush port was found to be completely clear and the other had some debris and was slightly obstructed.

Recommendation: Repair the seal and return it to service. Be sure to follow all manufacturers recommendations when installing the mechanical seal. Please properly prime the pump and seal prior to startup. Ensure an adequate seal flush is always provided to the seal.

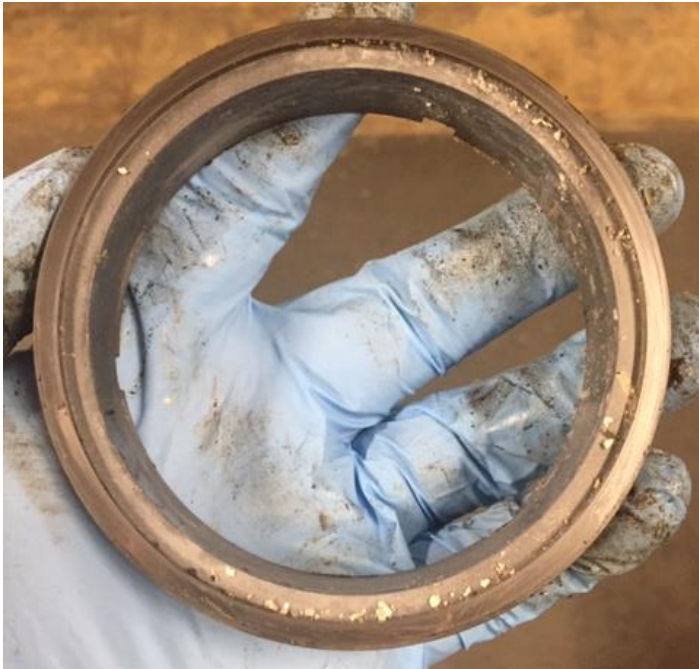
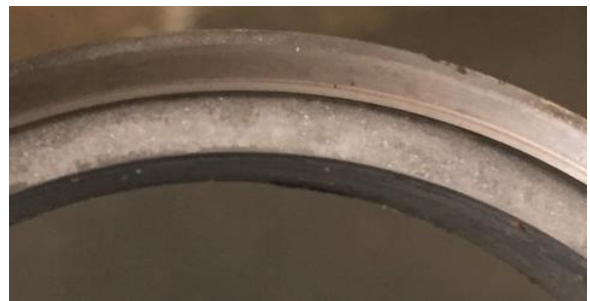
Figure 4 & 5: Stationary Face

The Tungsten Carbide stationary face showed an even wear pattern.

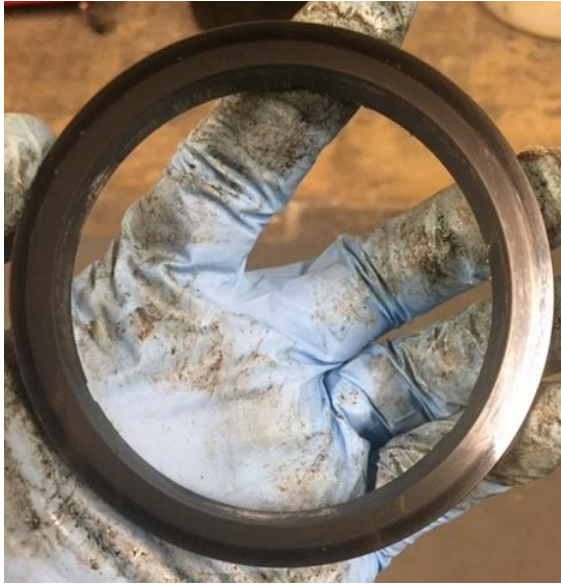
Figure 6: Rotary Face

The Silicon Carbide rotary face showed an even and concentric wear pattern. There were a few small divots in the sealing face showing signs of possibly blistering.

Failure Explanation: The overall condition of the seal is in good condition. There are no signs of metal-to-metal contact. The elastomers are in fair condition. Based on the condition of the seal faces it is possible that the seal ran without sufficient lubrication across the seal faces. This is what could have resulted in the slight blistering on the rotary face. This would have resulting in a small visible leak.

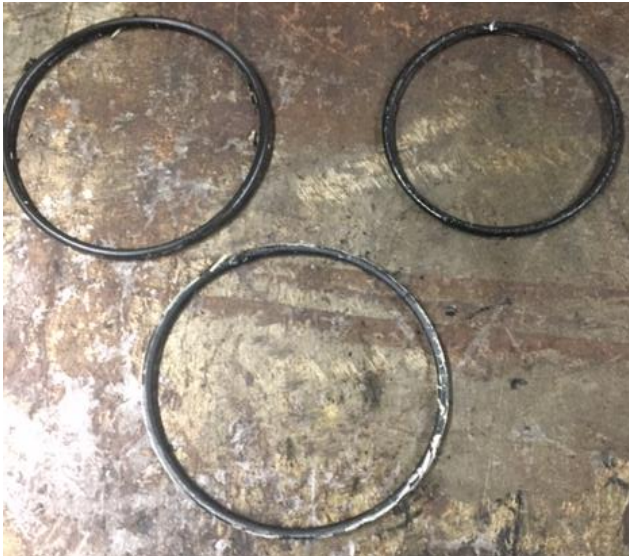
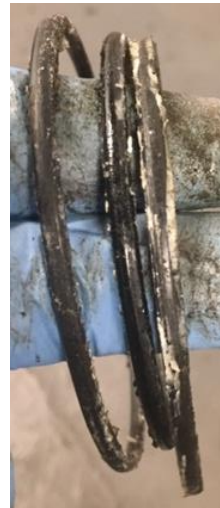
Figure 7 & 8: O-Rings

All Kalrez O-rings were in fair condition for sealing purposes.

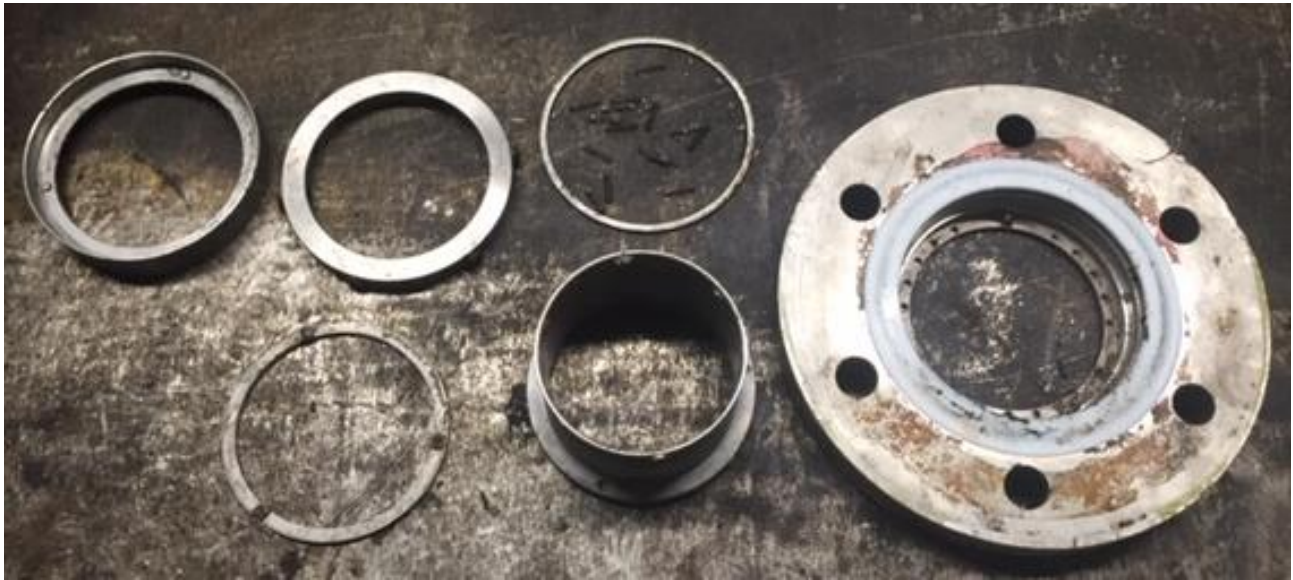
Figure 9: Metal Components

All metal parts are in good working order. There is no signs of metal to metal contact.

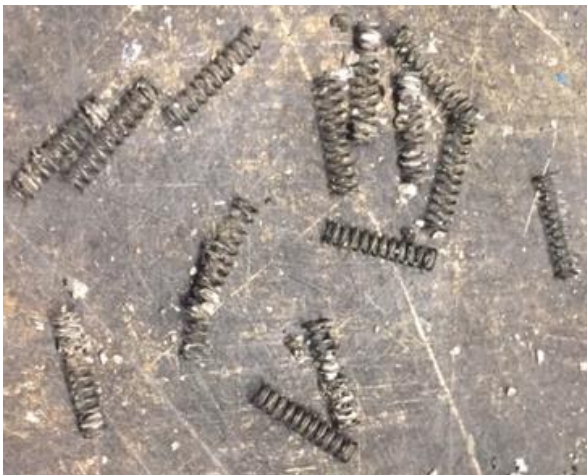
Figure 10: Springs

The springs flexed freely upon removal.
