Mechanical Seal Analysis (MSA)

Date	1/21/2022	Pump Position	2019
MSA #	2022-005	Seal Manufacturer	FSI
Inquiry #	I-22-0007	Seal Model	MS1040HD0034-2395
Customer	Anchor Seals	Shaft Size	2.125"
Customer Ref #	12316843	Drawing #	FSI-2395
End User	USS Clairton Works	Seal Serial #	01708-R03
Pump House	TEC	Inboard Rotary Material	Silicon Carbide
Contact	Brandon Spithaler	Inboard Stationary Material	Silicon Carbide
Phone	412-865-2101	Outboard Rotary Material	-
Salesperson	Brandon Spithaler	Outboard Stationary Material	-
		Elastomers	Kalrez 1050LF

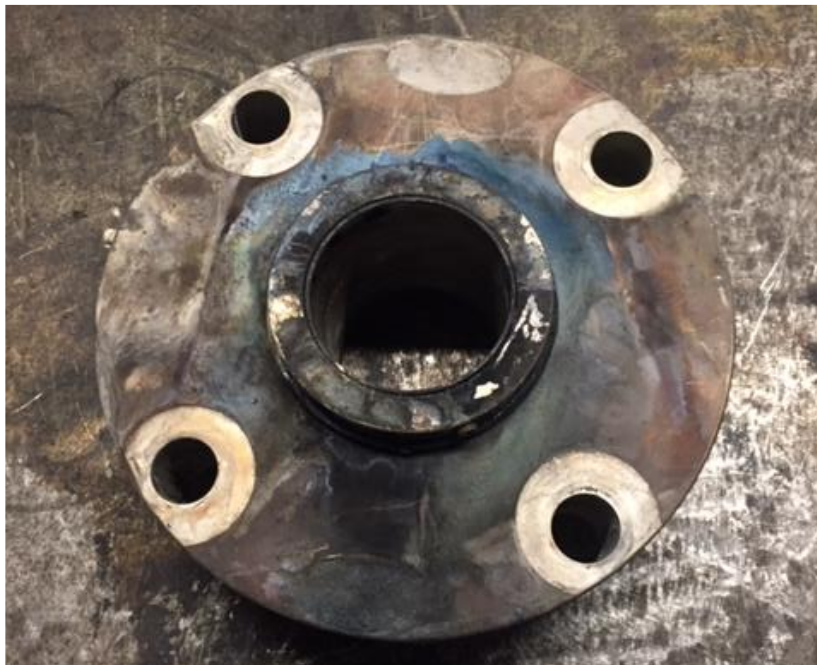
Figure 1: Seal Assembly

The seal arrived assembled and covered in traces of product.

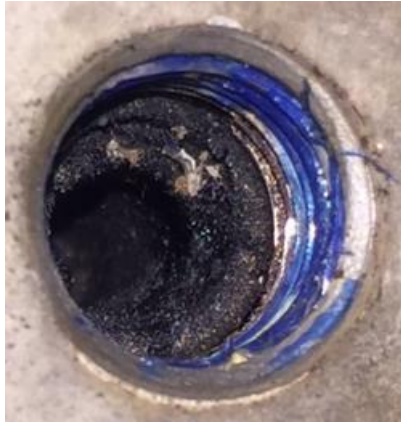
Figure 2: Flush Ports

The flush port orifice was found mostly clear

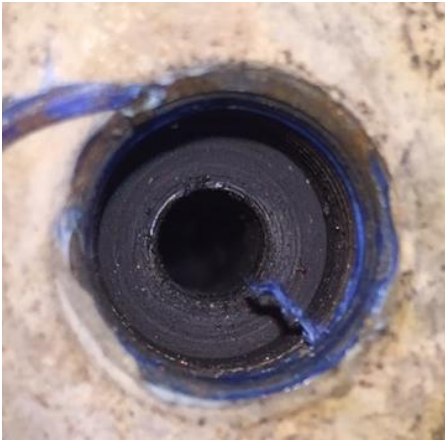
Figure 2: Quench Ports

Failure Explanation: It appears that this seal failed due to a loss of steam quench and subsequent product build up on an around the seal faces. This then resulted in the cracking of the seal faces due to the added torque of the buildup. The cracked seal faces are shown throughout the report. As well as product residue in the steam quench port suggesting that the steam supply was lost at some point during the operation.

Recommendation: Ensure that the steam quench is always provided to the seal at 3-5psi.

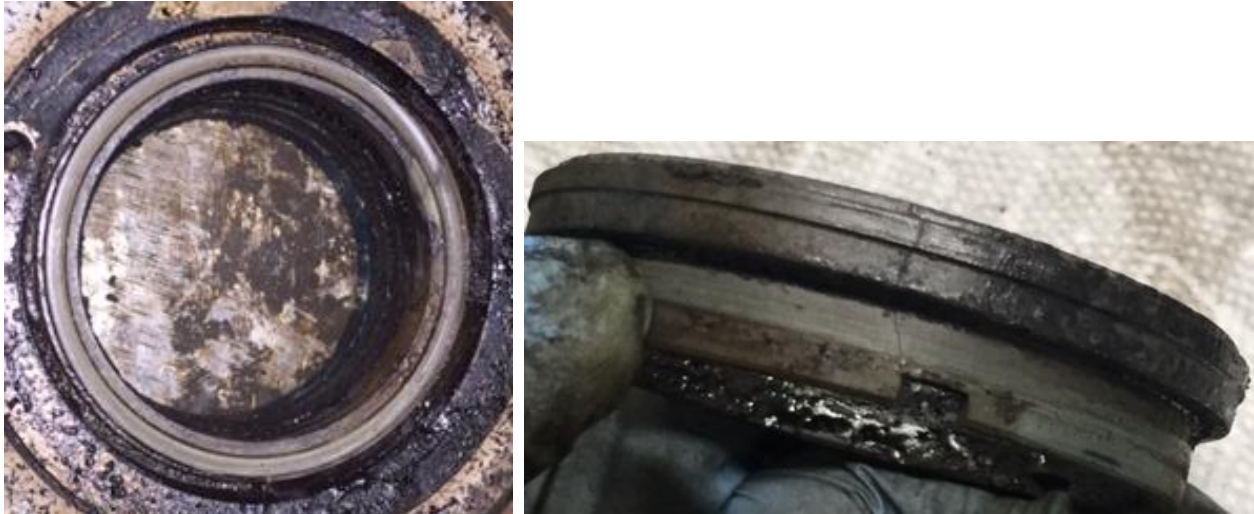
Figure 3 & 4: Stationary Face

The Silicon Carbide stationary face was cracked where it would engage with the thrust disk.

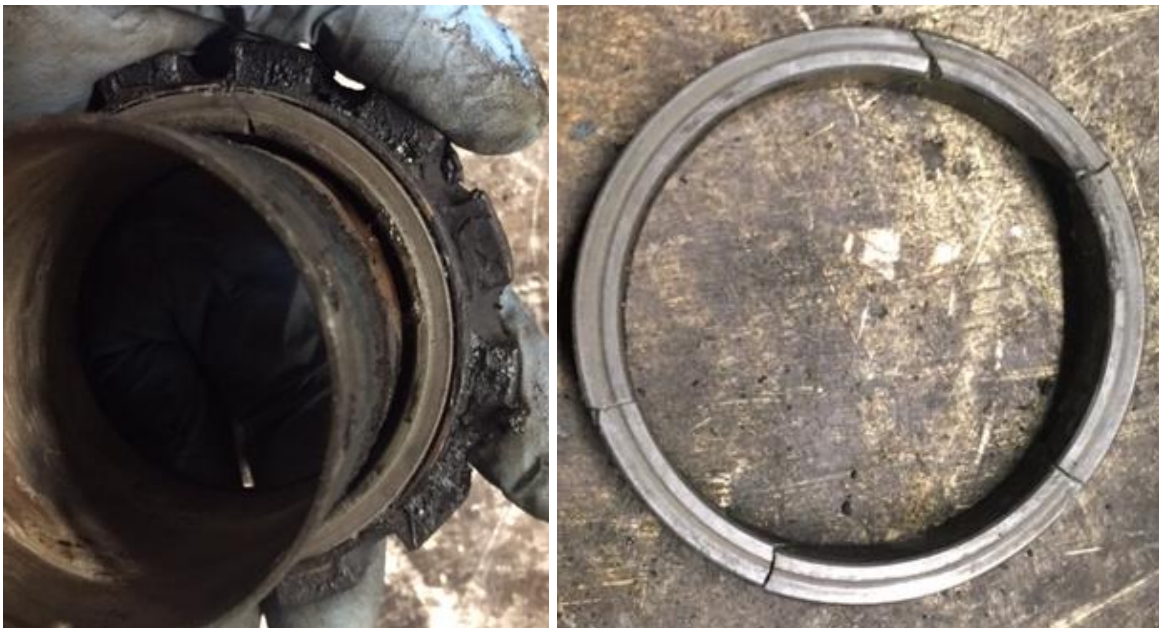
Figure 5 & 6: Rotary Face

The Silicon Carbide rotary face was cracked prior to being removed from the inboard carrier. Once removed it was broken in multiple locations.

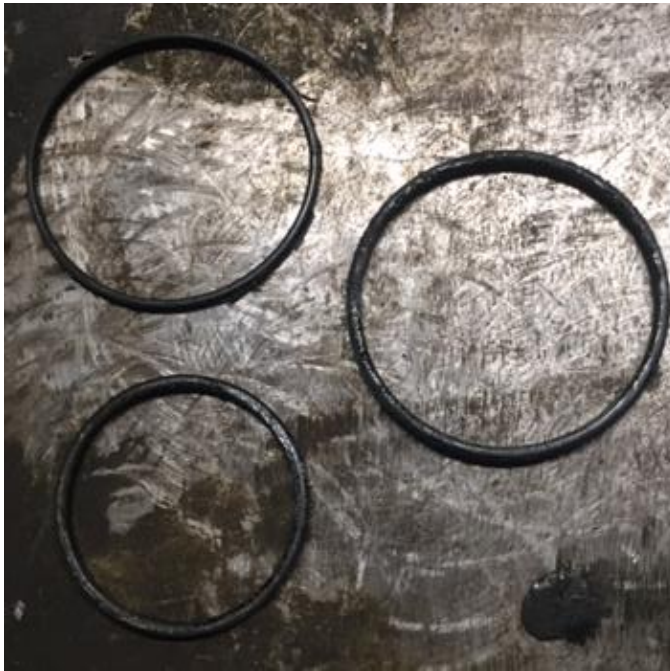
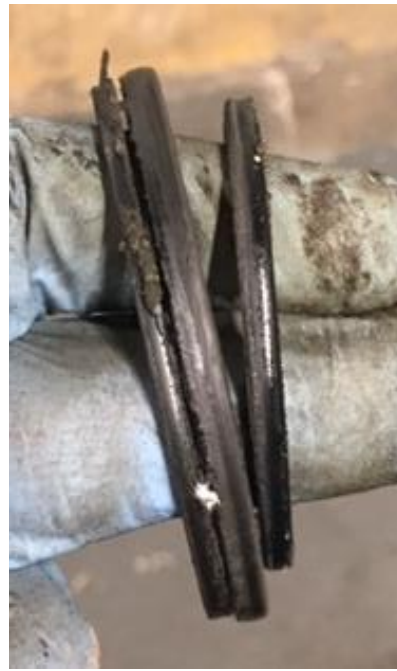
Figure 7 & 8: O-Rings

All O-rings are in fair condition for sealing purposes.

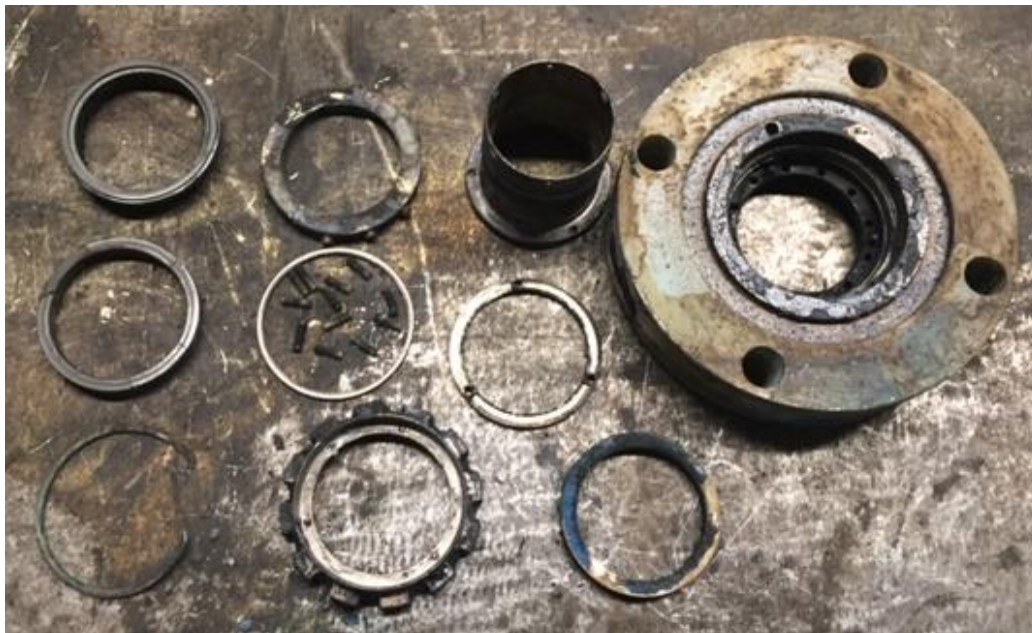
Figure 9: Metal Components

Most all metal parts were in good working condition.

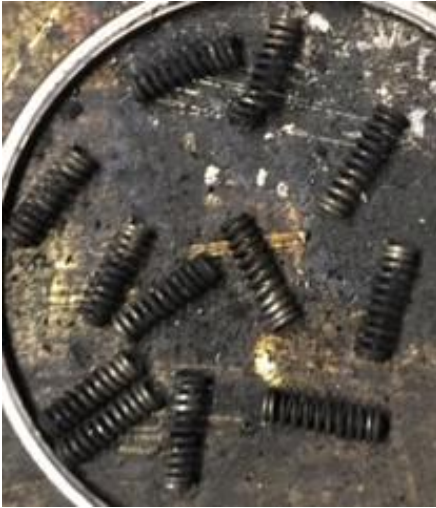
Figure 10: Springs

Some springs were difficult to remove from the seal gland.
