Mechanical Seal Analysis (MSA)

Date	3/22/22	Pump Position	P-620A
MSA #	2022-015	Seal Manufacturer	FSI
Inquiry #	I-22-0034	Seal Model	MS104000342XSXJJ
Customer	Anchor Seals	Shaft Size	2.125"
Customer Ref #	12462293	Drawing #	FSI-2009-34
End User	USS Clairton	Seal Serial #	01703-R01
Pump House	TEC	Inboard Rotary Material	Silicon Carbide
Contact	Brandon Spithaler	Inboard Stationary Material	Tungsten Carbide
Phone	412-865-2101	Outboard Rotary Material	-
Salesperson	Brandon Spithaler	Outboard Stationary Material	-
		Elastomers	Kalrez 6375

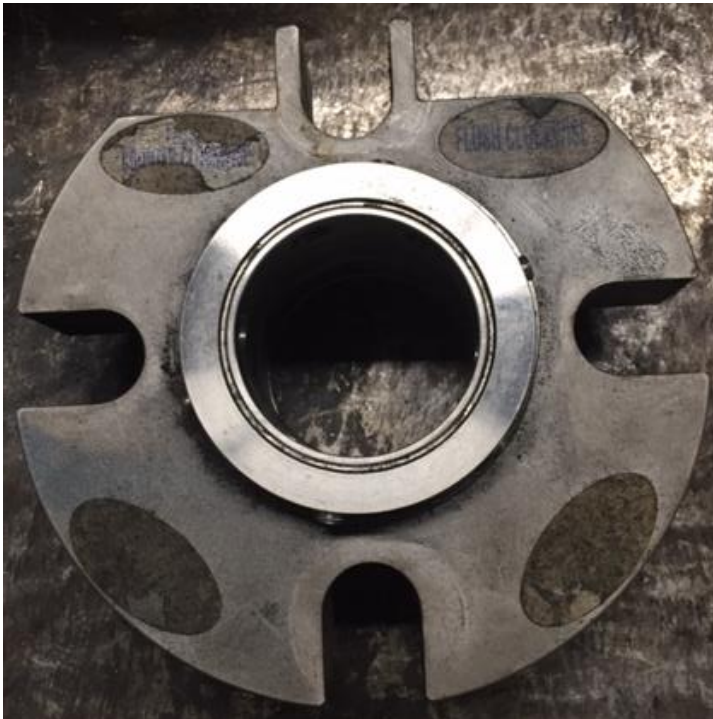
Figure 1: Seal Assembly

The seal was returned assembled.

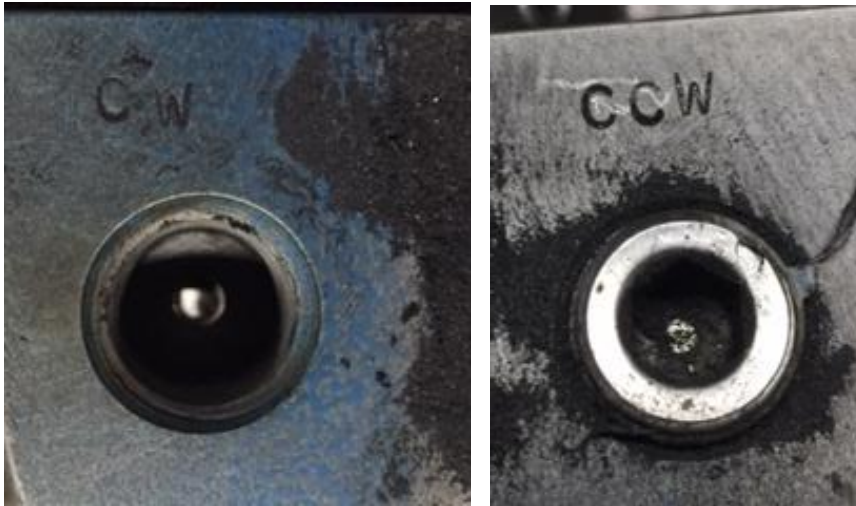
Figure 2 & 3: Flush Port

The clockwise flush port was found to open. The

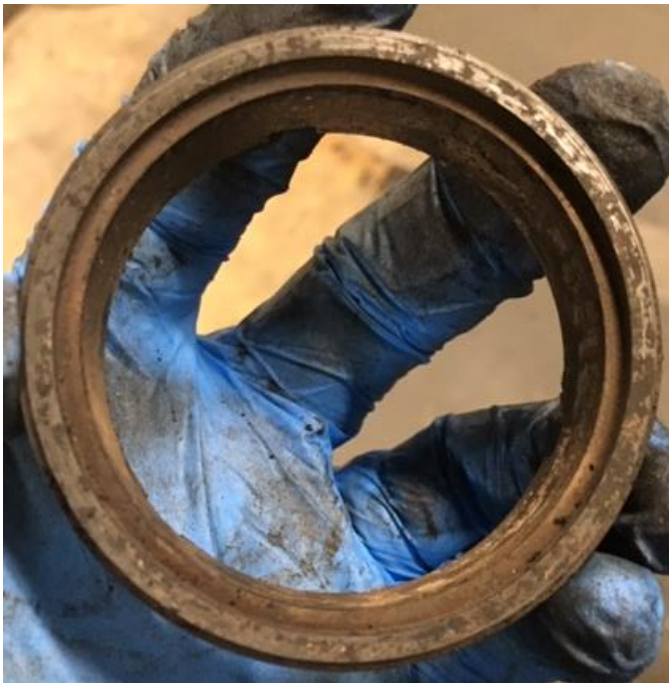
Figure 4: Stationary Face

The Tungsten Carbide stationary face shows markings on the seal face that may have resulted from the vibration/ cavitation that the pump experienced due to the hole worn in the cut water of the pump.

Failure Explanation: This pump was reported to have experienced a failure due to a hole worn in the cutwater of the pump that caused vibration that loosened the impeller and caused it to back loose then making contact with the pump casing and seizing the pump.

Recommendation: Repair the seal and return it to service.

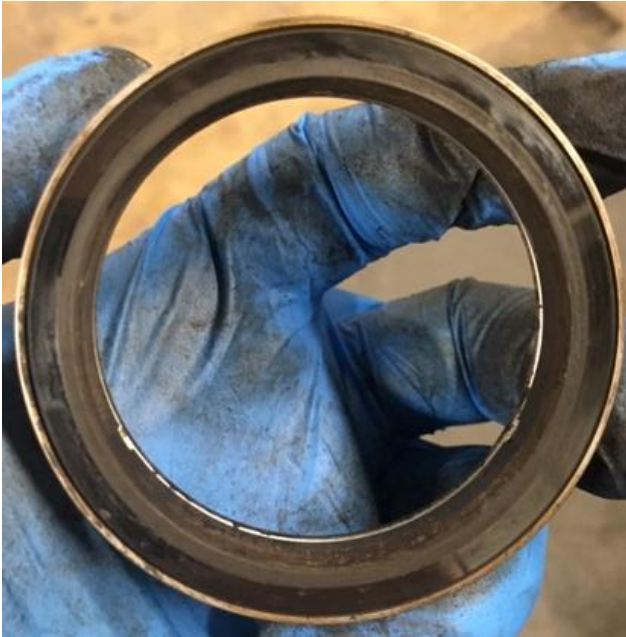
Figure 5: Rotary Face

The Silicon Carbide rotary face showed a concentric wear pattern.

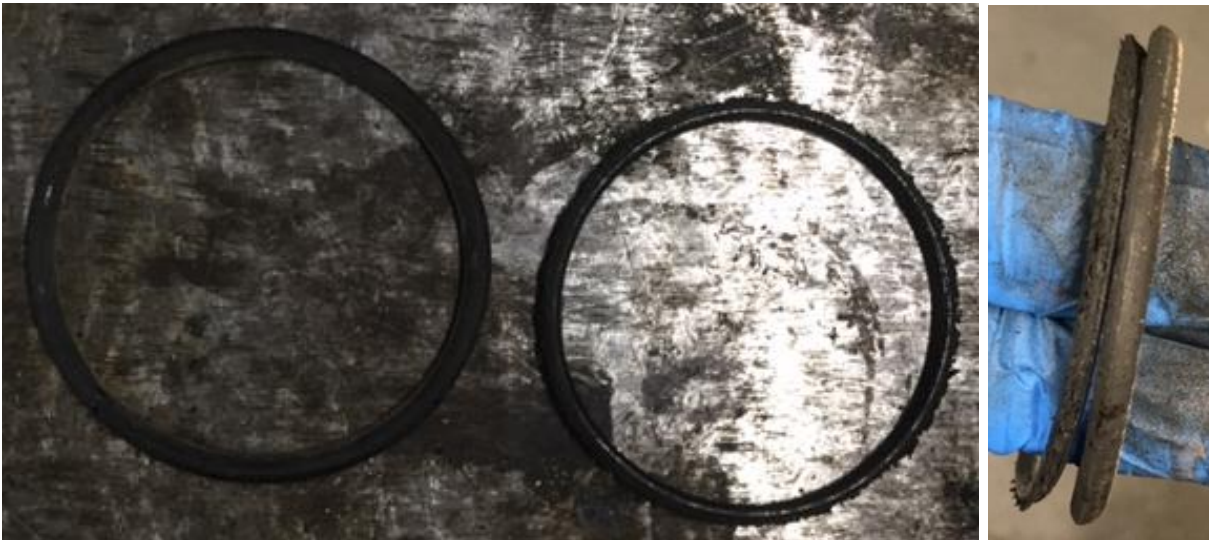
Figure 6 & 7: O-rings

The stationary seal face O-ring is fretted which coincides with the vibration the seal would have experienced with the issues found in the pump.

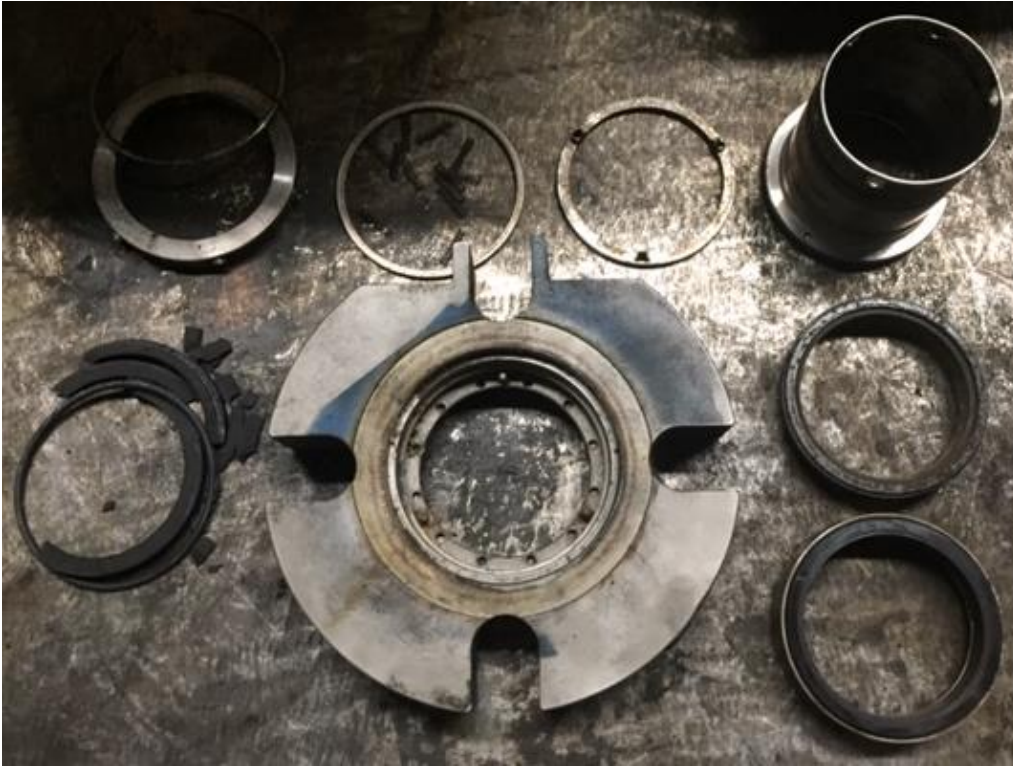
Figure 8: Metal Components

Most metal parts are in good working order.

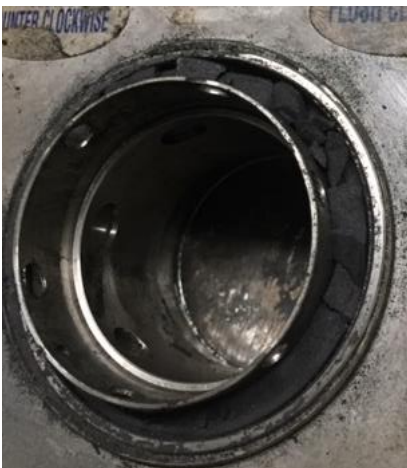
Figure 9: Carbon Gland Bushing

The gland bushing is shattered, this damage was more than likely caused when the pump seized up.

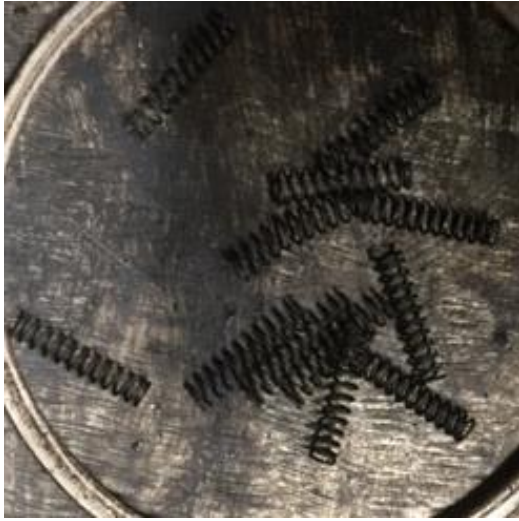
Figure 10: Springs

All springs flexed freely upon removal.
