Mechanical Seal Analysis (MSA)

Date	3/22/22	Pump Position	P-620
MSA #	2022-015	Seal Manufacturer	FSI
Inquiry #	I-22-0034	Seal Model	MS104000342XSXJJ
Customer	Anchor Seals	Shaft Size	2.125"
Customer Ref #	12462293	Drawing #	FSI-2009-34
End User	USS Clairton	Seal Serial #	01703-R01
Pump House	TEC	Inboard Rotary Material	Silicon Carbide
Contact	Brandon Spithaler	Inboard Stationary Material	Tungsten Carbide
Phone	412-865-2101	Outboard Rotary Material	-
Salesperson	Brandon Spithaler	Outboard Stationary Material	-
		Elastomers	Kalrez 6375

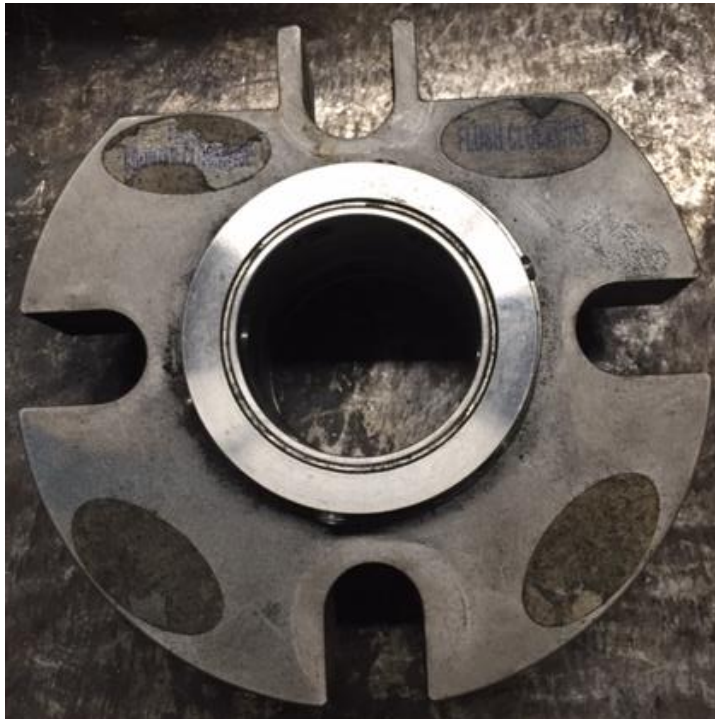
Figure 1: Seal Assembly

The seal was returned assembled.

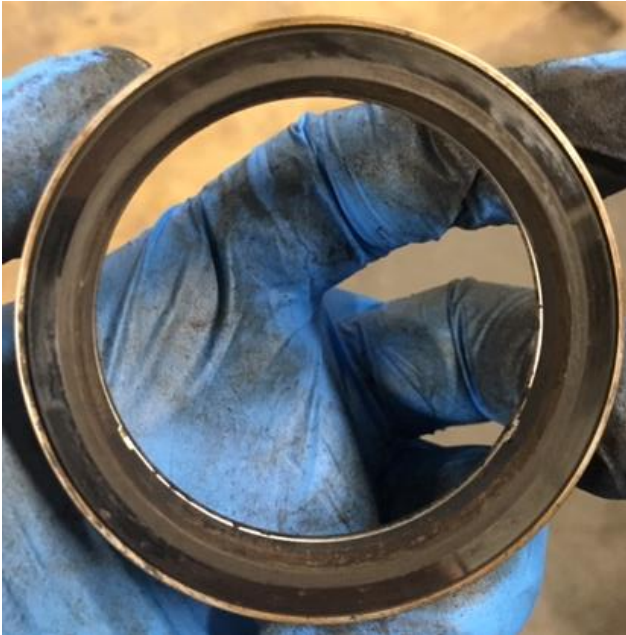
Figure 5: Rotary Face

The Silicon Carbide rotary face showed a concentric wear pattern.

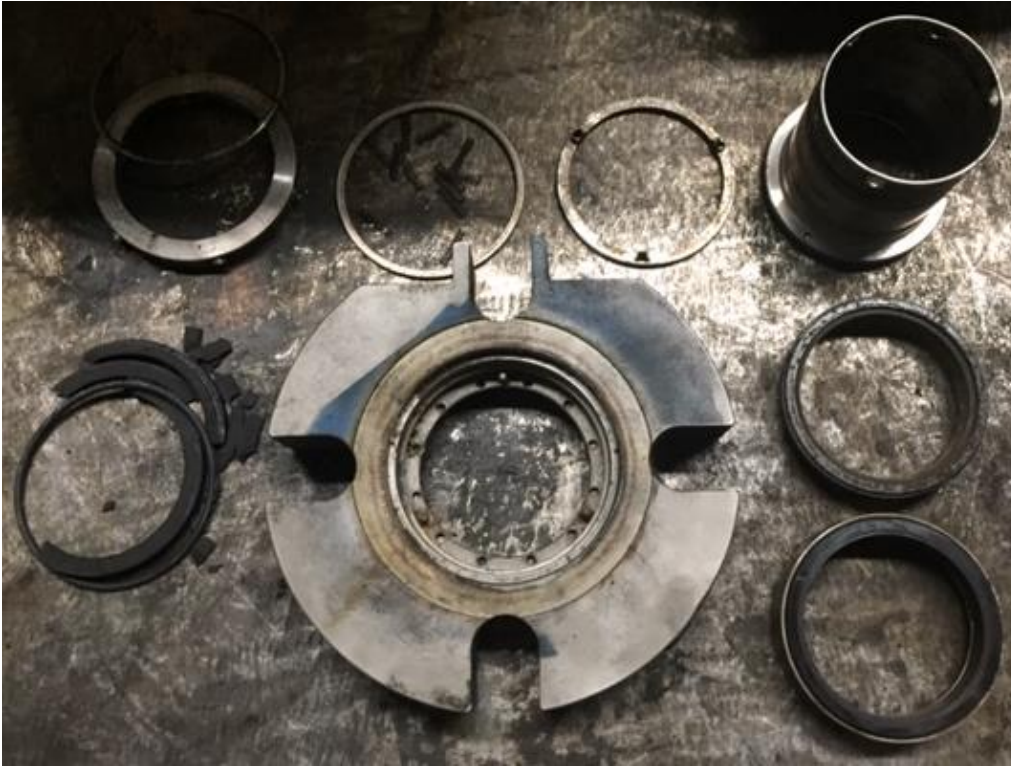
Figure 8: Metal Components

Most metal parts are in good working order.

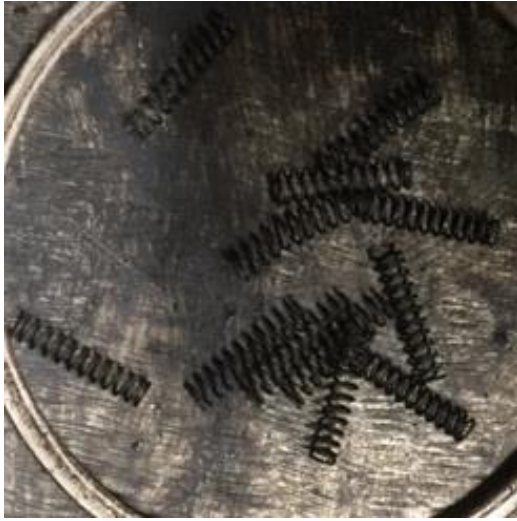
Figure 10: Springs

All springs flexed freely upon removal.
