Mechanical Seal Analysis (MSA)

Date	8/14/22	Pump Position	805P1-B
MSA #	2022-032	Seal Manufacturer	FSI
Inquiry #	I-22-0086	Seal Model	MS1040HD0038-2511
Customer	Anchor Seals	Shaft Size	2.375"
Customer Ref #	12693853	Drawing #	FSI-2511
End User	USS Clairton Works	Seal Serial #	02386
Pump House	TEC	Inboard Rotary Material	Tungsten Carbide
Contact	Brandon Spithaler	Inboard Stationary Material	Tungsten Carbide
Phone	412-865-2101	Outboard Rotary Material	-
Salesperson	Brandon Spithaler	Outboard Stationary Material	-
		Elastomers	FFKM

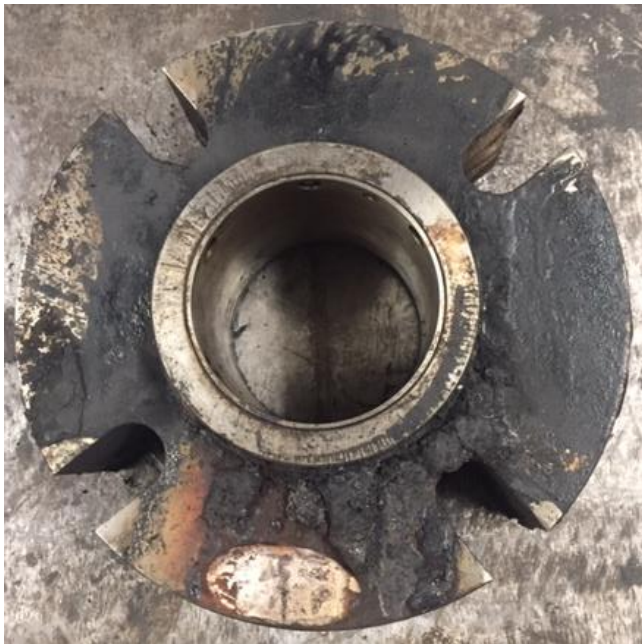
Figure 1: Seal Assembly

The seal was removed assembled and covered in product.

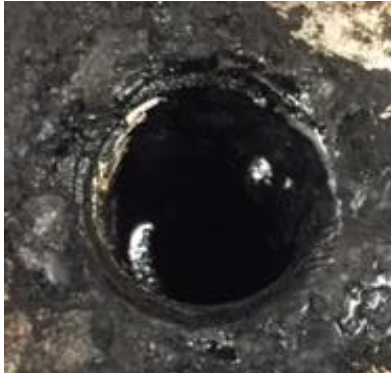
Figure 2: Flush Port

The flush port was filled with liquid product residue.

Failure Explanation: It appears that the seal failed due to a buildup of product on and around the seal faces. This is probably a result of the seal drain port eventually being clogged with debris over time. This would have eliminated the ability of the steam quench to carry away the traces of particles that make their way across the seal faces during operation.

Recommendation: Please repair this seal and return it to service. It is important to always maintain the steam quench source to the seal, as well as to limit the amount of sharp turns the drain piping has in it to help to prevent clogging.

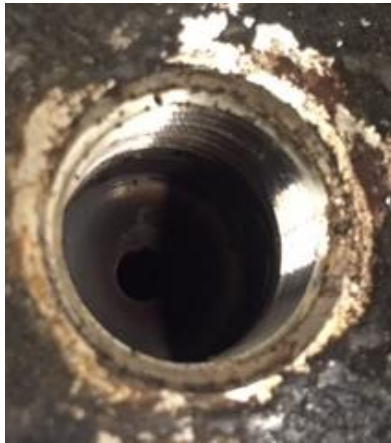
Figure 3: Quench Port

The quench port appeared to be clear of debris.

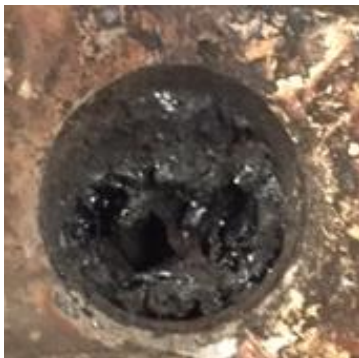
Figure 4: Drain Port

The Drain port was found to be clogged with hardened debris.

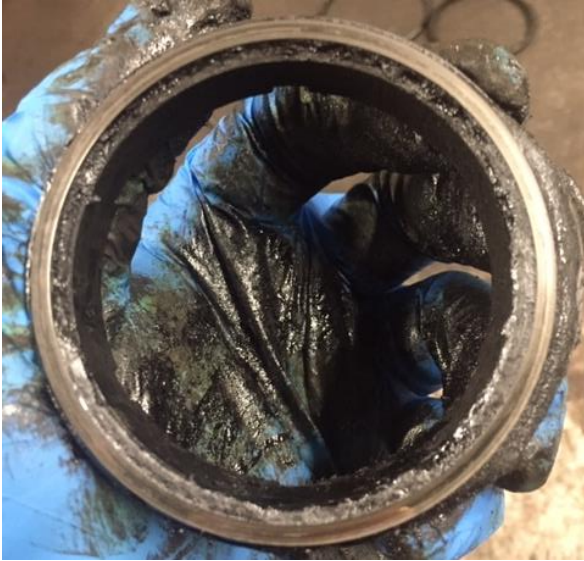
Figure 5: Stationary Face

The Tungsten Carbide stationary face showed evidence of wear and a lack of lubrication across the seal face.

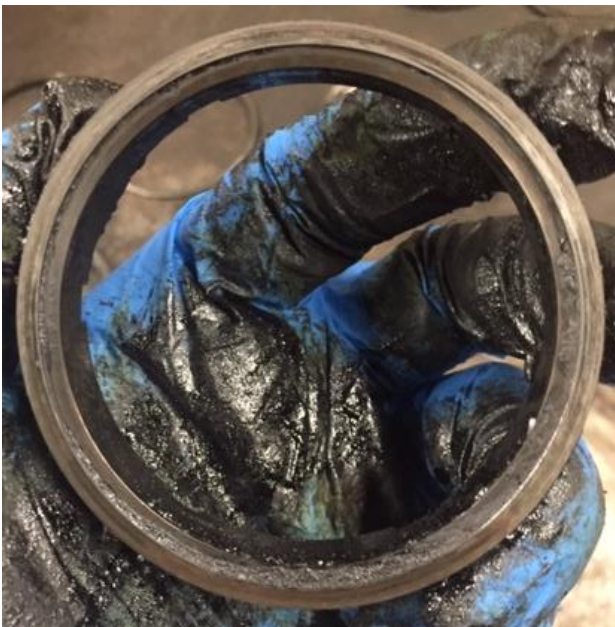
Figures 6: Rotary Face

The Tungsten Carbide stationary face showed evidence of wear and a lack of lubrication across the seal face.

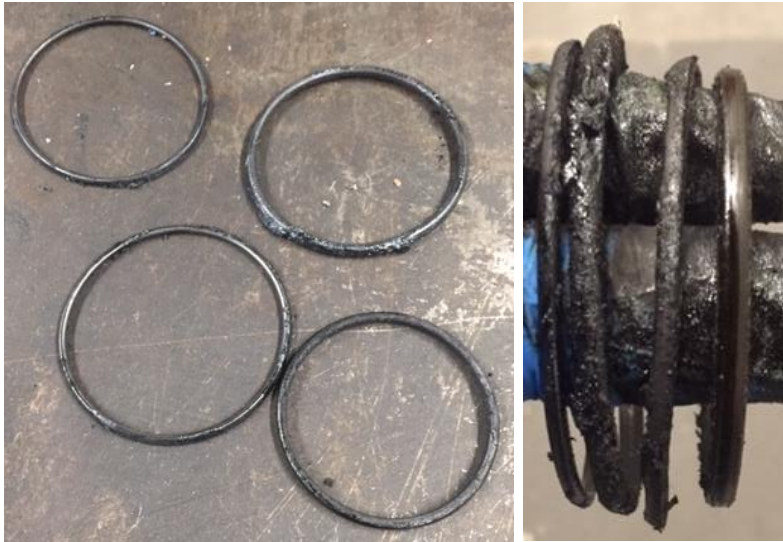
Figure 7 & 8: O-Rings

All O-rings were in good condition for sealing purposes.

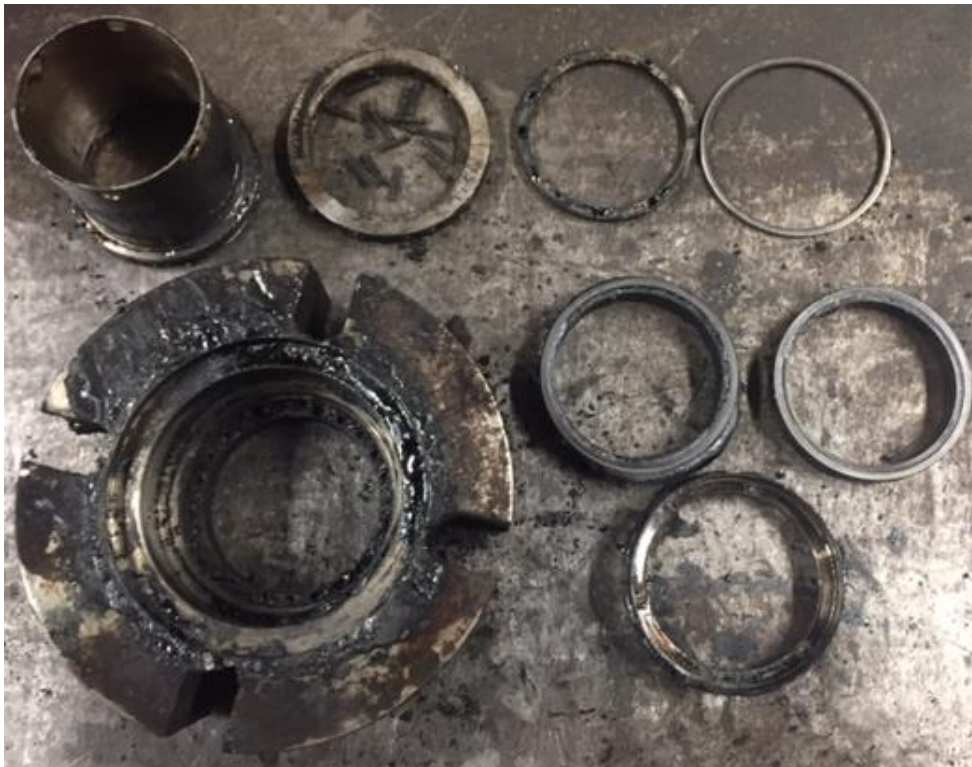
Figure 9: Metal Components

All metal parts are in good working condition.

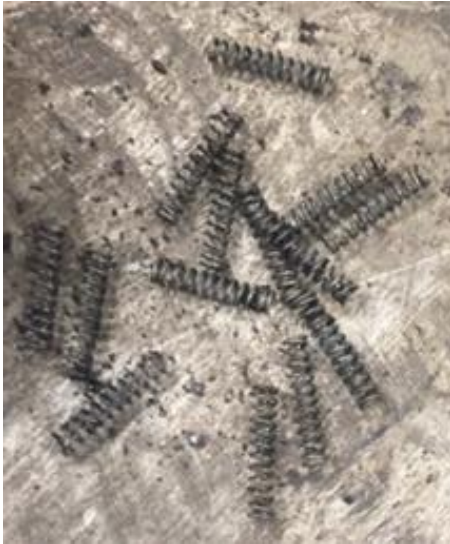
Figure 10: Springs

All the springs flexed freely when removed.
